# 1986 Corvette: Recall Notice: Anti-Skid Brake System Master Cylinder Center Valve

**Bulletin No:** 86C12, Number 5

Subject: PRODUCT SAFETY CAMPAIGN 86C12  
ANTI-SKID BRAKE SYSTEM  
MASTER CYLINDER CENTER VALVE

Model and Year: 1986 CHEVROLET CORVETTE

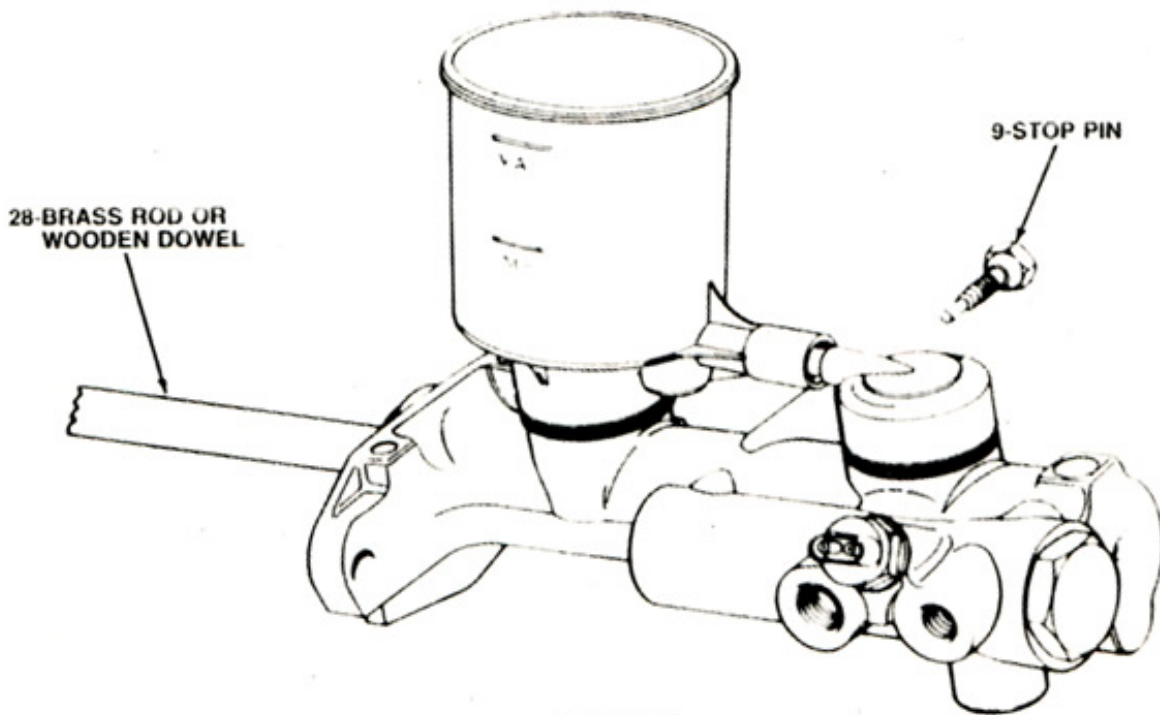
FIGURE 1

General Motors has determined that a defect which relates to motor vehicle safety exists in certain 1986 Corvettes. Certain severe and unusual braking conditions may cause damage to the brake master cylinder center valve. If sufficient damage accumulates, loss of front brakes may occur with accompanying increased pedal travel and reduced braking ability. A reduction of braking ability at a time when minimum stopping distance is required could result in a vehicle crash without prior warning.

1. Remove master cylinder from vehicle.
2. Drain and discard brake fluid from master cylinder reservoir and bore.
3. Fully depress the master cylinder pistons with a brass rod or wooden dowel (28) (as shown in Fig. 1) and remove stop bolt (9). Then remove snap ring (1) with suitable Truarc pliers.

Do not remove stop bolt (9) unless both  
pistons are fully bottomed in bore.

4. Remove brass rod or wooden dowel (28) and gently bump open end of master cylinder body on a piece of wood to remove primary piston (3) secondary piston assembly (7) and center valve assembly (8).
5. Discard secondary piston assembly and center valve assembly (7 & 8).
6. Remove primary piston seal retainer (6) by carefully prying open the legs of the seal retainer with a small screwdriver. Discard the retainer.
7. Remove and discard the primary piston seals (2 & 5). Do not dismantle any other part of the master cylinder.
