1986 Corvette: Recall Notice: Anti-Skid Brake System Master Cylinder Center Valve

Bulletin No: 86C12, Number 5

Subject: PRODUCT SAFETY CAMPAIGN 86C12
ANTI-SKID BRAKE SYSTEM
MASTER CYLINDER CENTER VALVE

Model and Year: 1986 CHEVROLET CORVETTE

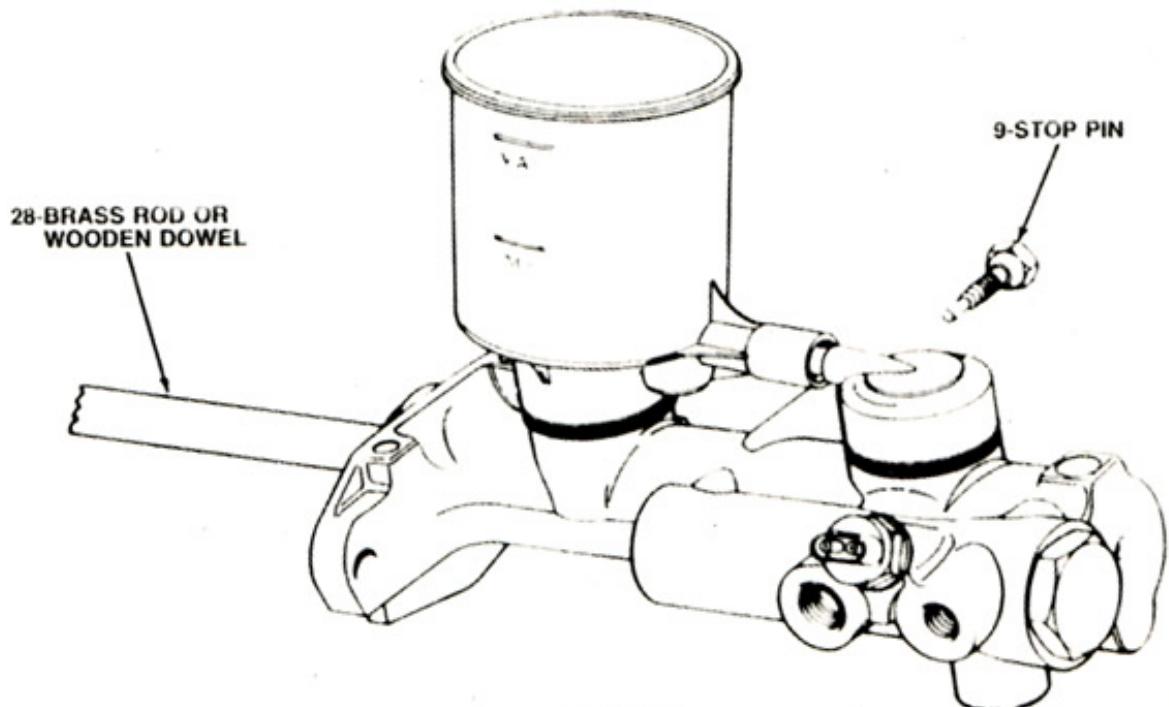
FIGURE 1

General Motors has determined that a defect which relates to motor vehicle safety exists in certain 1986 Corvettes. Certain severe and unusual braking conditions may cause damage to the brake master cylinder center valve. If sufficient damage accumulates, loss of front brakes may occur with accompanying increased pedal travel and reduced braking ability. A reduction of braking ability at a time when minimum stopping distance is required could result in a vehicle crash without prior warning.

1. Remove master cylinder from vehicle.
2. Drain and discard brake fluid from master cylinder reservoir and bore.
3. Fully depress the master cylinder pistons with a brass rod or wooden dowel (28) (as shown in Fig. 1) and remove stop bolt (9). Then remove snap ring (1) with suitable Truarc pliers.

Do not remove stop bolt (9) unless both
pistons are fully bottomed in bore.
4. Remove brass rod or wooden dowel (28) and gently bump open end of master cylinder body on a piece of wood to remove primary piston (3) secondary piston assembly (7) and center valve assembly (8).
5. Discard secondary piston assembly and center valve assembly (7 & 8).
6. Remove primary piston seal retainer (6) by carefully prying open the legs of the seal retainer with a small screwdriver. Discard the retainer.
7. Remove and discard the primary piston seals (2 & 5). Do not dismantle any other part of the master cylinder.
