1986 Corvette: Recall Notice: Anti-Skid Brake System Master Cylinder Center Valve

Bulletin No: 86C12, Number 5

Subject: PRODUCT SAFETY CAMPAIGN 86C12
ANTI-SKID BRAKE SYSTEM
MASTER CYLINDER CENTER VALVE

Model and Year: 1986 CHEVROLET CORVETTE

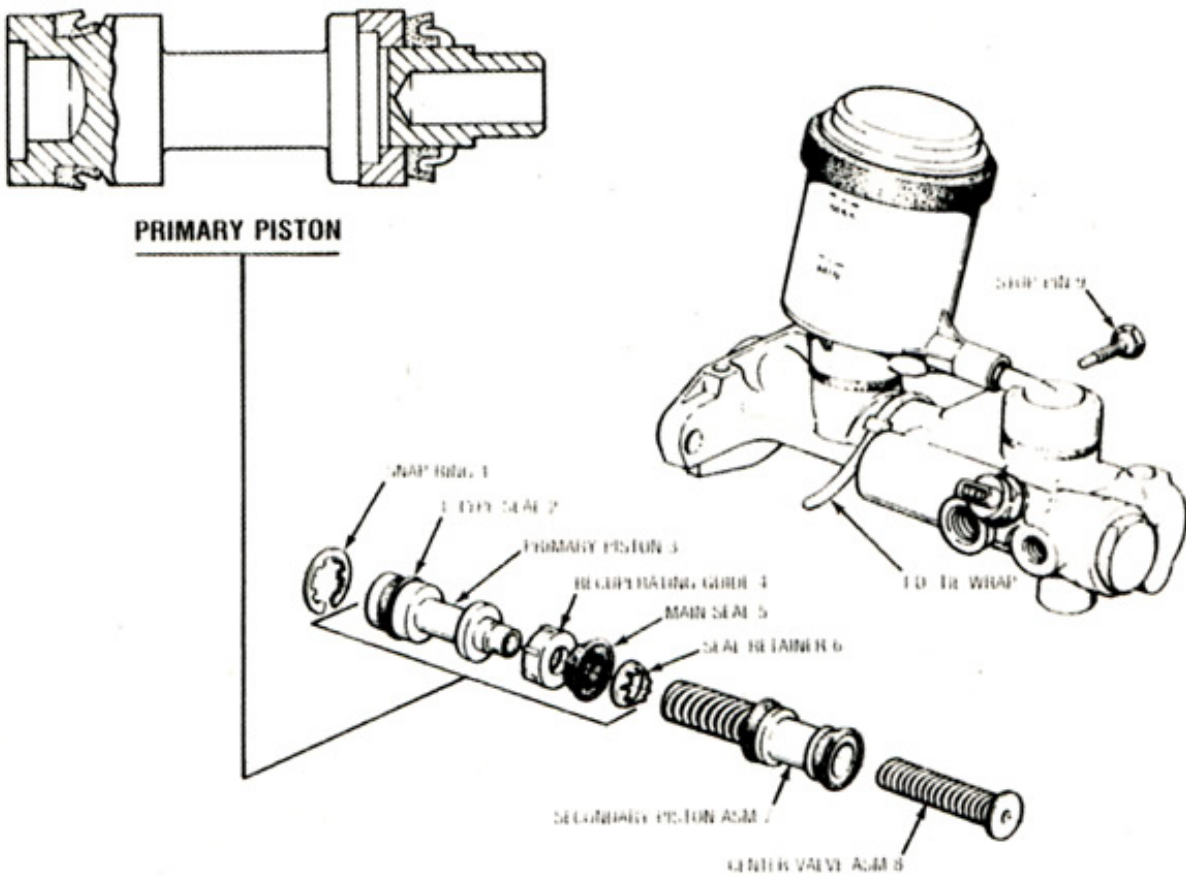
FIGURE 2

1. Lubricate new secondary seal (2) with clean brake fluid and install on primary piston with seal lip facing as shown (Fig. 2).
2. Insure recuperating guide (4) is located on primary piston as shown (Fig. 2).

3. Lubricate new main seal (5) with clean brake fluid and install on primary piston (3) with lip facing as shown (Fig. 2).
4. Press new seal retainer (6) onto primary piston (3). Make sure retainer tabs snap into piston groove.
