1984 Corvette: Service Bulletin: Side Door Lateral Movement

Subject: Side Door Lateral Movement

Model Year: 1984 Corvette

Bulletin No: 84-118, Section: 10 (I)

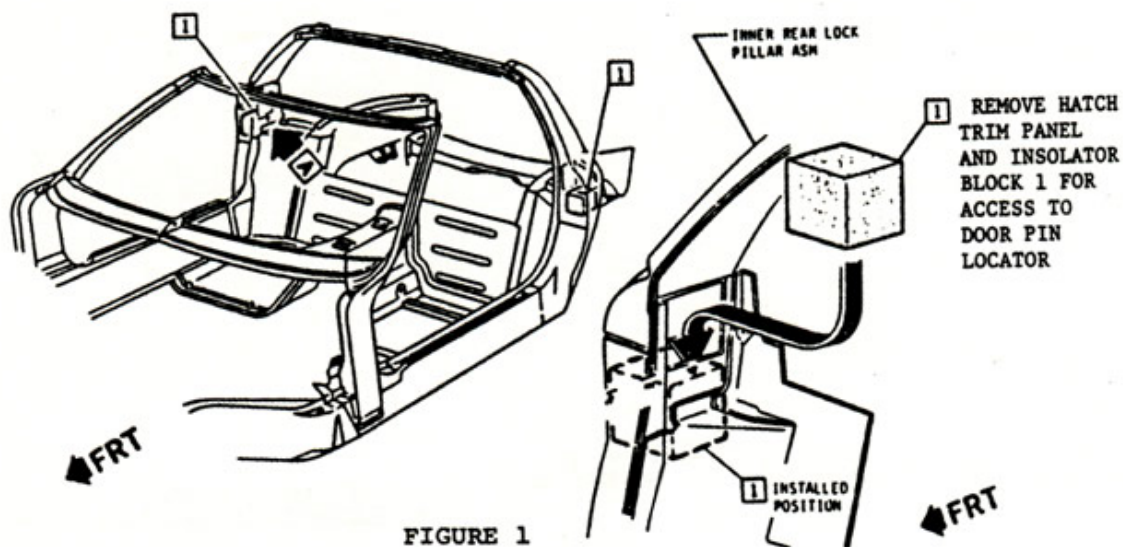
FIGURE 1

Some 1984 Corvettes may experience lateral side door movement with the side window rolled down.

Verify the plastic sleeve is installed in the pin locator assembly. With the vehicle door closed, loosen the locator three (3) attaching bolts (see Figure 1). The locator assembly is to be centered fore-aft and vertically on the door pin. Push the locator outboard to fully engage the door pin and tighten the locator attaching bolts to 11 N.m (8 ft. lbs.)
