# 1984 Corvette: Service Bulletin: Side Door Lateral Movement

**Source:** Chevrolet Dealer Service Bulletin

**Bulletin No:** 84-118, Section: 10 (I)

**Date:** April, 1984

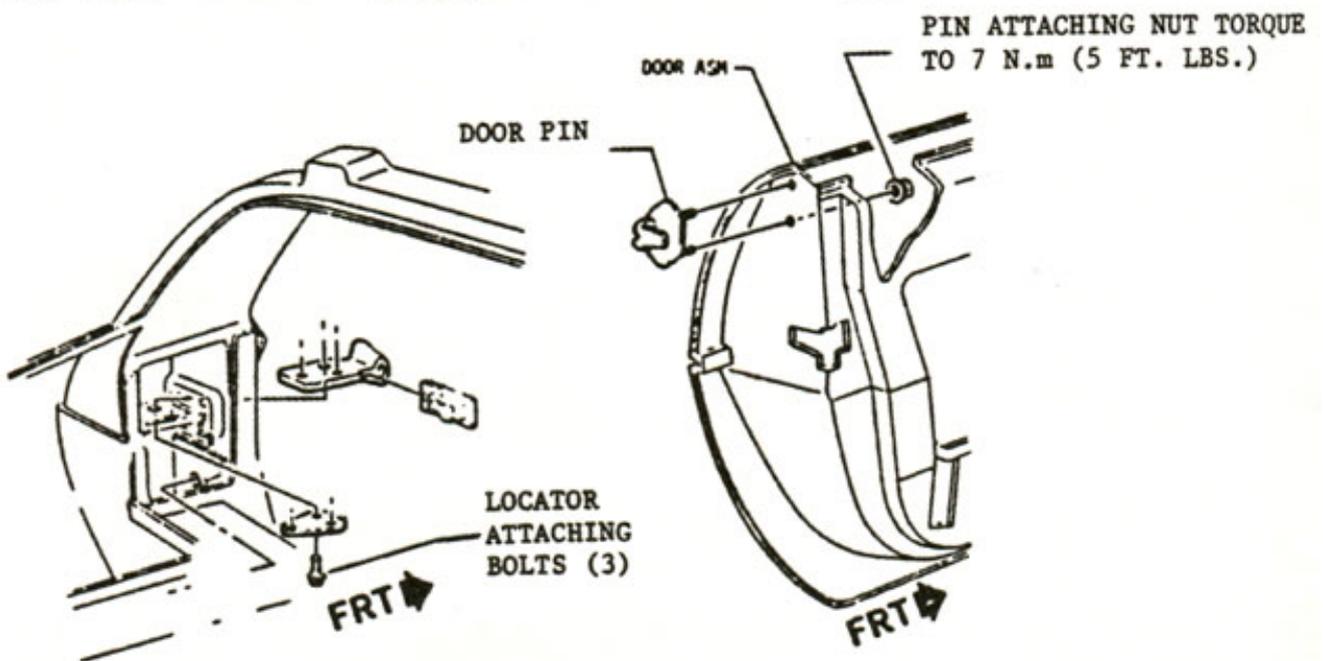
FIGURE 1

Some 1984 Corvettes may experience lateral side door movement with the side window rolled down.

Verify the plastic sleeve is installed in the pin locator assembly. With the vehicle door closed, loosen the locator three (3) attaching bolts (see Figure 1). The locator assembly is to be centered fore-aft and vertically on the door pin. Push the locator outboard to fully engage the door pin and tighten the locator attaching bolts to 11 N.m (8 ft. lbs.)

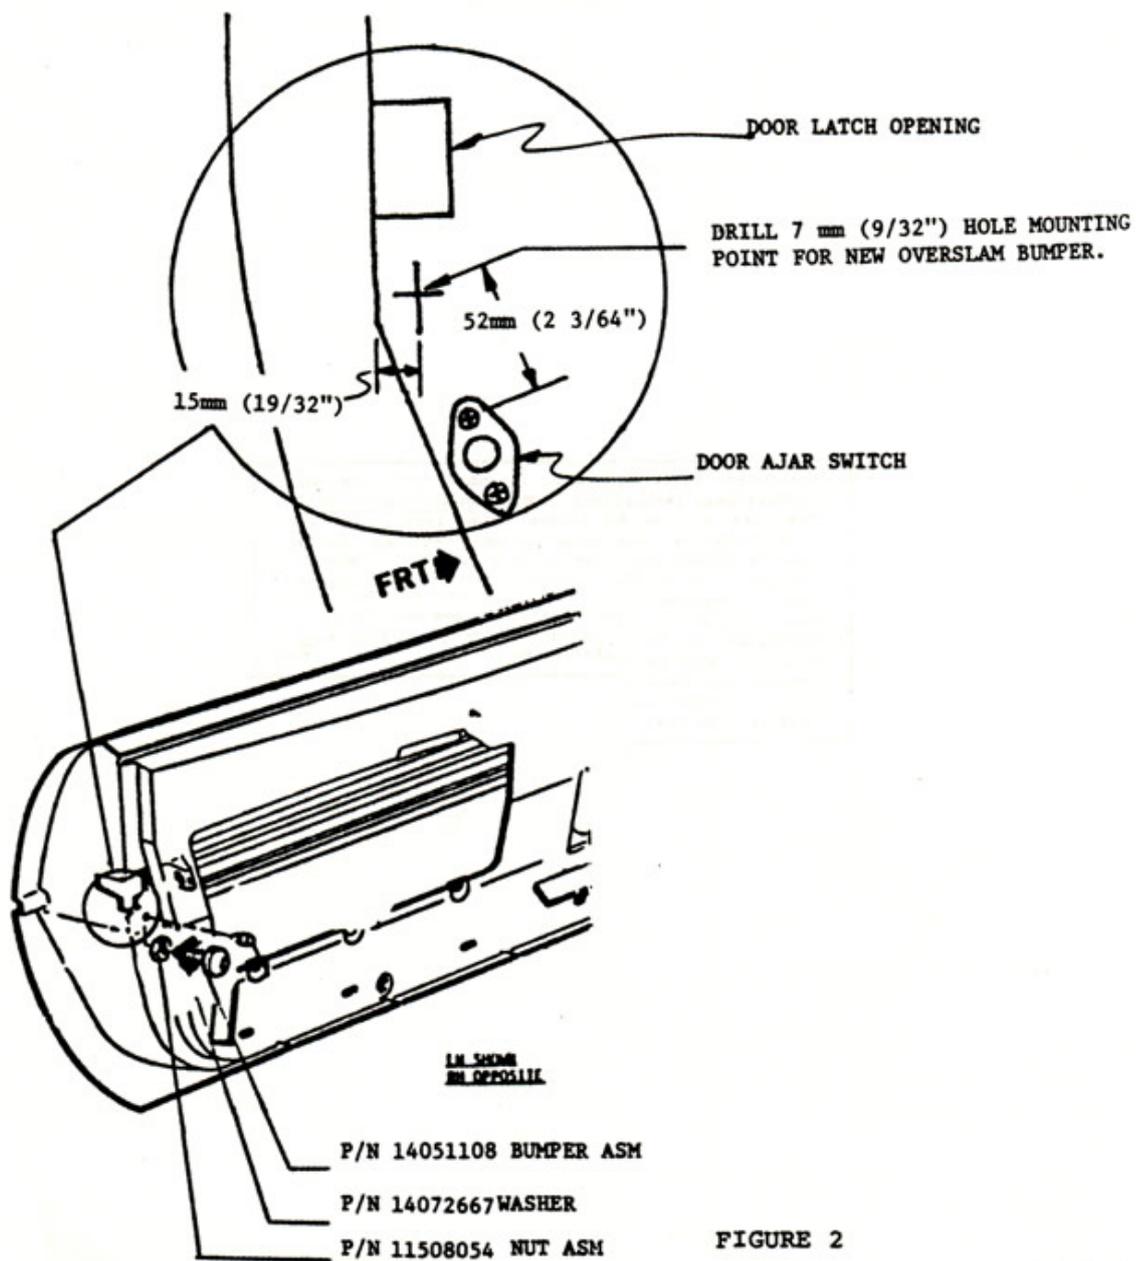
FIGURE 2

Some early built vehicles did not have overslam bumpers. if this is the case, it will be necessary to drill a 7mm (9/32") hole in the door (see Figure 2).

Replace the discarded production bumper(s) with bumper, P/N 14051108, attaching nut, P/N 11508276, and P/N 14072667, flat washers, which are to be used as bumper shims. The number of shims required will vary form vehicle to vehicle depending on "Build stacks".

Add shims (washers) between bumper and door, as required, to eliminate lateral door movement (see Figure 2). DO NOT "OVERSHIM" BUMPER.

Once shim pack has been established, tighten bumper retaining nut to 12 N.m (9 ft. lbs.) and check the door ajar lamp for proper operation. The door ajar switch is self-adjusting and cannot be reset.
