1984 Corvette: Service Bulletin: Side Door Lateral Movement

Subject: Side Door Lateral Movement

Model Year: 1984 Corvette

Bulletin No: 84-118, Section: 10 (I)

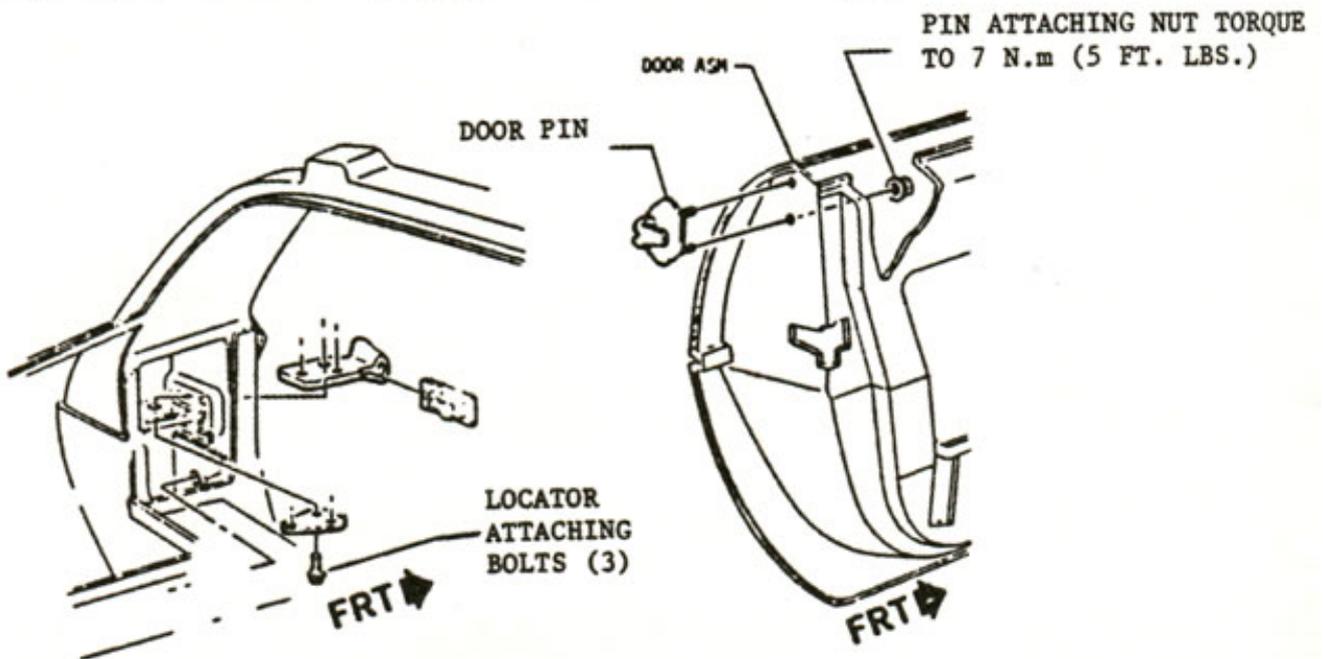
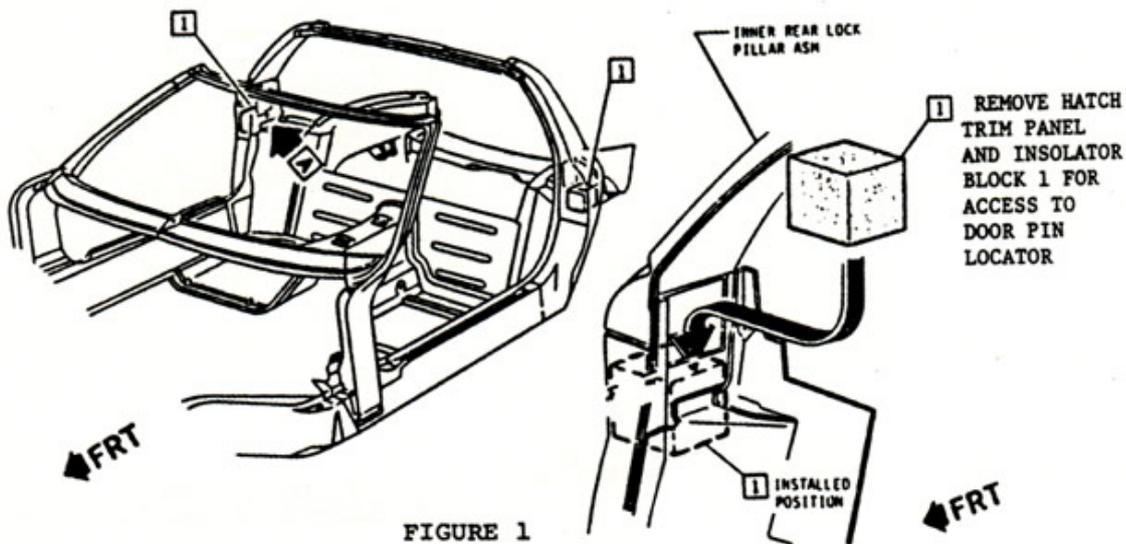
FIGURE 1

Some 1984 Corvettes may experience lateral side door movement with the side window rolled down.

Verify the plastic sleeve is installed in the pin locator assembly. With the vehicle door closed, loosen the locator three (3) attaching bolts (see Figure 1). The locator assembly is to be centered fore-aft and vertically on the door pin. Push the locator outboard to fully engage the door pin and tighten the locator attaching bolts to 11 N.m (8 ft. lbs.)
