1984 Corvette: Service Bulletin: Side Door Lateral Movement

Source: Chevrolet Dealer Service Bulletin

Bulletin No: 84-118, Section: 10 (I)

Date: April, 1984

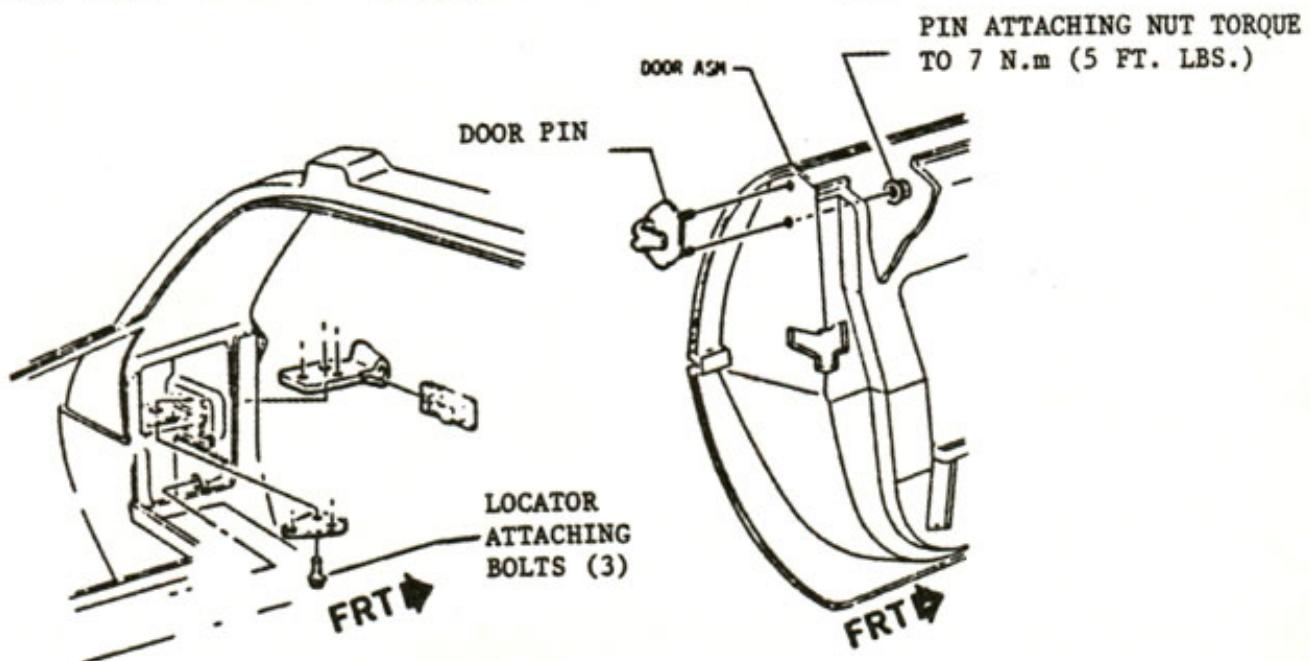
Some 1984 Corvettes may experience lateral side door movement with the side window rolled down.

Verify the plastic sleeve is installed in the pin locator assembly. With the vehicle door closed, loosen the locator three (3) attaching bolts (see Figure 1). The locator assembly is to be centered fore-aft and vertically on the door pin. Push the locator outboard to fully engage the door pin and tighten the locator attaching bolts to 11 N.m (8 ft. lbs.)

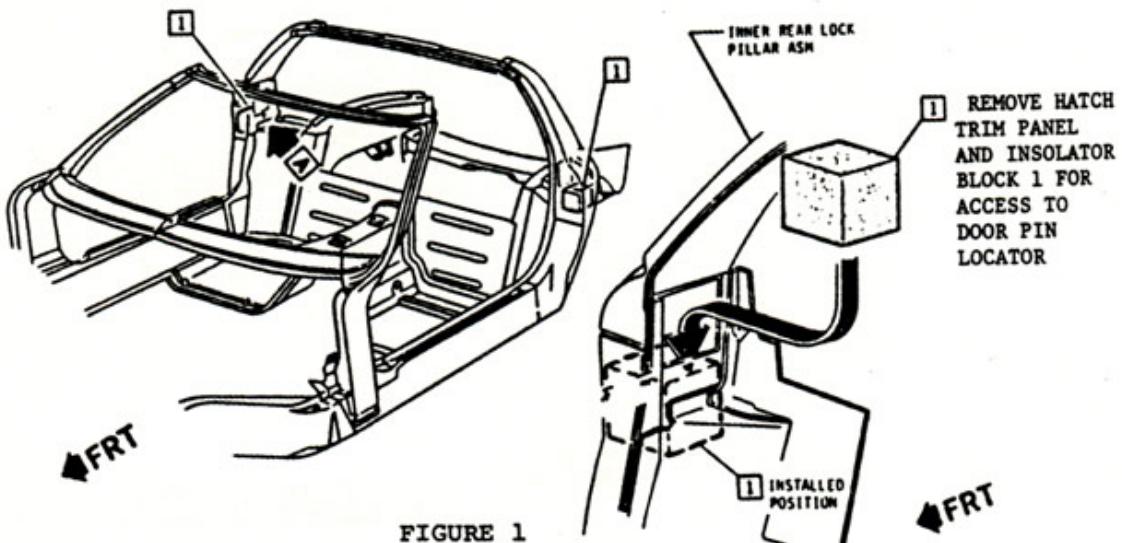
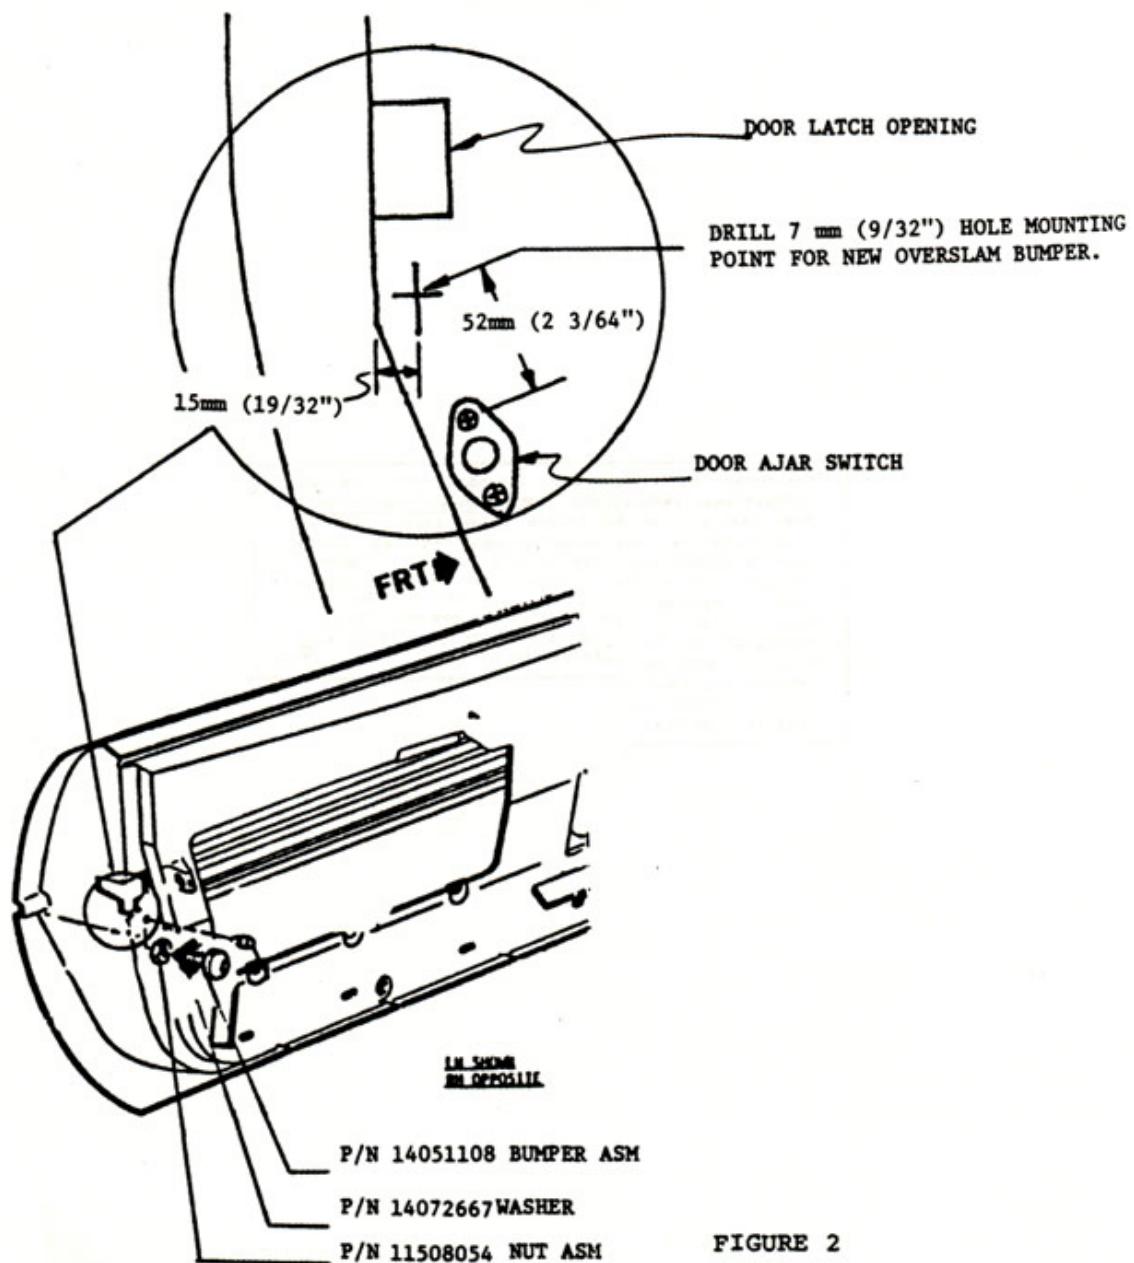
Some early built vehicles did not have overslam bumpers. If this is the case, it will be necessary to drill a 7mm (9/32") hole in the door (see Figure 2).

Replace the discarded production bumper(s) with bumper, P/N 14051108, attaching nut, P/N 11508276, and P/N 14072667, flat washers, which are to be used as bumper shims. The number of shims required will vary form vehicle to vehicle depending on "Build stacks".

Add shims (washers) between bumper and door, as required, to eliminate lateral door movement (see Figure 2). DO NOT "OVERSHIM" BUMPER.

Once shim pack has been established, tighten bumper retaining nut to 12 N.m (9 ft. lbs.) and check the door ajar lamp for proper operation. The door ajar switch is self-adjusting and cannot be reset.
