1962 Corvette: Service Bulletin: Excessive Idle Speed

Bulletin No: DR #522

Date: February 14, 1962

SUBJECT: EXCESSIVE IDLE SPEED -
1962 PASSENGER CARS

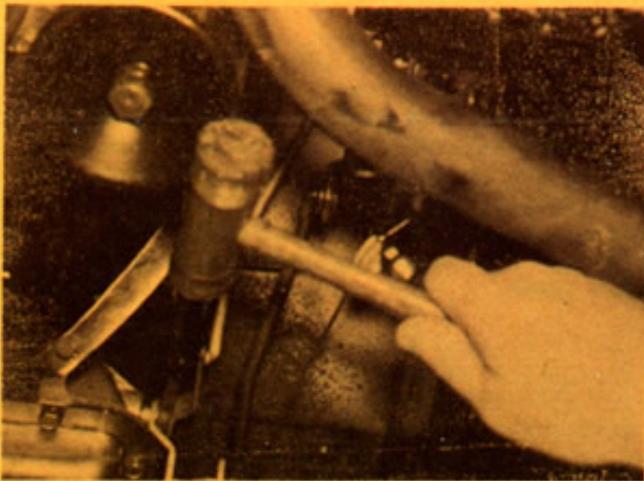
FIGURE 1

Excessive idle speed due mainly to poor return to idle on 1962 Passenger Cars equipped with 327 cu. in. engines and Powerglide transmissions, may be due to a bind in the transmission throttle valve linkage at the throttle valve rod to throttle valve lever clip and/or between the throttle valve control inner lever and the range selector shaft. Either of these conditions combined with the carburetor throttle valve return spring being marginal, may prevent the throttle linkage from returning completely to idle. This results in excessive idle speed.

2. Remove the transmission throttle valve rod to throttle lever clip and replace with plain washer #120392 and 3/32" x 5/8" cotter pin.
3. Position a screwdriver having a blade width of 3/8" between the transmission throttle lever and manual lever as shown in Figure 1.
4. Gently tap screwdriver wedging the throttle lever outboard until .010" - .015" clearance may be measured with a feeler gauge between the throttle lever and the washer which is between the two levers as shown in Figure 2.
