1962 Corvette: Service Bulletin: Excessive Idle Speed

Bulletin No: DR #522

SUBJECT: EXCESSIVE IDLE SPEED -
1962 PASSENGER CARS

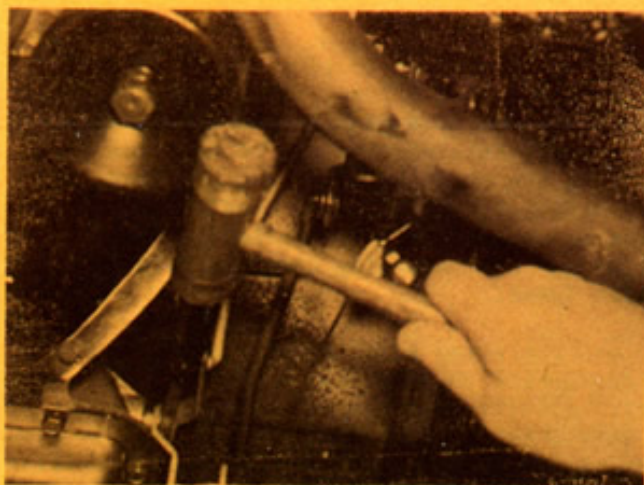
FIGURE 1

Excessive idle speed due mainly to poor return to idle on 1962 Passenger Cars equipped with 327 cu. in. engines and Powerglide transmissions, may be due to a bind in the transmission throttle valve linkage at the throttle valve rod to throttle valve lever clip and/or between the throttle valve control inner lever and the range selector shaft. Either of these conditions combined with the carburetor throttle valve return spring being marginal, may prevent the throttle linkage from returning completely to idle. This results in excessive idle speed.

2. Remove the transmission throttle valve rod to throttle lever clip and replace with plain washer #120392 and 3/32" x 5/8" cotter pin.
3. Position a screwdriver having a blade width of 3/8" between the transmission throttle lever and manual lever as shown in Figure 1.
4. Gently tap screwdriver wedging the throttle lever outboard until .010" - .015" clearance may be measured with a feeler gauge between the throttle lever and the washer which is between the two levers as shown in Figure 2.
