# 1963 - 1964 Corvette: Service News: Air Conditioning Changes

**Subject:** Air Conditioning Changes

**Model and Year:** 1963 - 1964 Corvette

**Date:** March 1964 - Volume 36 - Number 3

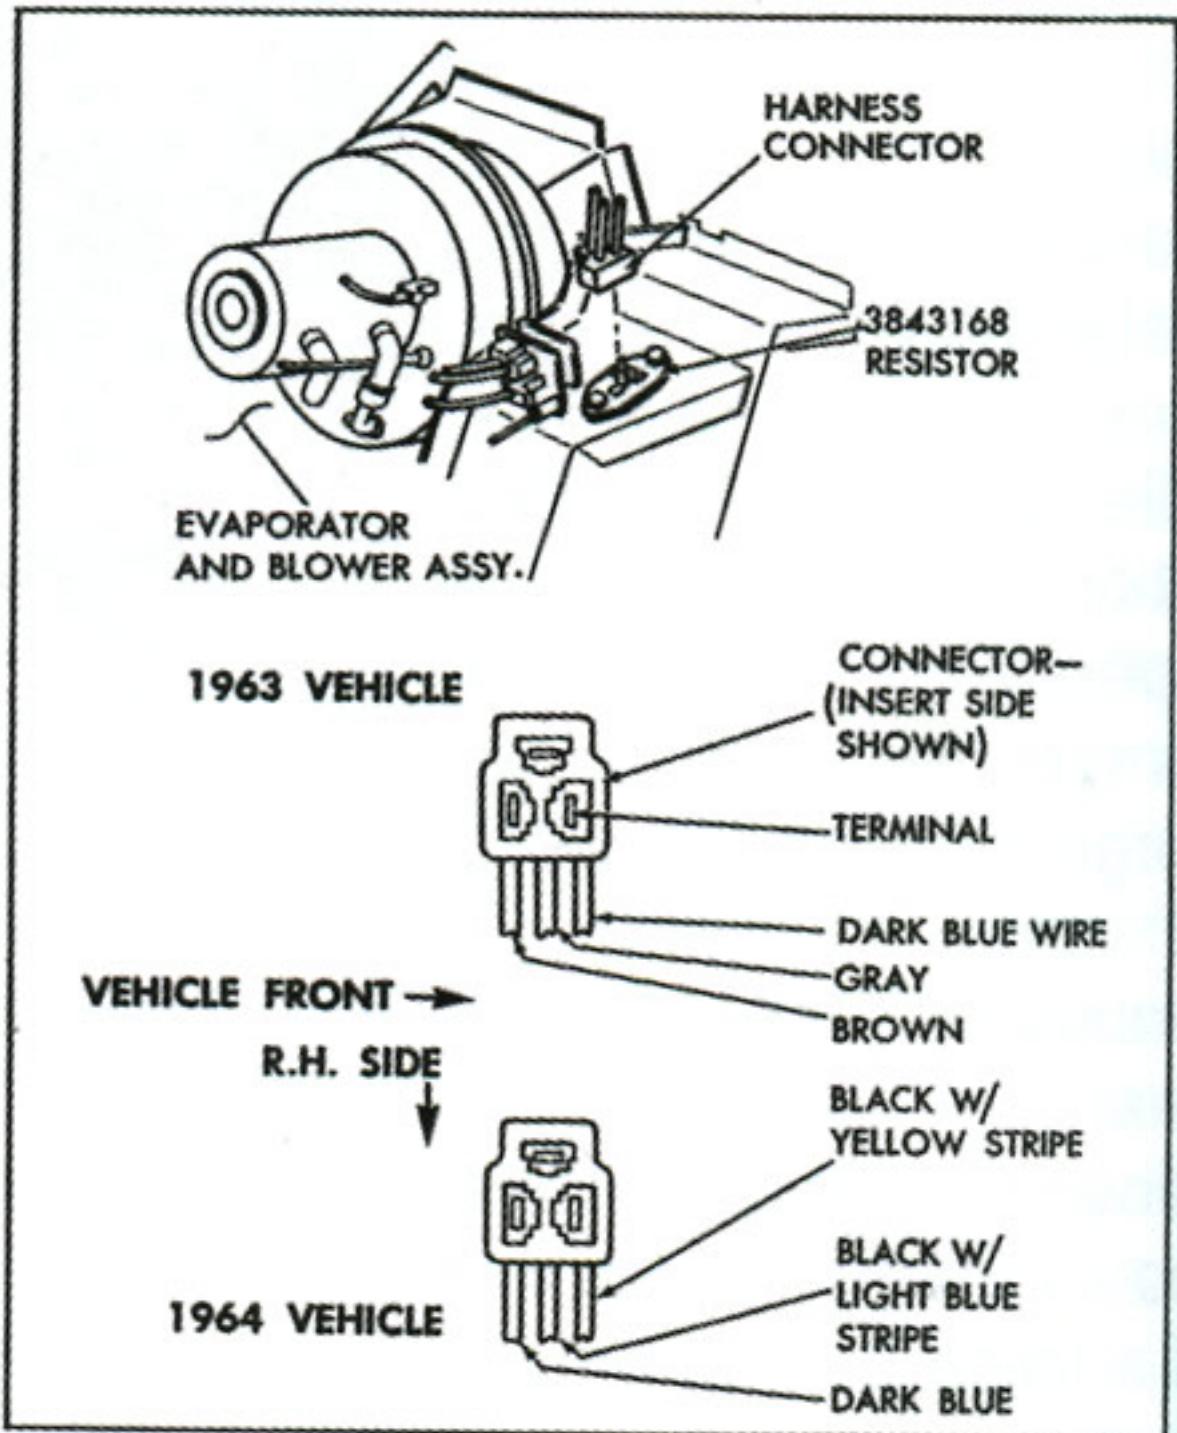
*Fig. 1—Rework of Blower Motor Circuit*

On all 1963 and early 1964 Corvettes equipped with Air Conditioner RPO C60, it would be necessary to slightly modify the electrical circuit to provide a true medium blower speed for the heater. In these RPO C60 installations, the resistor that was used in the blower motor circuit to establish blower medium and low speeds, unfortunately, during heater operation provides blower "low" RPM at the MEDIUM as well as at the LOW speed setting of the operator's control lever.

1. Replace the installed blower motor resistor with Resistor Part No. 3843168.
2. Reverse the location of two leads in the multiple connector that plugs into the blower motor resistor assembly; reinstalling the color coded leads in the connector body at the locations show in Fig. 1.

**NOTE:** To remove the terminals from the connector body, insert a small screwdriver along the inboard side of the terminal and move the end of the screwdriver outboard to disengage the terminal from the locking ledge in the connector. Before reinstalling the terminals in the connector, spread the

terminals to insure that they lock securely when installed.
