1963 - 1964 Corvette: Service News: Air Conditioning Changes

Subject: Air Conditioning Changes

Model and Year: 1963 - 1964 Corvette

Date: March 1964 - Volume 36 - Number 3

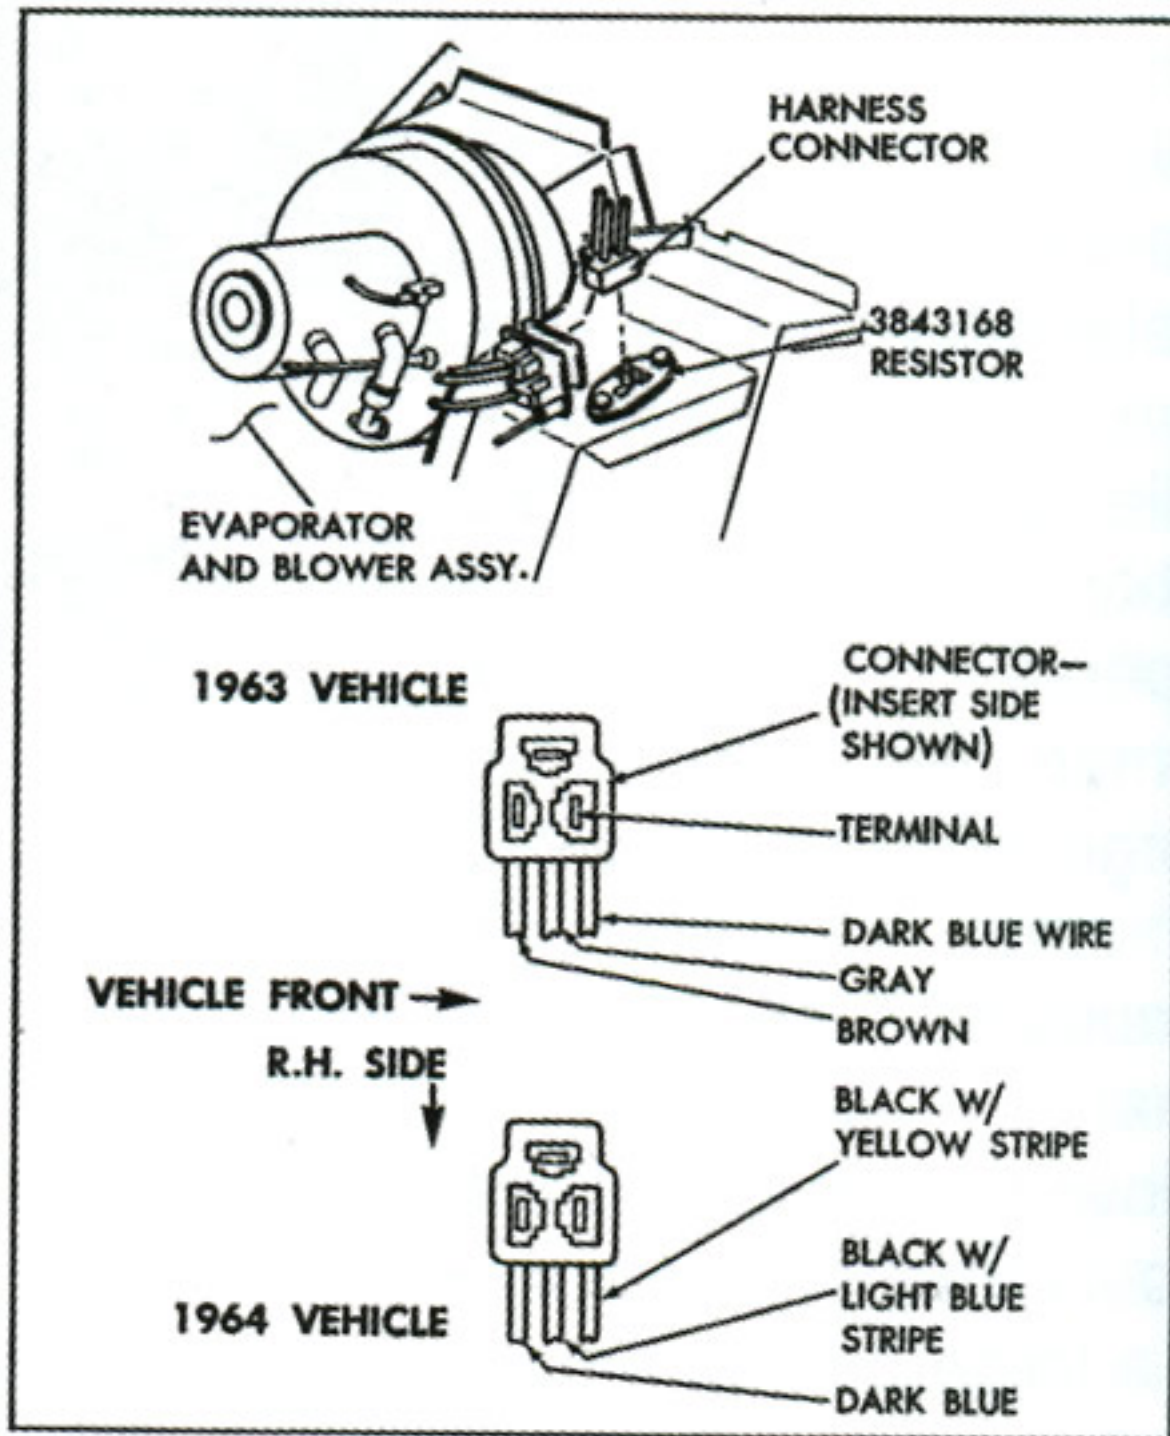
Fig. 1—Rework of Blower Motor Circuit

On all 1963 and early 1964 Corvettes equipped with Air Conditioner RPO C60, it would be necessary to slightly modify the electrical circuit to provide a true medium blower speed for the heater. In these RPO C60 installations, the resistor that was used in the blower motor circuit to establish blower medium and low speeds, unfortunately, during heater operation provides blower "low" RPM at the MEDIUM as well as at the LOW speed setting of the operator's control lever.

1. Replace the installed blower motor resistor with Resistor Part No. 3843168.
2. Reverse the location of two leads in the multiple connector that plugs into the blower motor resistor assembly; reinstalling the color coded leads in the connector body at the locations show in Fig. 1.

NOTE: To remove the terminals from the connector body, insert a small screwdriver along the inboard side of the terminal and move the end of the screwdriver outboard to disengage the terminal from the locking ledge in the connector. Before reinstalling the terminals in the connector, spread the

terminals to insure that they lock securely when installed.
