1968 - 1970 Corvette: Service Bulletin: Depressed Park Windshield Wipers Unable to Park

Model and Year: 1968 - 1970 Corvette

Source: Chevrolet Dealer Service Technical Service Bulletin

Bulletin No: 70-T-59

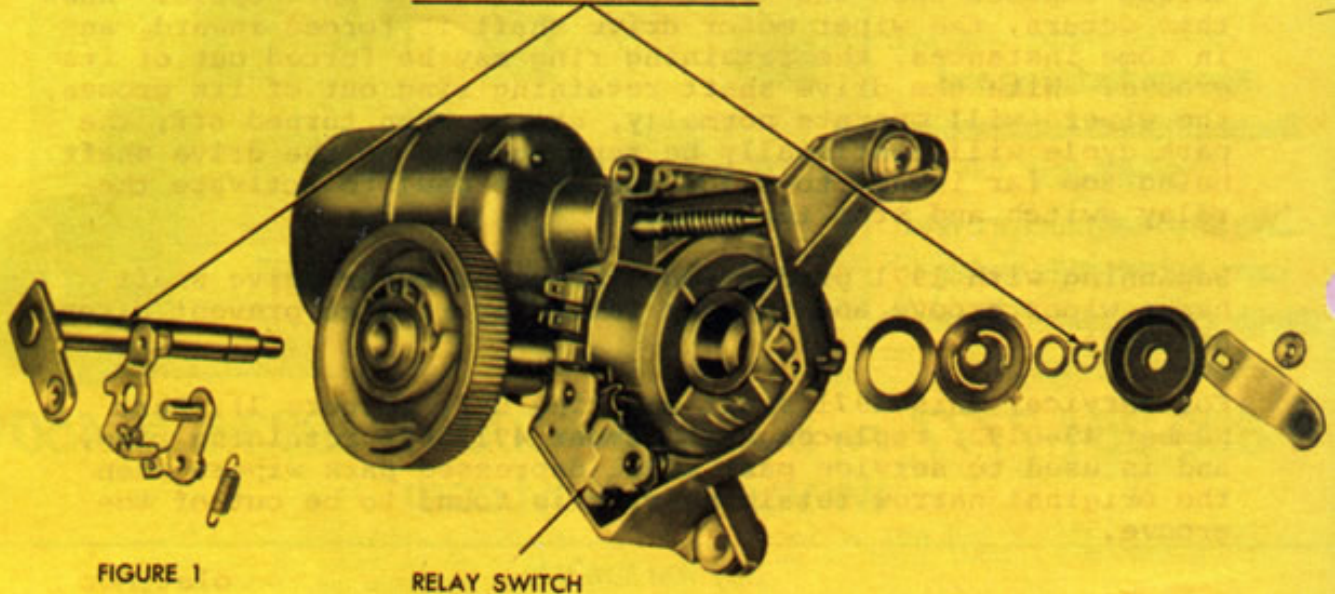
DRIVE SHAFT AND RING
UNIT PART NUMBER 4960192

A few reports have been received on vehicles, equipped with depressed park windshield wipers, that the wipers do not park when turned off.

This problem usually is a result of heavy snow or ice accumulation on the lower portion of the windshield, resulting in heavy torque imposed upon the wiper arms during the park cycle. When this occurs, the wiper motor drive shaft is forced inward, and in some instances, the retaining ring may be forced out of its groove. With the drive shaft retaining ring out of its groove, the wipers will operate normally, except when turned off, the park cycle will continually be repeated due to the drive shaft being too far inward to allow the drive pawl to activate the relay switch and stop the motor.

Beginning with 1971 production, the wiper motor drive shaft has a wider groove and thicker retaining ring to prevent disengagement.

For service, this 1971 shaft and ring unit (Figure 1), Part Number 4960192, replaces Part Number 4911264, retaining ring, and is used to service past model depressed park wipers when the original narrow retaining ring is found to be out of the groove.
