1968 - 1970 Corvette: Service Bulletin: Depressed Park Windshield Wipers Unable to Park

Source: Chevrolet Dealer Service Technical Service Bulletin

Bulletin No: 70-T-59

Date: May 5, 1971

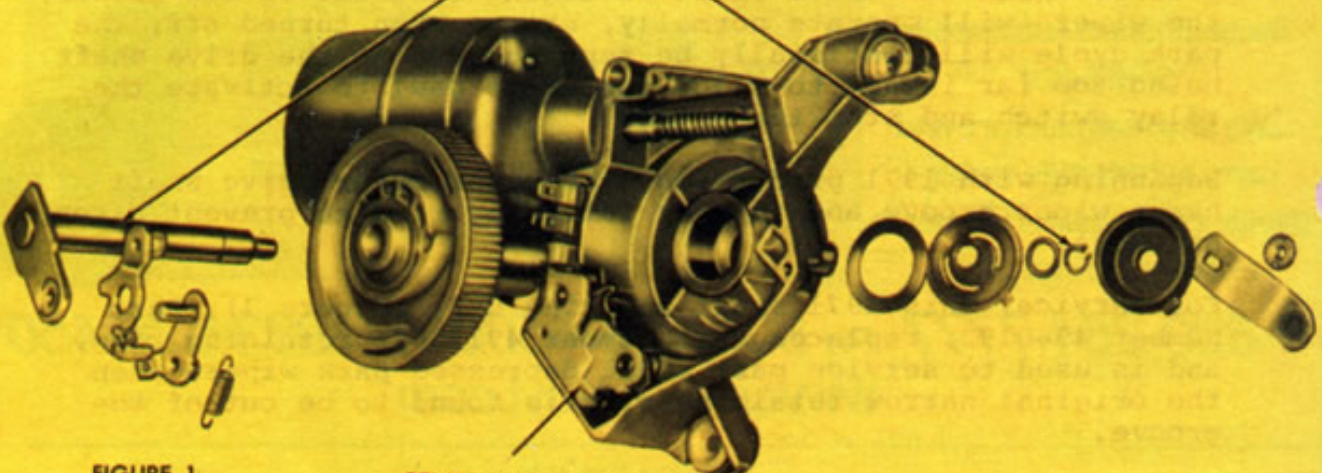
FIGURE 1

This problem usually is a result of heavy snow or ice accumulation on the lower portion of the windshield, resulting in heavy torque imposed upon the wiper arms during the park cycle. When this occurs, the wiper motor drive shaft is forced inward, and in some instances, the retaining ring may be forced out of its groove. With the drive shaft retaining ring out of its groove, the wipers will operate normally, except when turned off, the park cycle will continually be repeated due to the drive shaft being too far inward to allow the drive pawl to activate the relay switch and stop the motor.

DRIVE SHAFT AND RING
UNIT PART NUMBER 4960192

For service, this 1971 shaft and ring unit (Figure 1), Part Number 4960192, replaces Part Number 4911264, retaining ring, and is used to service past model depressed park wipers when the original narrow retaining ring is found to be out of the groove.
