1959 Corvette: Service News: Fuel Injection Pump Leakage

Subject: Fuel Injection Pump Leakage

Model and Year: 1959 Corvette

Date: March 1959 - Volume 31 - Number 3

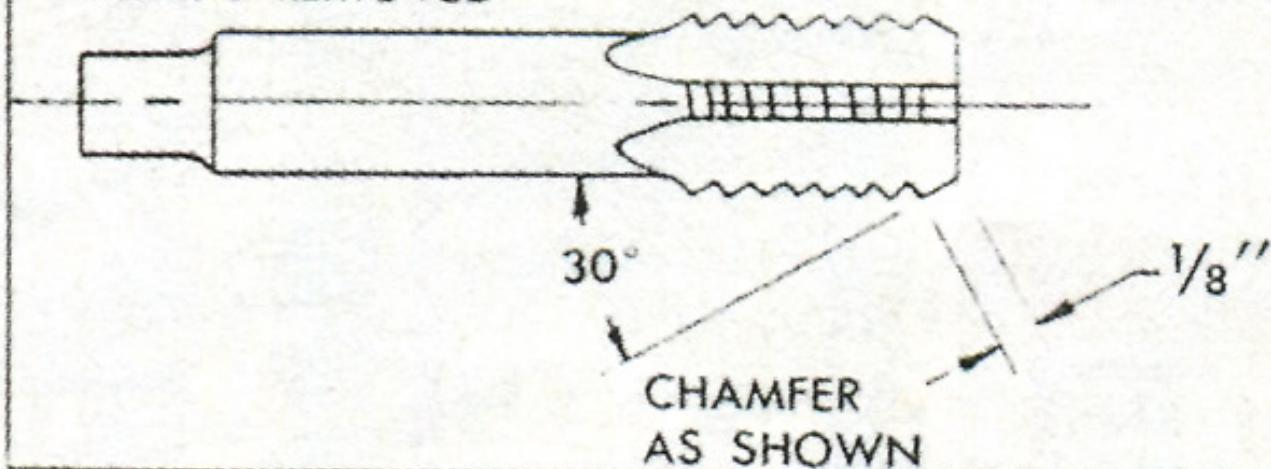
Fig. 6—Seal Remover

**9/16-18 NF TAP
WITH ALL LEAD
THREADS REMOVED**

1. Remove high pressure fuel pump from fuel meter.
2. Mark relationship of pump body, gear housing, and front cover.
3. Remove four Allen head screws and remove front cover.
4. Using china marking pencil, mark relationship of idler gear to drive gear.
5. Remove gear housing and idler gear.
6. Remove drive gear by extending shaft beyond gear so that drive pin may be removed.
7. Screw reworked tap (Fig. 6) into seal.

CAUTION: Tap must be seated in seal in no more than 2 or 3 turns or damage to the rear busing will occur.

8. Drive seal and tap out of pump housing using old drive shaft inserted from bearing end.
9. Slide drive shaft through the pump body and remove through seal end to avoid the possibility of burrs scratching the bushing.
10. Place a new seal in position in pump body with open end of seal downward. To satisfactorily replace the seal, it will be necessary to first make a seal remover (Fig. 6) and seal installer (Fig. 7), then perform the replacement exactly as described in the following.
