# 1959 Corvette: Service News: Fuel Injection Pump Leakage

**Subject:** Fuel Injection Pump Leakage

**Model and Year:** 1959 Corvette

**Date:** March 1959 - Volume 31 - Number 3

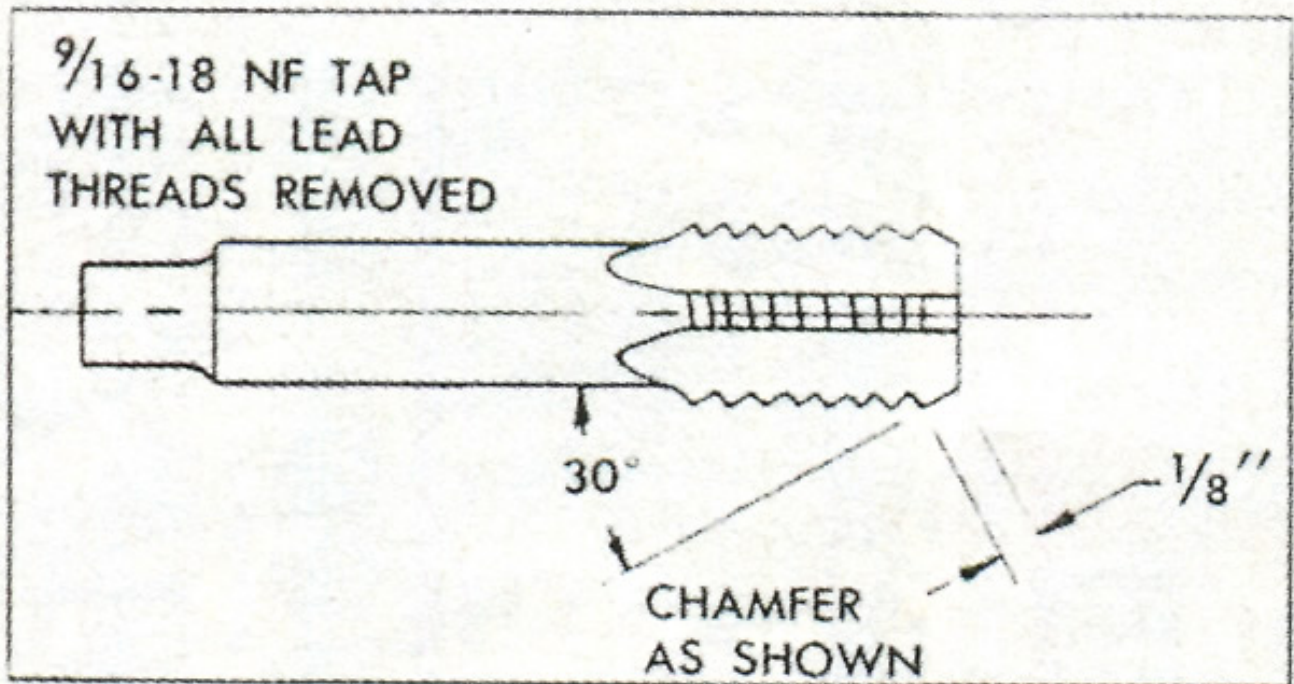
*Fig. 6--Seal Remover*

Gasoline leakage observed at rear of the fuel injection fuel meter may result from a worn drive shaft seal on the high pressure fuel pump. The pump mounts on the rear face of the meter housing.

1. Remove high pressure fuel pump from fuel meter.
2. Mark relationship of pump body, gear housing, and front cover.
3. Remove four Allen head screws and remove front cover.
4. Using china marking pencil, mark relationship of idler gear to drive gear.
5. Remove gear housing and idler gear.
6. Remove drive gear by extending shaft beyond gear so that drive pin may be removed.
7. Screw reworked tap (Fig. 6) into seal.

CAUTION: Tap must be seated in seal in no more than 2 or 3 turns or damage to the rear busing will occur.
8. Drive seal and tap out of pump housing using old drive shaft inserted from bearing end.
9. Slide drive shaft through the pump body and remove through seal end to avoid the possibility of burrs scratching the bushing.
10. Place a new seal in position in pump body with open end of seal downward. To satisfactorily replace the seal, it will be necessary to first make a seal remover (Fig. 6) and seal installer (Fig. 7), then perform the replacement exactly as described in the following.
