1963 - 1964 Corvette: Service Bulletin: 3-Speed Transmission Problems

Subject: 3-Speed Transmission Problems

Source: Chevrolet Technical Service Bulletin

Bulletin No: TSB #1008 DR #676

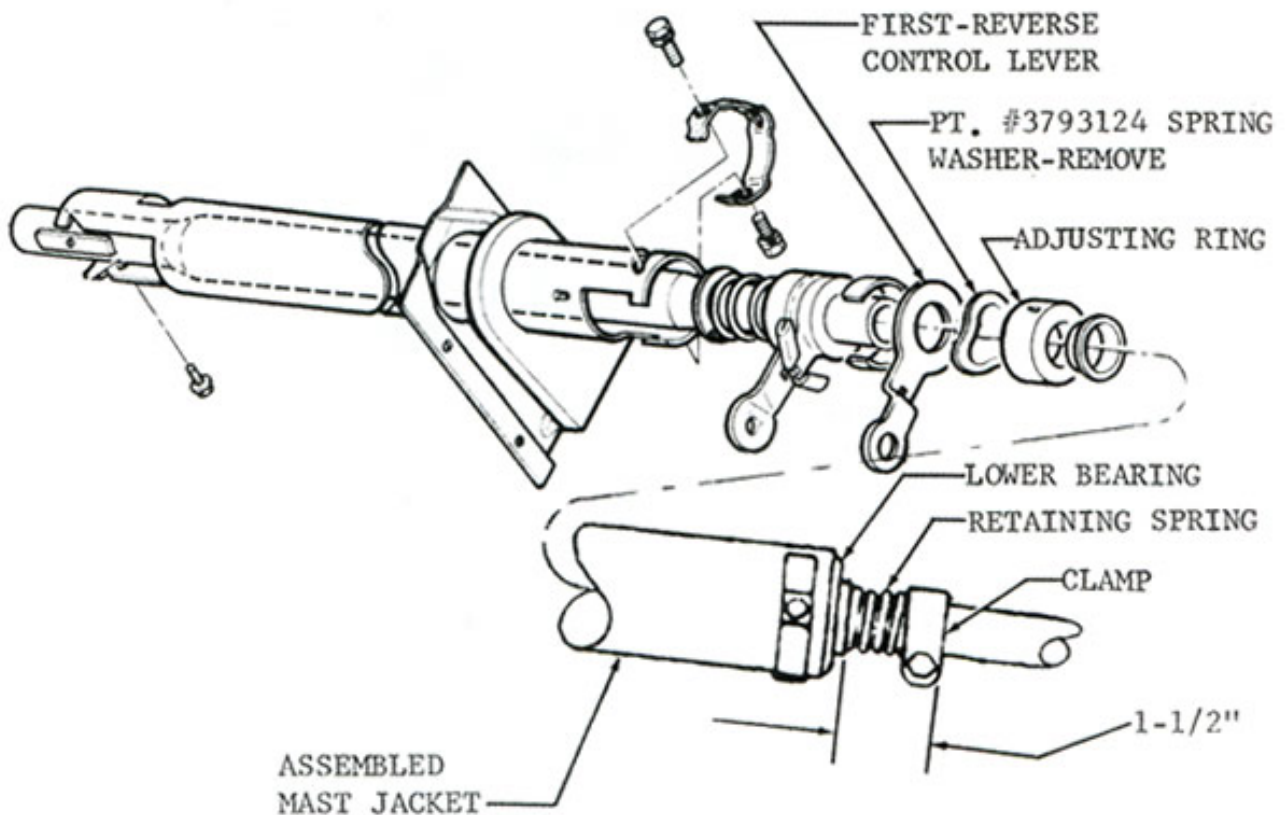
FIGURE 2 - MAST JACKET ASSEMBLY

The major sources of difficulty in shifting are the clearance adjustment between the transmission control levers located at the lower end of the mast jacket and the adjustment of the selector rods at the control levers for neutral cross-over. Excessive clearance between the levers or incorrect neutral cross-over may result in block-out.

To provide a more positive shift on truck models, Part No. 3793124, transmission control 1st and reverse lever spring washer is being omitted in production and should be removed from units in service. The procedure to remove this spring washer and to readjust lever clearance is as follows:

1. Refer to Figure 2 for parts identification. Place shift lever in neutral; remove access cover from fender skirt.

2. Remove cap screws retaining adjusting ring to mast jacket.
3. Loosen steering shaft lower bearing retaining spring clamp.
4. Slide adjusting ring downward along steering shaft until Part No. 3793124, spring washer, is exposed. Cut and remove spring washer from steering shaft.
5. Apply lubriplate to thrust surfaces of control levers, relay lever and adjusting ring.
6. Position adjusting ring in mast jacket; align holes in ring with slots in mast jacket and install cap screws, but do not tighten.
7. Rotate adjusting ring upward until clearance of .005" exists between first-reverse control lever and ring as shown in Figure 3. Tighten cap screws.

8. Force lower bearing retaining spring clamp upward against spring tension until a dimension of 1-1/2" exists between lower bearing and clamp as shown in Figure 2. Tighten clamp bolt.
9. With transmission side cover selector levers in neutral position, adjust selector rod lengths per instructions in the appropriate shop manual to provide proper neutral cross-over. Replace access cover when adjustments are completed.

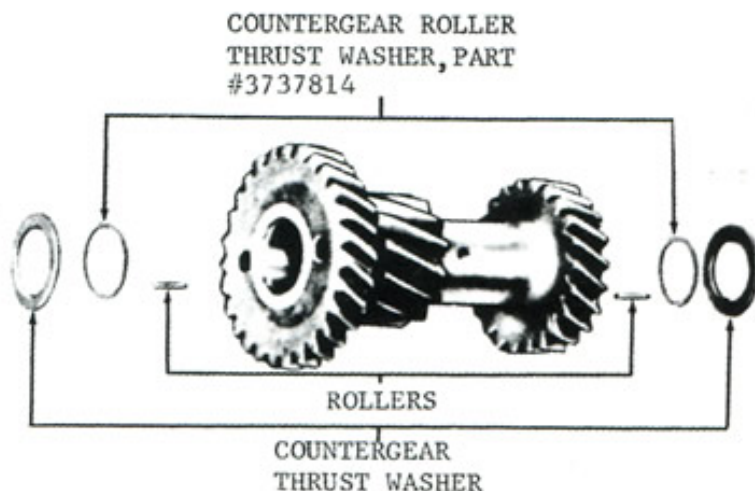
FIGURE 4 - INSTALLATION OF THRUST WASHERS IN CHEVY VAN

On Chevy Van models with three-speed transmissions, a small steel thrust washer is used between the countergear thrust washer and the countergear roller bearings at each end of the countergear. Since the 1964 Chevy Van Shop Manual is supplemented to the 1963 Truck Shop Manual in this area, reference to this part is omitted in error.

Figure 4 illustrates installed location of this thrust washer in Chevy Van transmissions.

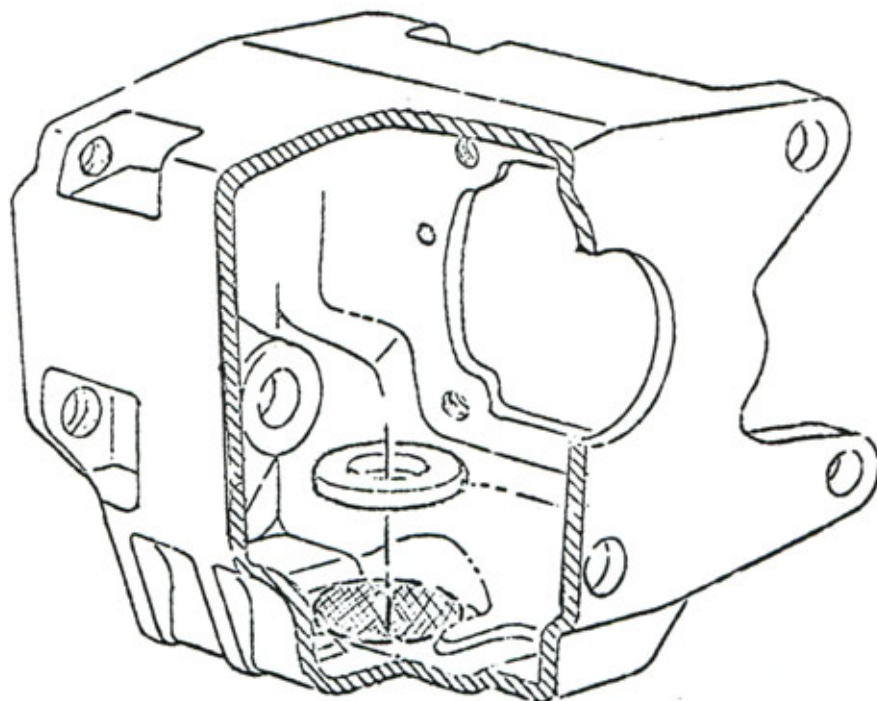
FIGURE 5 - INSTALLATION OF MAGNETIC CHIP COLLECTOR

Gear clash will cause rounding of the chamfers on the first and reverse gear, countergear and reverse idler gear and possibly break loose some fine chips. These fine particles are a major contributor to bearing noise.

To reduce bearing noise and increase bearing durability, two changes have been released for production. First is the installation of a magnetic chip collector which went into effect on June 5, 1964. Second is the use of a new clutch gear and mainshaft bearing that incorporates a slinger ring on the inner race. This change went into effect on transmissions for use on 327 cu. in. engines on June 11, 1964, and is estimated to go into effect the week of June 22, 1964, on remaining transmissions.

3. Wipe magnet and area in case where magnet is to be installed with Acetone or Toluol (available at most drugstores). Area where magnet is to be installed must be clean, dry and free from oil and grease film. When Acetone or Toluol is applied, be sure to use in ample quantity to neutralize grease and oil which may be in pores of casting surface. Do not touch cleaned area with hands.

4. Using cement supplied in kit, apply about a 1/16 inch thick film over entire bottom surface of magnet and immediately place in case as shown in sketch. Press straight down - do not twist while pressing in position. Note: If cement from tube appears to be thick, discard thick or hardened chunks and use cement from middle or bottom of tube.

5. To cure cement, place a trouble light with a 100 watt lamp inside of case as close to magnet as possible, and allow to stand for a minimum of 30 minutes. Use care not to touch magnet or knock it out of position. A heat lamp, if available, may be used in place of 100 watt lamp.
