1963 - 1964 Corvette: Service Bulletin: 3-Speed Transmission Problems

Subject: 3-Speed Transmission Problems

Source: Chevrolet Technical Service Bulletin

Bulletin No: TSB #1008 DR #676

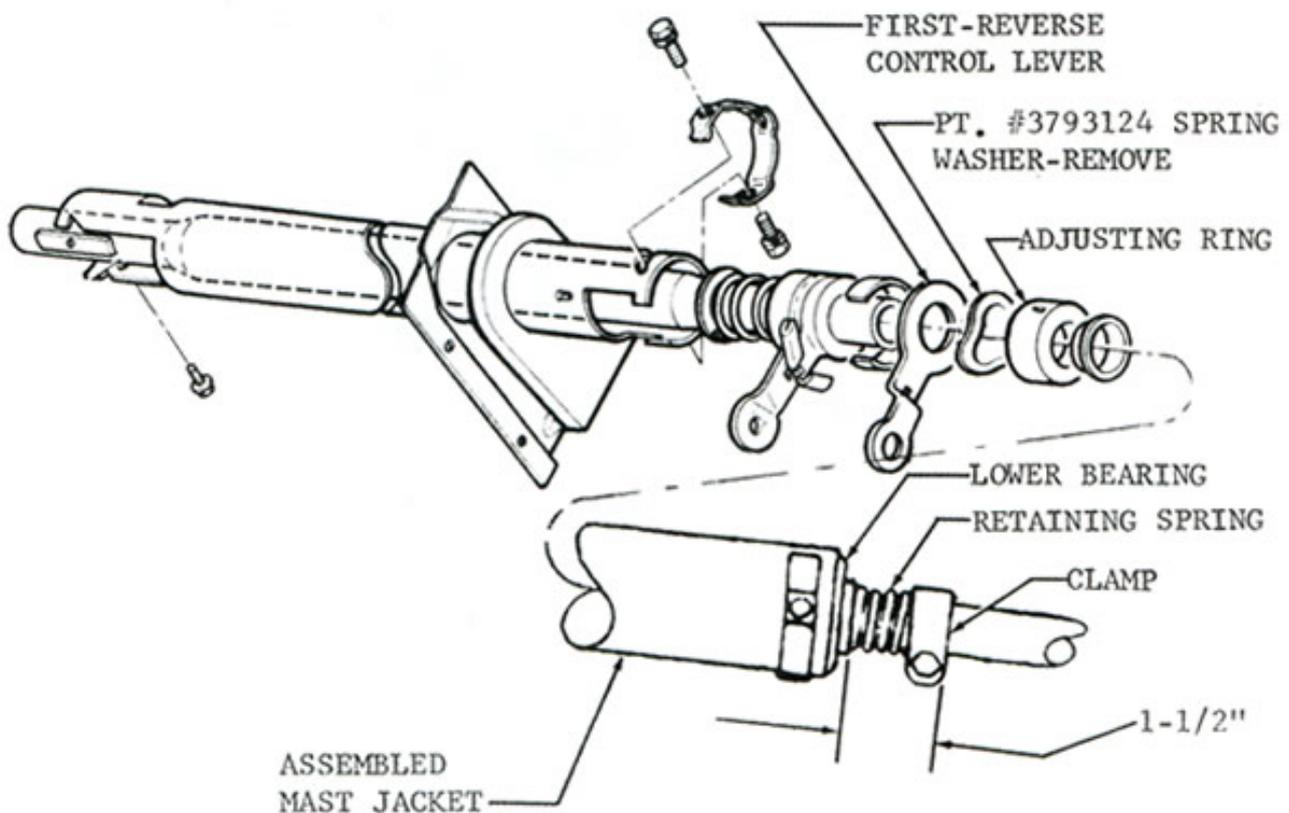
FIGURE 2 - MAST JACKET ASSEMBLY

The major sources of difficulty in shifting are the clearance adjustment between the transmission control levers located at the lower end of the mast jacket and the adjustment of the selector rods at the control levers for neutral cross-over. Excessive clearance between the levers or incorrect neutral cross-over may result in block-out.

To provide a more positive shift on truck models, Part No. 3793124, transmission control 1st and reverse lever spring washer is being omitted in production and should be removed from units in service. The procedure to remove this spring washer and to readjust lever clearance is as follows:

1. Refer to Figure 2 for parts identification. Place shift lever in neutral; remove access cover from fender skirt.

2. Remove cap screws retaining adjusting ring to mast jacket.
3. Loosen steering shaft lower bearing retaining spring clamp.
4. Slide adjusting ring downward along steering shaft until Part No. 3793124, spring washer, is exposed. Cut and remove spring washer from steering shaft.
5. Apply lubriplate to thrust surfaces of control levers, relay lever and adjusting ring.
6. Position adjusting ring in mast jacket; align holes in ring with slots in mast jacket and install cap screws, but do not tighten.
7. Rotate adjusting ring upward until clearance of .005" exists between first-reverse control lever and ring as shown in Figure 3. Tighten cap screws.

8. Force lower bearing retaining spring clamp upward against spring tension until a dimension of 1-1/2" exists between lower bearing and clamp as shown in Figure 2. Tighten clamp bolt.
9. With transmission side cover selector levers in neutral position, adjust selector rod lengths per instructions in the appropriate shop manual to provide proper neutral cross-over. Replace access cover when adjustments are completed.

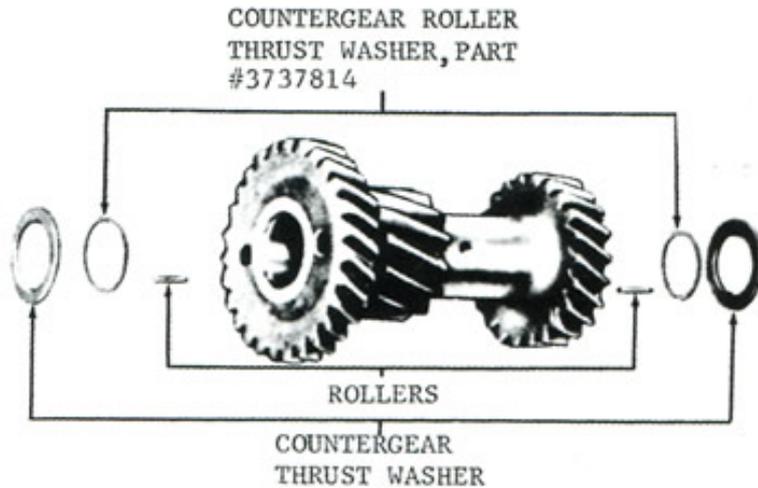
FIGURE 4 - INSTALLATION OF THRUST WASHERS IN CHEVY VAN

On Chevy Van models with three-speed transmissions, a small steel thrust washer is used between the countergear thrust washer and the countergear roller bearings at each end of the countergear. Since the 1964 Chevy Van Shop Manual is supplemented to the 1963 Truck Shop Manual in this area, reference to this part is omitted in error.

Figure 4 illustrates installed location of this thrust washer in Chevy Van transmissions.

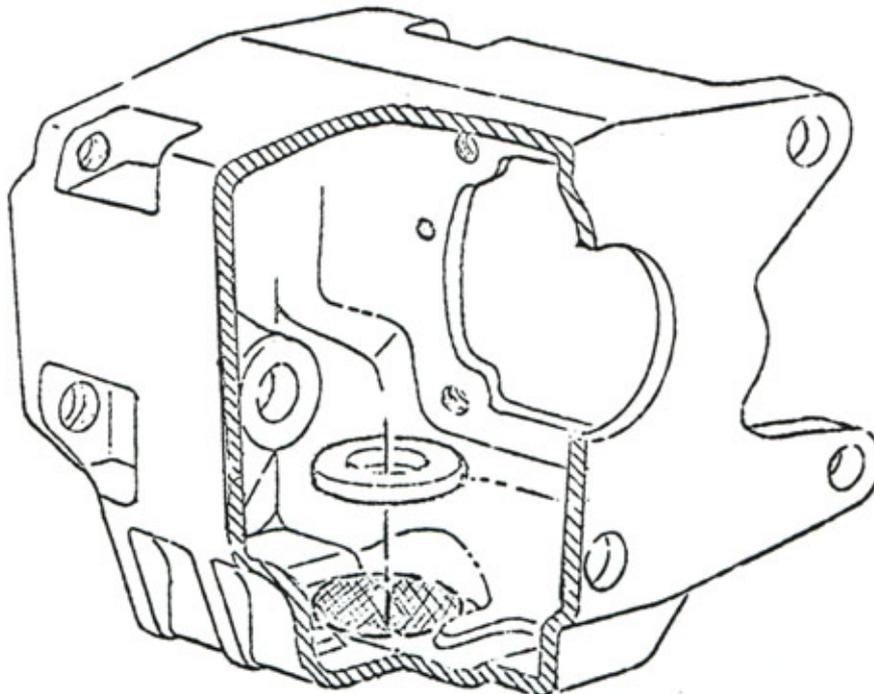
FIGURE 5 - INSTALLATION OF MAGNETIC CHIP COLLECTOR

Gear clash will cause rounding of the chamfers on the first and reverse gear, countergear and reverse idler gear and possibly break loose some fine chips. These fine particles are a major contributor to bearing noise.

To reduce bearing noise and increase bearing durability, two changes have been released for production. First is the installation of a magnetic chip collector which went into effect on June 5, 1964. Second is the use of a new clutch gear and mainshaft bearing that incorporates a slinger ring on the inner race. This change went into effect on transmissions for use on 327 cu. in. engines on June 11, 1964, and is estimated to go into effect the week of June 22, 1964, on remaining transmissions.

1. Remove all components from case.
2. Clean inside of case with steam cleaner, if available. In the absence of steam cleaning equipment, mineral spirits, kerosene or gasoline may be used. Evaporate all traces of cleaning agent by blowing out inside of transmission case with compressed air. To remove loose particles, sand area in case where magnet is to be installed with coarse emery cloth.

3. Wipe magnet and area in case where magnet is to be installed with Acetone or Toluol (available at most drugstores). Area where magnet is to be installed must be clean, dry and free from oil and grease film. When Acetone or Toluol is applied, be sure to use in ample quantity to neutralize grease and oil which may be in pores of casting surface. Do not touch cleaned area with hands.

4. Using cement supplied in kit, apply about a 1/16 inch thick film over entire bottom surface of magnet and immediately place in case as shown in sketch. Press straight down - do not twist while pressing in position. Note: If cement from tube appears to be thick, discard thick or hardened chunks and use cement from middle or bottom of tube.

5. To cure cement, place a trouble light with a 100 watt lamp inside of case as close to magnet as possible, and allow to stand for a minimum of 30 minutes. Use care not to touch magnet or knock it out of position. A heat lamp, if available, may be used in place of 100 watt lamp.
