# 1963 - 1964 Corvette: Service Bulletin: 3-Speed Transmission Problems

**Source:** Chevrolet Technical Service Bulletin

**Bulletin No:** TSB #1008 DR #676

**Date:** July 16, 1964

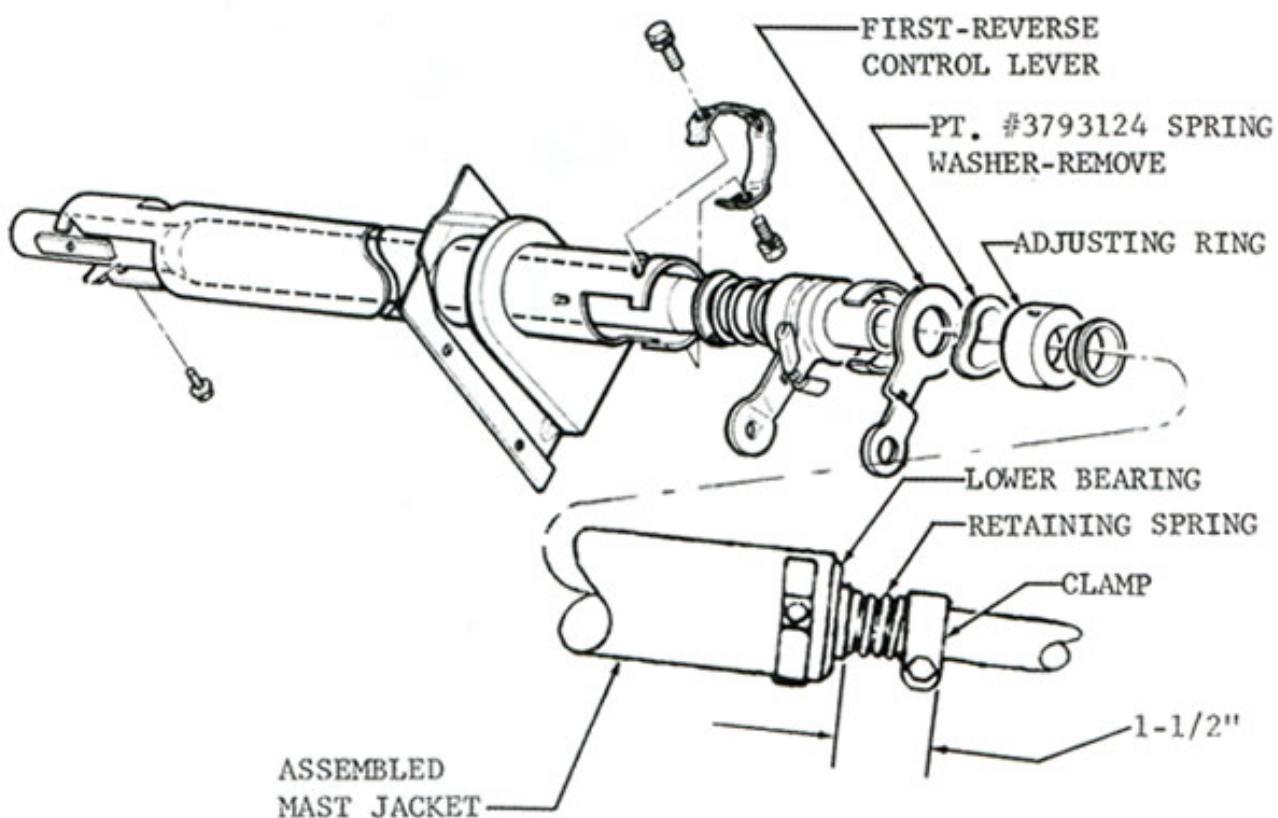
FIGURE 2 - MAST JACKET ASSEMBLY

The major sources of difficulty in shifting are the clearance adjustment between the transmission control levers located at the lower end of the mast jacket and the adjustment of the selector rods at the control levers for neutral cross-over. Excessive clearance between the levers or incorrect neutral cross-over may result in block-out.

To provide a more positive shift on truck models, Part No. 3793124, transmission control 1st and reverse lever spring washer is being omitted in production and should be removed from units in service. The procedure to remove this spring washer and to readjust lever clearance is as follows:

1. Refer to Figure 2 for parts identification. Place shift lever in neutral; remove access cover from fender skirt.

2. Remove cap screws retaining adjusting ring to mast jacket.
3. Loosen steering shaft lower bearing retaining spring clamp.
4. Slide adjusting ring downward along steering shaft until Part No. 3793124, spring washer, is exposed. Cut and remove spring washer from steering shaft.
5. Apply lubriplate to thrust surfaces of control levers, relay lever and adjusting ring.
6. Position adjusting ring in mast jacket; align holes in ring with slots in mast jacket and install cap screws, but do not tighten.
7. Rotate adjusting ring upward until clearance of .005" exists between first-reverse control lever and ring as shown in Figure 3. Tighten cap screws.

8. Force lower bearing retaining spring clamp upward against spring tension until a dimension of 1-1/2" exists between lower bearing and clamp as shown in Figure 2. Tighten clamp bolt.
9. With transmission side cover selector levers in neutral position, adjust selector rod lengths per instructions in the appropriate shop manual to provide proper neutral cross-over. Replace access cover when adjustments are completed.

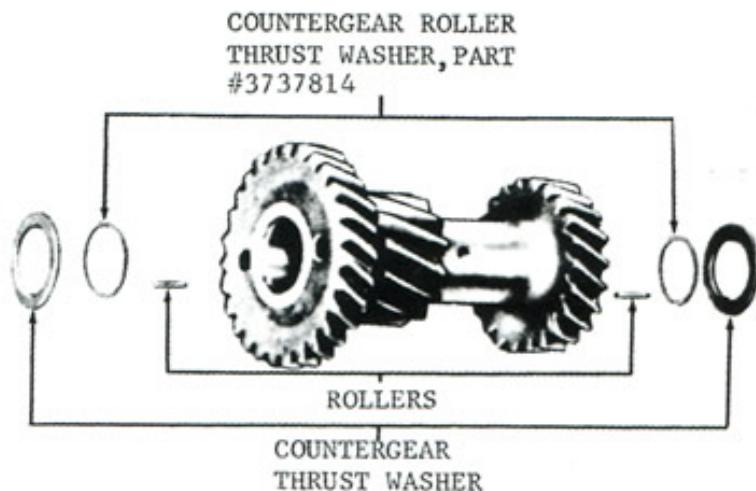
FIGURE 4 - INSTALLATION OF THRUST WASHERS IN CHEVY VAN

On Chevy Van models with three-speed transmissions, a small steel thrust washer is used between the countergear thrust washer and the countergear roller bearings at each end of the countergear. Since the 1964 Chevy Van Shop Manual is supplemented to the 1963 Truck Shop Manual in this area, reference to this part is omitted in error.

Figure 4 illustrates installed location of this thrust washer in Chevy Van transmissions.

NOTE: For service replacement procure (1) 3740819 Countergear Thrust Washer & (1) 3737814 Countergear Roller Thrust Washer for each steel thrust washer replaced. The roller thrust washer is installed between the countergear rollers and the countergear thrust washer.

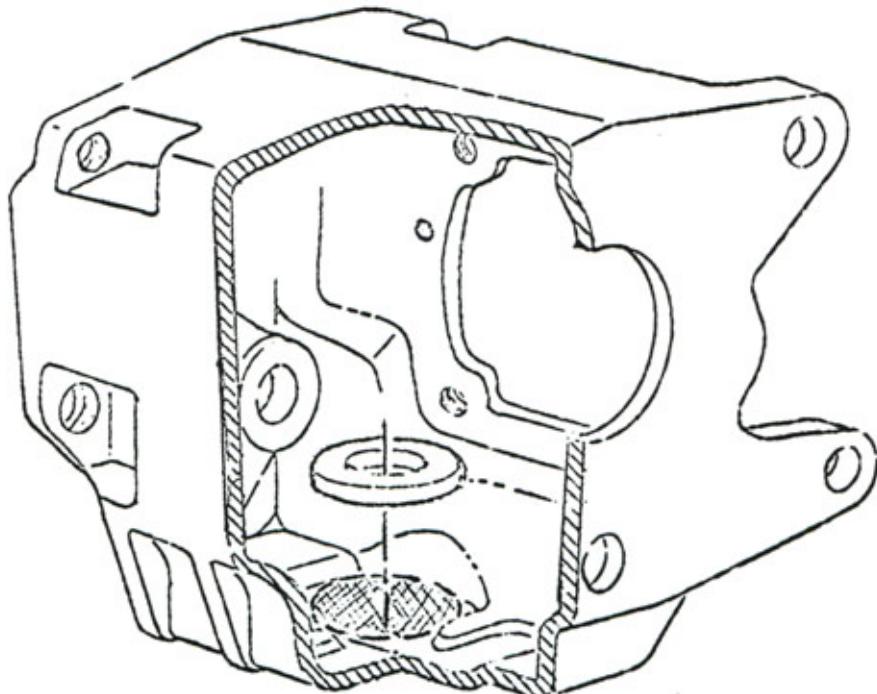
FIGURE 5 - INSTALLATION OF MAGNETIC CHIP COLLECTOR

Gear clash will cause rounding of the chamfers on the first and reverse gear, countergear and reverse idler gear and possibly break loose some fine chips. These fine particles are a major contributor to bearing noise.

To reduce bearing noise and increase bearing durability, two changes have been released for production. First is the installation of a magnetic chip collector which went into effect on June 5, 1964. Second is the use of a new clutch gear and mainshaft bearing that incorporates a slinger ring on the inner race. This change went into effect on transmissions for use on 327 cu. in. engines on June 11, 1964, and is estimated to go into effect the week of June 22, 1964, on remaining transmissions.

1. Remove all components from case.
2. Clean inside of case with steam cleaner, if available. In the absence of steam cleaning equipment, mineral spirits, kerosene or gasoline may be used. Evaporate all traces of cleaning agent by blowing out inside of transmission case with compressed air. To remove loose particles, sand area in case where magnet is to be installed with coarse emery cloth.

3. Wipe magnet and area in case where magnet is to be installed with Acetone or Toluol (available at most drugstores). Area where magnet is to be installed must be clean, dry and free from oil and grease film. When Acetone or Toluol is applied, be sure to use in ample quantity to neutralize grease and oil which may be in pores of casting surface. Do not touch cleaned area with hands.

4. Using cement supplied in kit, apply about a 1/16 inch thick film over entire bottom surface of magnet and immediately place in case as shown in sketch. Press straight down - do not twist while pressing in position. Note: If cement from tube appears to be thick, discard thick or hardened chunks and use cement from middle or bottom of tube.

5. To cure cement, place a trouble light with a 100 watt lamp inside of case as close to magnet as possible, and allow to stand for a minimum of 30 minutes. Use care not to touch magnet or knock it out of position. A heat lamp, if available, may be used in place of 100 watt lamp.
