# 1963 - 1964 Corvette: Service Bulletin: 3-Speed Transmission Problems

**Source:** Chevrolet Technical Service Bulletin

**Bulletin No:** TSB #1008 DR #676

**Date:** July 16, 1964

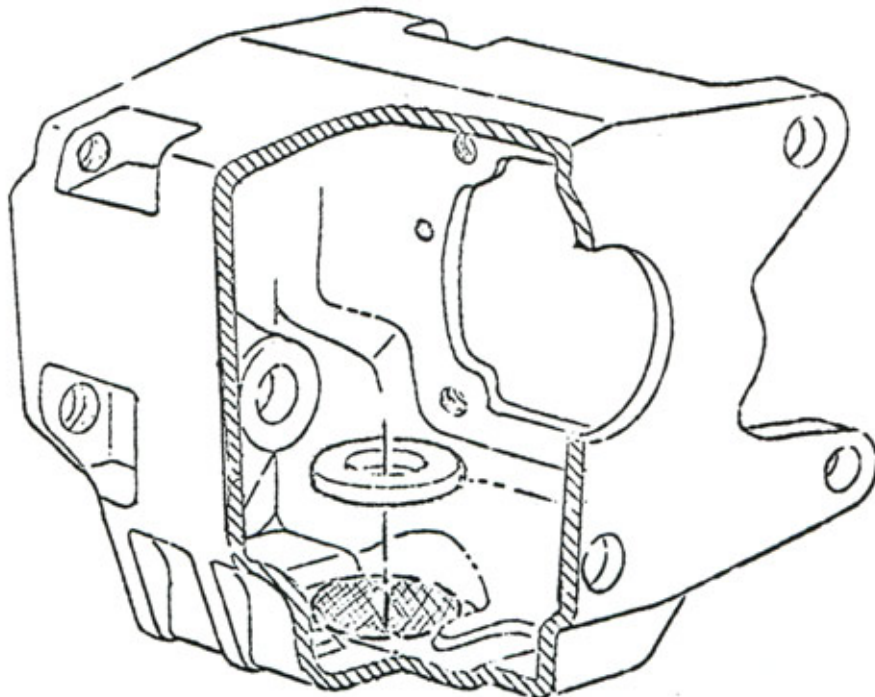
FIGURE 5 - INSTALLATION OF MAGNETIC CHIP COLLECTOR

Gear clash will cause rounding of the chamfers on the first and reverse gear, countergear and reverse idler gear and possibly break loose some fine chips. These fine particles are a major contributor to bearing noise.

To reduce bearing noise and increase bearing durability, two changes have been released for production. First is the installation of a magnetic chip collector which went into effect on June 5, 1964. Second is the use of a new clutch gear and mainshaft bearing that incorporates a slinger ring on the inner race. This change went into effect on transmissions for use on 327 cu. in. engines on June 11, 1964, and is estimated to go into effect the week of June 22, 1964, on remaining transmissions.

Service Kit #3869240 has been released for field installation of the chip collector on 1963 and 1964 3-speed transmissions built prior to the above dates. The kit includes the magnet, cement, and instruction sheet. It also contains a 3/8 inch high pedal bumper for increasing clutch release on all except Chevy Van (Reference - Gear Clash - First and Reverse Shift). It is recommended that whenever a 1963 or 1964 3-speed transmission is disassembled for any reason, that the magnet be installed using the following procedure.

4. Using cement supplied in kit, apply about a 1/16 inch thick film over entire bottom surface of magnet and immediately place in case as shown in sketch. Press straight down - do not twist while pressing in position. Note: If cement from tube appears to be thick, discard thick or hardened chunks and use cement from middle or bottom of tube.
