1967 Corvette: Service News: Inspection and Realignment of the Energy Absorbing Steering Column

Model and Year: 1967 Passenger Cars

Source: Chevrolet Service News

Date: February, 1967 - Volume 39 - Number 2

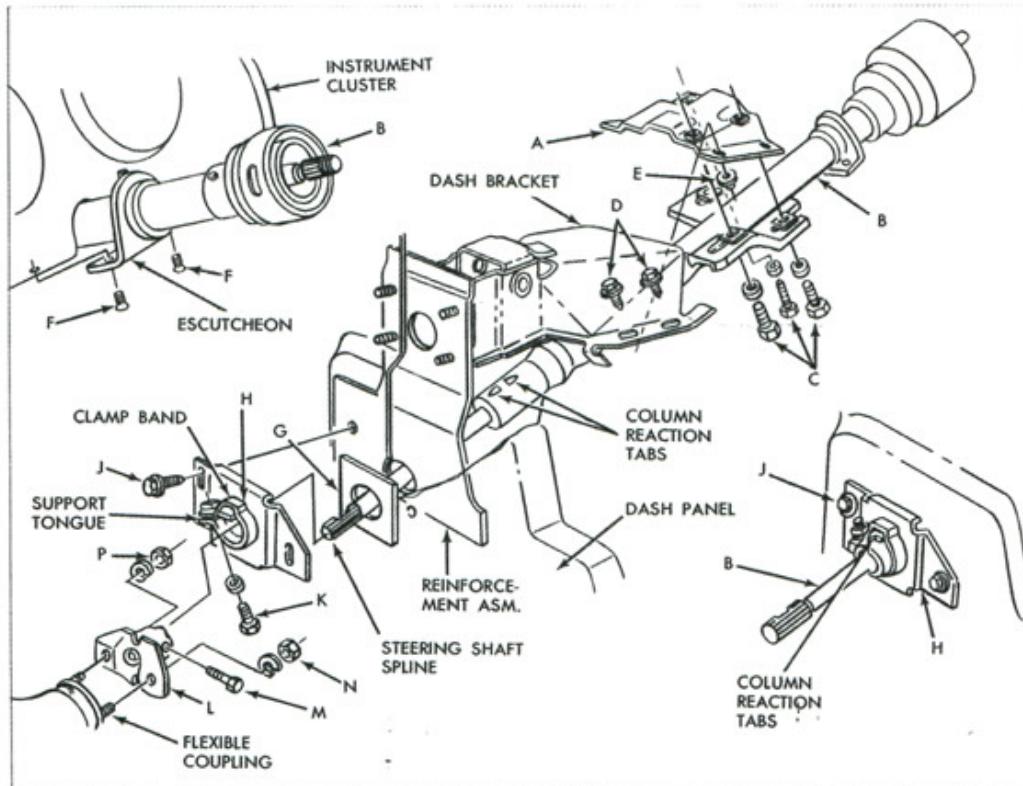
1967 CORVETTE STEERING COLUMN REALIGNMENT—FIGURE 6

A slow steering recovery on turns, a noise, an irregular feel as the steering wheel is turned, or flexible coupling distortion, are conditions which indicated the need for the steering column to be readjusted and realigned.

1. Loosen, but do not remove, escutcheon attaching bolts (F).
2. Loosen, but do not remove, three bolts (C) which attach the column (B) to the intermediate bracket (A). Loosen four nuts (E) and bolts (D) which attach the intermediate bracket (A) to the dash bracket.
3. Loosen bolts (J) and (K) which secure the lower column to the toe pan.
4. Loosen flexible coupling flange pinch bolt (M).
5. Check steering column to insure column is

- loose and can be moved in all directions.
6. Tighten escutcheon attachment bolts (F) to 25 in.-lbs. torque.
7. Adjust column fore or aft to place the clamp band (part of H) between the column reaction tabs (part of B).
8. With the column position defined by flexible coupling and escutcheon, hold the steering column lower support (H) against the front of dash and tighten the wrap-around clamp bolt (K) to 150 in.-lbs. torque.
9. Check bracket (H) to insure that it is not

binding against bolts (J). Tighten bolts (J) to 150 in.-lbs. torque.

10. Pull intermediate bracket (A) rearward to accommodate the height differential of the

cluster to instrument panel brace, and tighten three bolts (C) to 20 in.-lbs. torque.

11. With flexible coupling held flat, tighten upper flange pitch bolt (M) to 30 ft.-lbs. torque.
