# 1967 Corvette: Service News: Inspection and Realignment of the Energy Absorbing Steering Column

**Subject:** Inspection and Realignment of the Energy Absorbing Steering Column

**Model and Year:** 1967 Passenger Cars

**Date:** February, 1967 - Volume 39 - Number 2

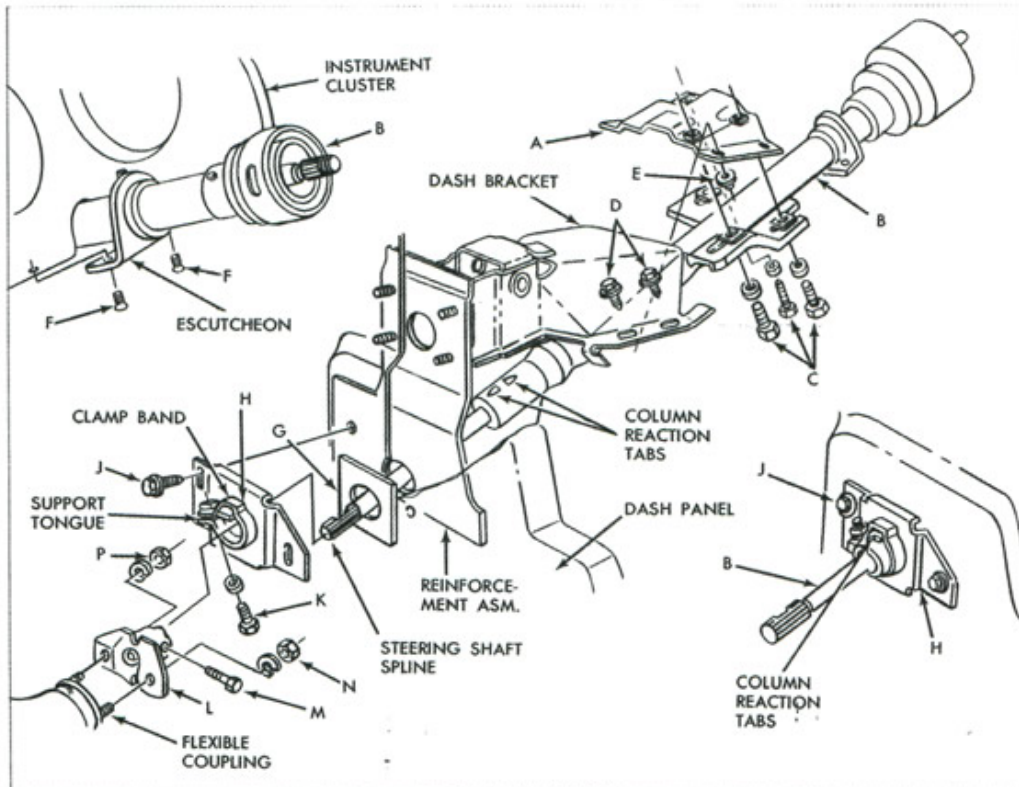
## 1967 CORVETTE STEERING COLUMN REALIGNMENT—FIGURE 6

A slow steering recovery on turns, a noise, an irregular feel as the steering wheel is turned, or flexible coupling distortion, are conditions which indicated the need for the steering column to be readjusted and realigned.

1. Loosen, but do not remove, escutcheon attaching bolts (F).
2. Loosen, but do not remove, three bolts (C) which attach the column (B) to the intermediate bracket (A). Loosen four nuts (E) and bolts (D) which attach the intermediate bracket (A) to the dash bracket.

3. Loosen bolts (J) and (K) which secure the lower column to the toe pan.
4. Loosen flexible coupling flange pinch bolt (M).
5. Check steering column to insure column is loose and can be moved in all directions.

6. Tighten escutcheon attachment bolts (F) to 25 in.-lbs. torque.
7. Adjust column fore or aft to place the clamp band (part of H) between the column reaction tabs (part of B).

8. With the column position defined by flexible coupling and escutcheon, hold the steering column lower support (H) against the front of dash and tighten the wrap-around clamp bolt (K) to 150 in.-lbs. torque.

10. Pull intermediate bracket (A) rearward to accommodate the height differential of the

cluster to instrument panel brace, and tighten three bolts (C) to 20 in.-lbs. torque.

11. With flexible coupling held flat, tighten upper flange pinch bolt (M) to 30 ft.-lbs. torque.
