# 1967 Corvette: Service News: Inspection and Realignment of the Energy Absorbing Steering Column

**Source:** Chevrolet Service News

**Date:** February, 1967 - Volume 39 - Number 2

## **INSPECTION and REALIGNMENT of the ENERGY ABSORBING STEERING COLUMN—ALL 1967 PASSENGER CARS**

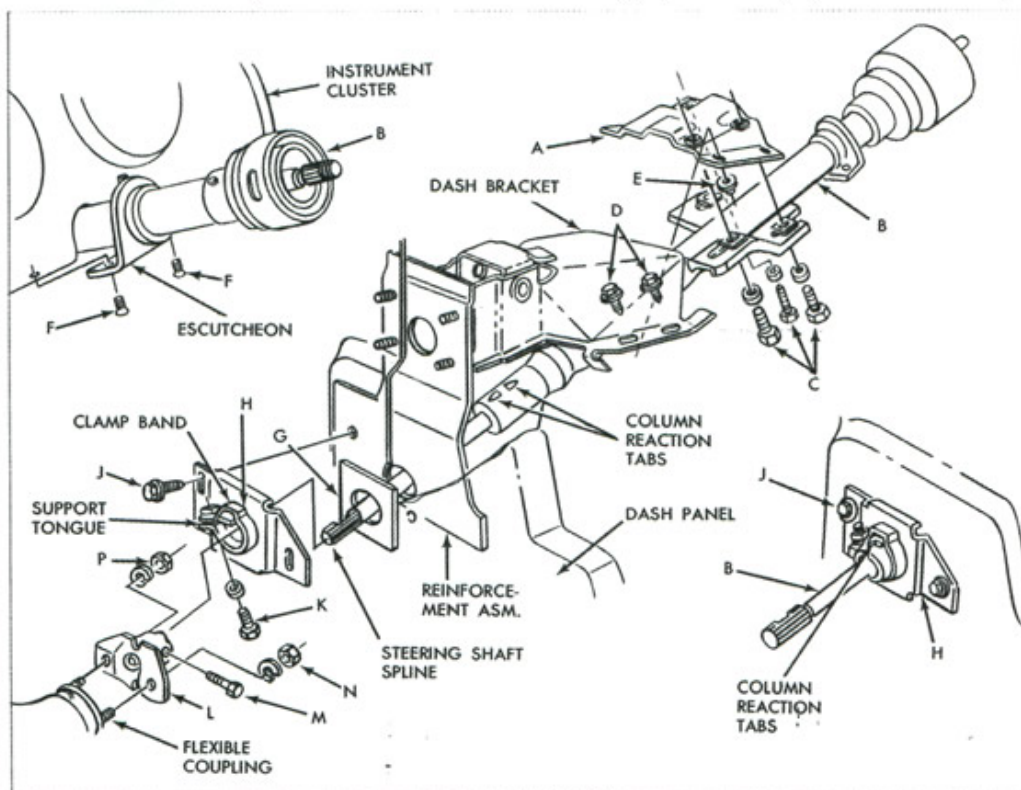
## 1967 CORVETTE STEERING COLUMN REALIGNMENT—FIGURE 6

A slow steering recovery on turns, a noise, an irregular feel as the steering wheel is turned, or flexible coupling distortion, are conditions which indicated the need for the steering column to be readjusted and realigned.

1. Loosen, but do not remove, escutcheon attaching bolts (F).
2. Loosen, but do not remove, three bolts (C) which attach the column (B) to the intermediate bracket (A). Loosen four nuts (E) and bolts (D) which attach the intermediate bracket (A) to the dash bracket.

3. Loosen bolts (J) and (K) which secure the lower column to the toe pan.
4. Loosen flexible coupling flange pinch bolt (M).
5. Check steering column to insure column is loose and can be moved in all directions.

6. Tighten escutcheon attachment bolts (F) to 25 in.-lbs. torque.
7. Adjust column fore or aft to place the clamp band (part of H) between the column reaction tabs (part of B).

8. With the column position defined by flexible coupling and escutcheon, hold the steering column lower support (H) against the front of dash and tighten the wrap-around clamp bolt (K) to 150 in.-lbs. torque.

9. Check bracket (H) to insure that it is not

binding against bolts (J). Tighten bolts (J) to 150 in.-lbs. torque.

10. Pull intermediate bracket (A) rearward to accommodate the height differential of the

cluster to instrument panel brace, and tighten three bolts (C) to 20 in.-lbs. torque.

11. With flexible coupling held flat, tighten upper flange pinch bolt (M) to 30 ft.-lbs. torque.
