1967 Corvette: Service News: Inspection and Realignment of the Energy Absorbing Steering Column

Model and Year: 1967 Passenger Cars

Source: Chevrolet Service News

Date: February, 1967 - Volume 39 - Number 2

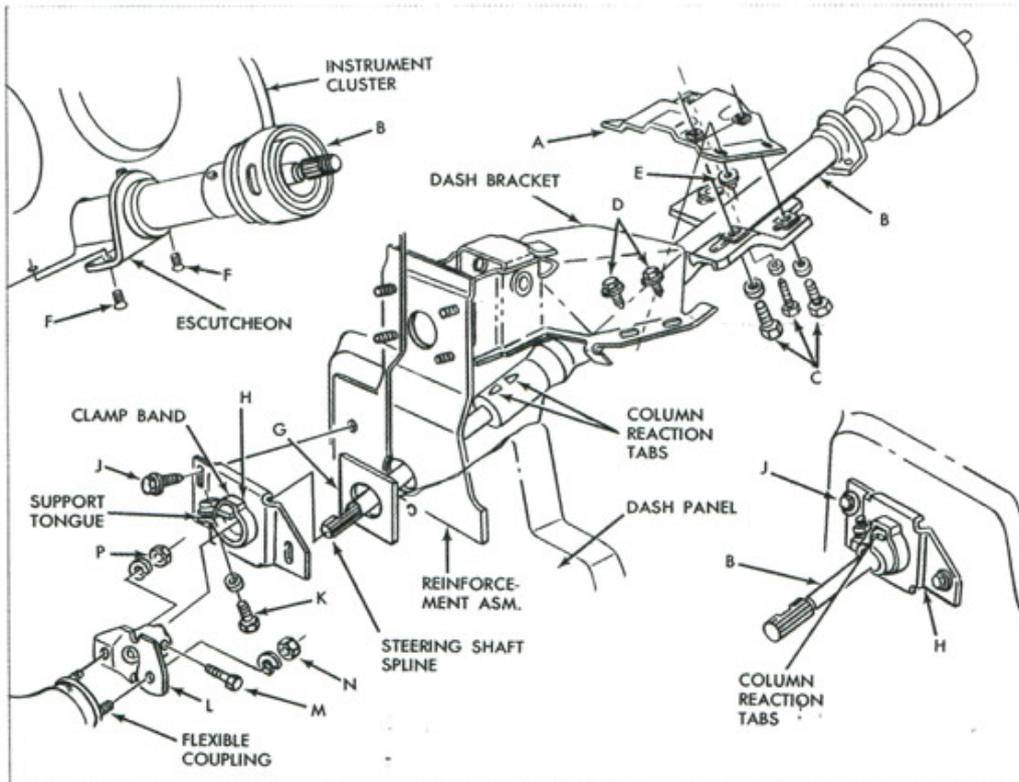
1967 CORVETTE STEERING COLUMN REALIGNMENT—FIGURE 6

A slow steering recovery on turns, a noise, an irregular feel as the steering wheel is turned, or flexible coupling distortion, are conditions which indicated the need for the steering column to be readjusted and realigned.

1. Loosen, but do not remove, escutcheon attaching bolts (F).
2. Loosen, but do not remove, three bolts (C) which attach the column (B) to the intermediate bracket (A). Loosen four nuts (E) and bolts (D) which attach the intermediate bracket (A) to the dash bracket.

3. Loosen bolts (J) and (K) which secure the lower column to the toe pan.
4. Loosen flexible coupling flange pinch bolt (M).
5. Check steering column to insure column is loose and can be moved in all directions.

6. Tighten escutcheon attachment bolts (F) to 25 in.-lbs. torque.
7. Adjust column fore or aft to place the clamp band (part of H) between the column reaction tabs (part of B).

8. With the column position defined by flexible coupling and escutcheon, hold the steering column lower support (H) against the front of dash and tighten the wrap-around clamp bolt (K) to 150 in.-lbs. torque.

10. Pull intermediate bracket (A) rearward to accommodate the height differential of the

cluster to instrument panel brace, and tighten three bolts (C) to 20 in.-lbs. torque.

11. With flexible coupling held flat, tighten upper flange pinch bolt (M) to 30 ft.-lbs. torque.
