1968 Corvette: Service Bulletin: Choke and Hot Restart Problems

Model and Year: 1968 Corvette with 427 cu. in. Engine

Source: Chevrolet Dealer Service Technical Service Bulletin

Bulletin No: 68-T-23 Re-Issue

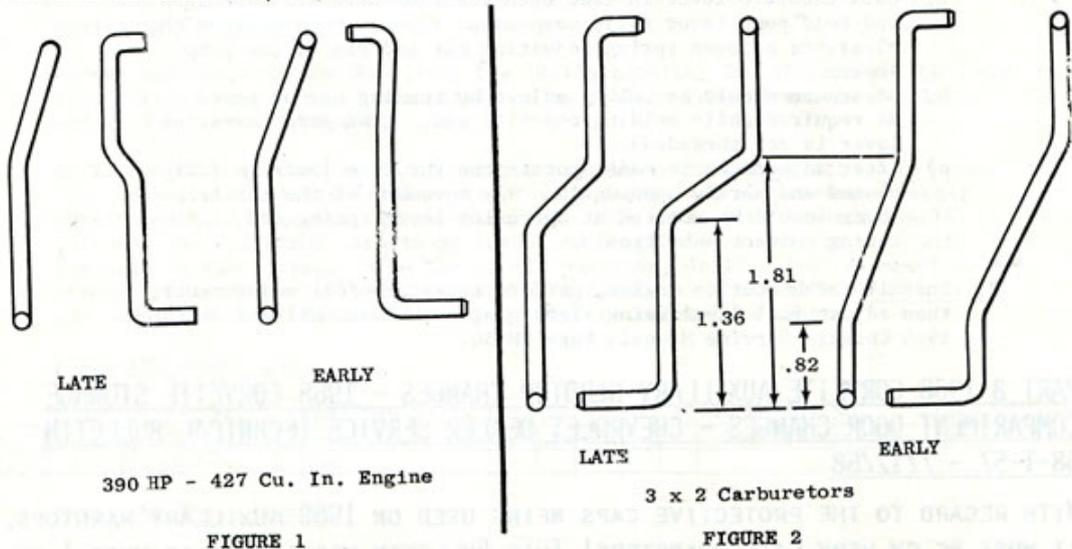
FIGURE 1

The hard cold starting problem may be due to interference or bind conditions of the choke rod, resulting in failure of the choke to move fully closed. Choke rod revisions corrected this possible condition with early October production vehicles. Field correction of this condition is outlined on Page2.

Install new choke rod (Part No. 3937738) which has a greater off-set and a reverse entry direction at the choke lever end. Adjust to one rod diameter interference by bending at the off-set as necessary.
