1959 Corvette: Service Bulletin: Excessive Driveline Vibration

Model and Year: 1959 Corvette

Source: General Motors of Canada Service Bulletin

Date: September 30, 1959

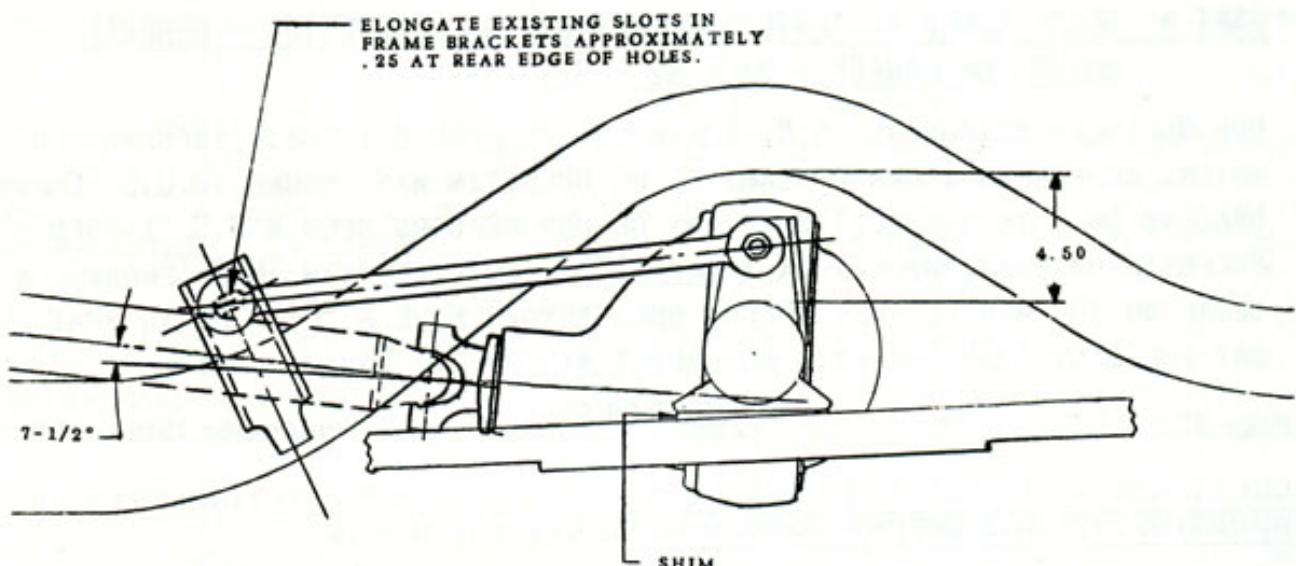
The nominal angle of the rear U-joint is 7-1/2°. Care should be taken in not going under 7-1/2° due to interference at full bump position.

The propeller shaft and pinion angle and the elongation of the radius rode mounting bracket hole is shown in Fig. 44.

2. The radius control rods should be disconnected before installing the shim. Before re-attaching the radius control rods, elongate the radius rod frame mounting hole 1/4" rearward if necessary to eliminate any interference between the radius control rods attaching bolt and mounting bracket. Shim part #3722797 (2°), or #3744488 (3°), or their equivalent may be utilized. The locating tab on the above shims should be removed to allow the shim to lie flat.
