1959 Corvette: Service Bulletin: Excessive Driveline Vibration

Subject: Excessive Drive Line Vibration

Model and Year: 1959 Corvette

Date: September 30, 1959

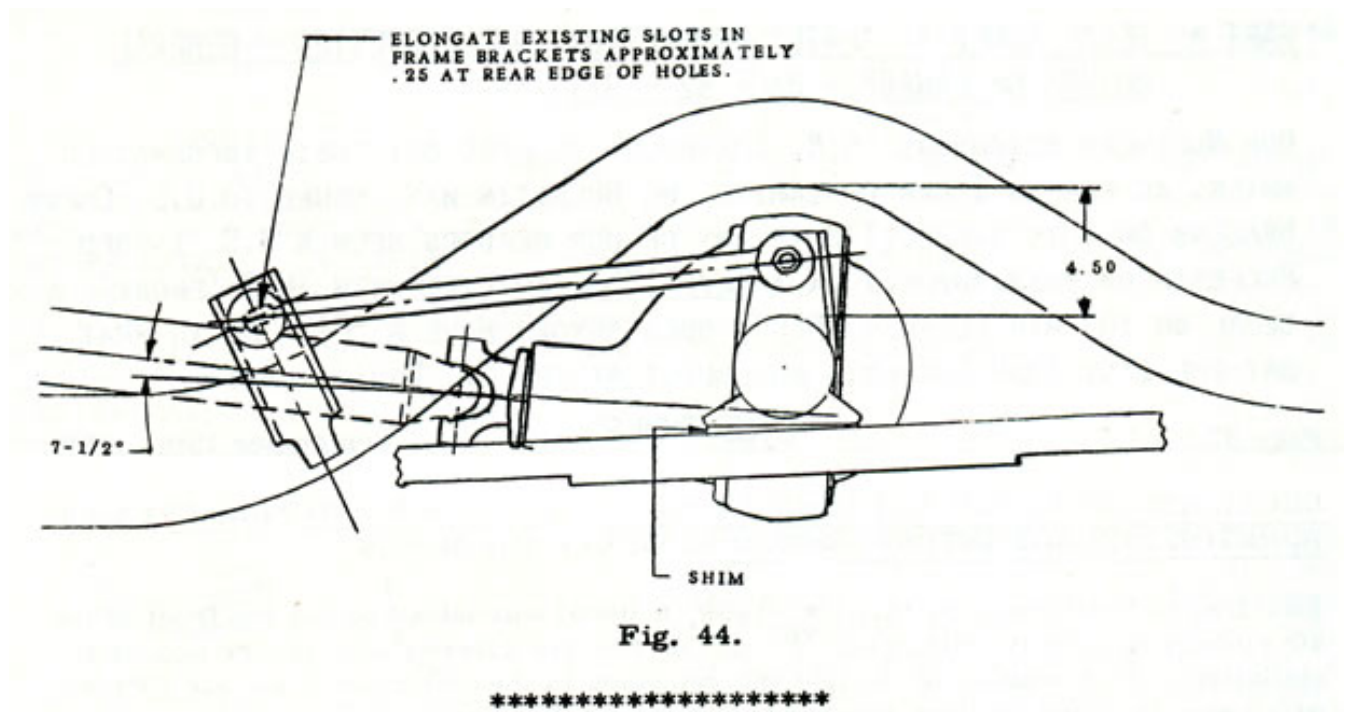
If excessive drive line vibration is encountered on the 1959 Corvette, it is probably due to excessive rear U-joint angle. Elimination of the vibration can be accomplished by installing either a 2° or 3° shim between the axle pads and springs on both sides, with the thick side to the front.

The nominal angle of the rear U-joint is 7-1/2°. Care should be taken in not going under 7-1/2° due to interference at full bump position.

The propeller shaft and pinion angle and the elongation of the radius rod mounting bracket hole is shown in Fig. 44.

2. The radius control rods should be disconnected before installing the shim. Before re-attaching the radius control rods, elongate the radius rod frame mounting hole 1/4" rearward if necessary to eliminate any interference between the radius control rods attaching bolt and mounting bracket. Shim part #3722797 (2 °), or #3744488 (3 °), or their equivalent may be utilized. The locating tab on the above shims should be removed to allow the shim to lie flat.
