1959 Corvette: Service Bulletin: Excessive Driveline Vibration

Model and Year: 1959 Corvette

Source: General Motors of Canada Service Bulletin

Date: September 30, 1959

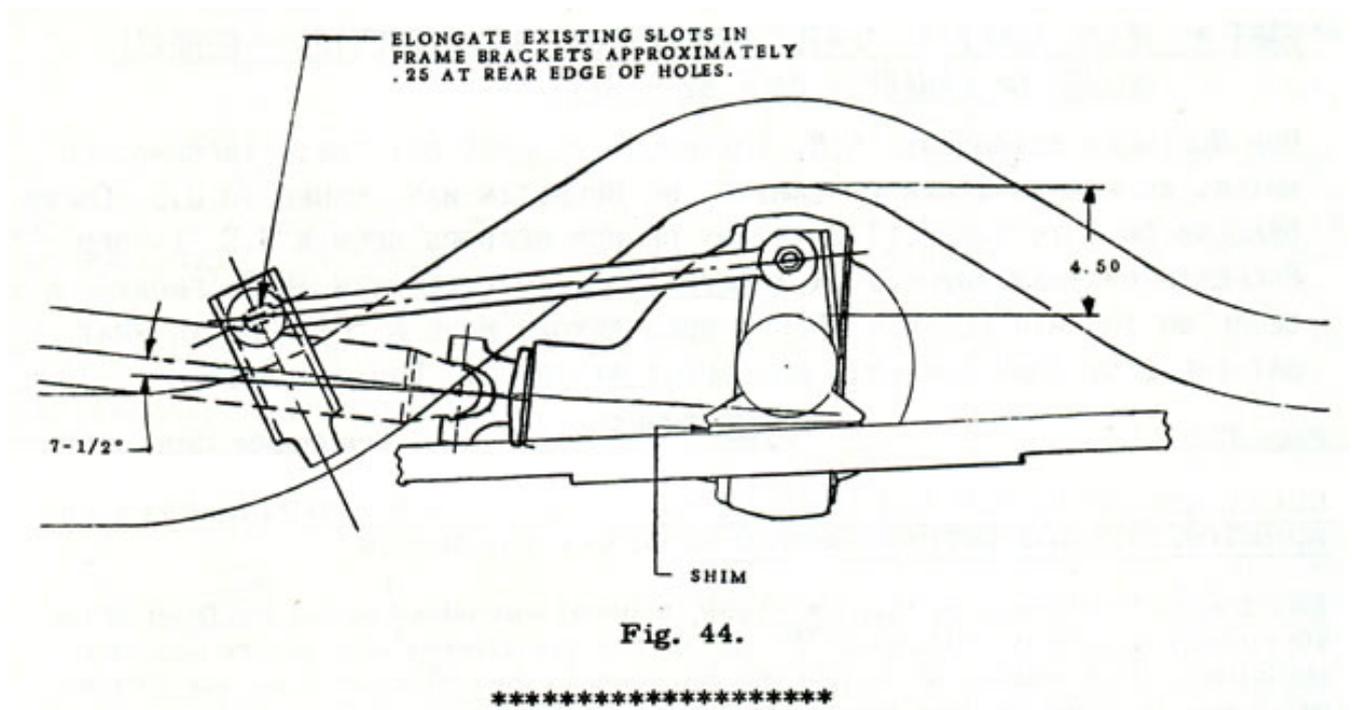
If excessive drive line vibration is encountered on the 1959 Corvette, it is probably due to excessive rear U-joint angle. Elimination of the vibration can be accomplished by installing either a 2° or 3° shim between the axle pads and springs on both sides, with the thick side to the front.

The nominal angle of the rear U-joint is 7-1/2°. Care should be taken in not going under 7-1/2° due to interference at full bump position.

The propeller shaft and pinion angle and the elongation of the radius rod mounting bracket hole is shown in Fig. 44.

2. The radius control rods should be disconnected before installing the shim. Before re-attaching the radius control rods, elongate the radius rod frame mounting hole 1/4" rearward if necessary to eliminate any interference between the radius control rods attaching bolt and mounting bracket. Shim part #3722797 (2 °), or #3744488 (3 °), or their equivalent may be utilized. The locating tab on the above shims should be removed to allow the shim to lie flat.
