# 1968 Corvette: Service Bulletin: Heat Damage to Engine Wiring Harness

**Model and Year:** 1968 Passenger Vehicles with 396 or 427 Cubic Inch Engine

**Bulletin No:** 68-T-25

**Date:** Feb. 19, 1968

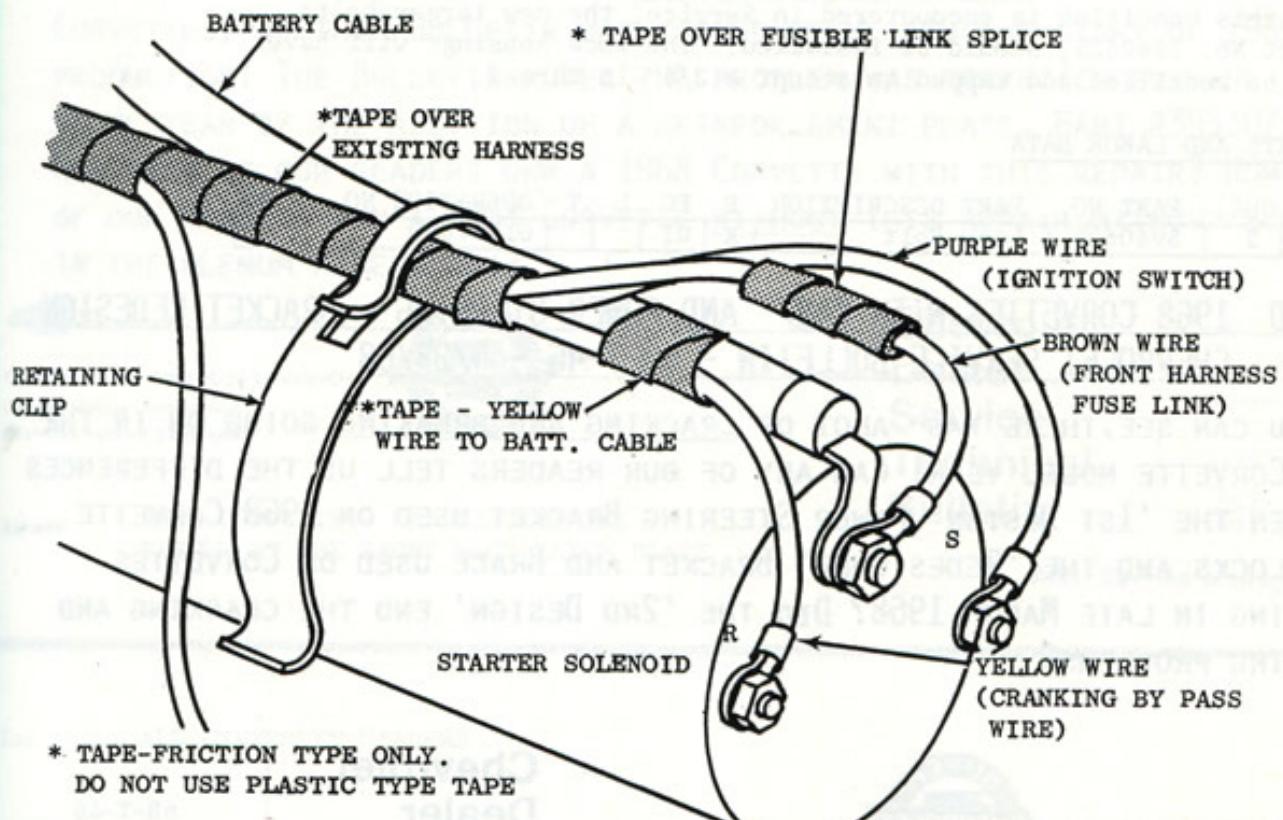
FIGURE 1

The engine wiring harness on some early production 1968 passenger vehicles equipped with either the 396 or 427 cubic inch engine may be subject to exhaust manifold heat damage harness wires are not properly routed through the retaining clip located on the starter solenoid. Reports have indicated that the yellow colored ignition or cranking by-pass wire, which attaches to the solenoid terminal closest to the exhaust manifold, is the wire most often damaged by exhaust manifold heat. To prevent damage, the wire must be routed "loop-free" through the solenoid retaining clip to the solenoid terminal.

ENGINE WIRING HARNESS ROUTING  
FOR 1968 CORVETTE  
396 AND 427 CUBIC INCH ENGINE

Effective November 27, 1967, the assembly plant is repositioning and taping the wiring harness on all Corvettes with either the 396 or 427 cubic inch engine as shown in figure 1. Proper routing of the engine wiring harness through the retaining clip on all other passenger vehicles with the 396 or 427 engine is being more closely maintained at all assembly plants.

If heat damage to the engine wiring harness is encountered on subject 1968 Corvette models in the field, the harness should be taped as shown in figure 1. If harness replacement is necessary, the new harness should be similarly taped at the time of installation. All other 396 or 427 cubic inch engine passenger cars require only proper wire routing to avoid heat damage from the manifold. This wiring should be checked for proper routing at the time of new car preparation.
