# 1968 Corvette: Service Bulletin: Heat Damage to Engine Wiring Harness

**Model and Year:** 1968 Passenger Vehicles with 396 or 427 Cubic Inch Engine

**Source:** Chevrolet Dealer Service Technical Bulletin

**Bulletin No:** 68-T-25

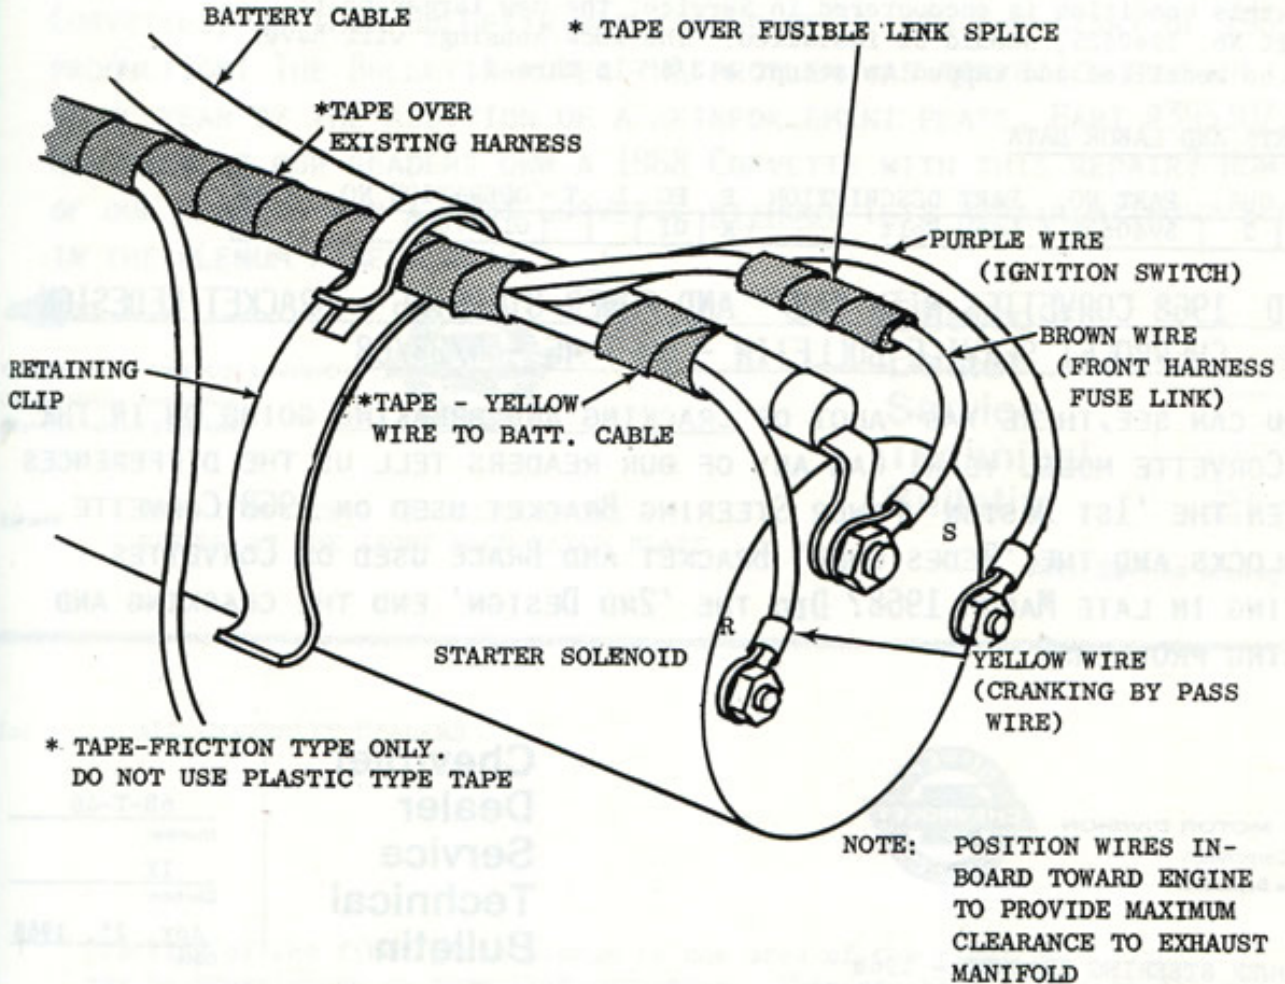
FIGURE 1

The engine wiring harness on some early production 1968 passenger vehicles equipped with either the 396 or 427 cubic inch engine may be subject to exhaust manifold heat damage harness wires are not properly routed through the retaining clip located on the starter solenoid. Reports have indicated that the yellow colored ignition or cranking by-pass wire, which attaches to the solenoid terminal closest to the exhaust manifold, is the wire most often damaged by exhaust manifold heat. To prevent damage, the wire must be routed "loop-free" through the solenoid retaining clip to the solenoid terminal.

ENGINE WIRING HARNESS ROUTING  
FOR 1968 CORVETTE  
396 AND 427 CUBIC INCH ENGINE

Effective November 27, 1967, the assembly plant is repositioning and taping the wiring harness on all Corvettes with either the 396 or 427 cubic inch engine as shown in figure 1. Proper routing of the engine wiring harness through the retaining clip on all other passenger vehicles with the 396 or 427 engine is being more closely maintained at all assembly plants.

If heat damage to the engine wiring harness is encountered on subject 1968 Corvette models in the field, the harness should be taped as shown in figure 1. If harness replacement is necessary, the new harness should be similarly taped at the time of installation. All other 396 or 427 cubic inch engine passenger cars require only proper wire routing to avoid heat damage from the manifold. This wiring should be checked for proper routing at the time of new car preparation.
