1968 Corvette: Service Bulletin: Cracking of the Plenum at the Right Hood Latch Plate

Source: Chevrolet Dealer Service Technical Bulletin

Bulletin No: 68-T-68

Date: Nov. 11, 1968

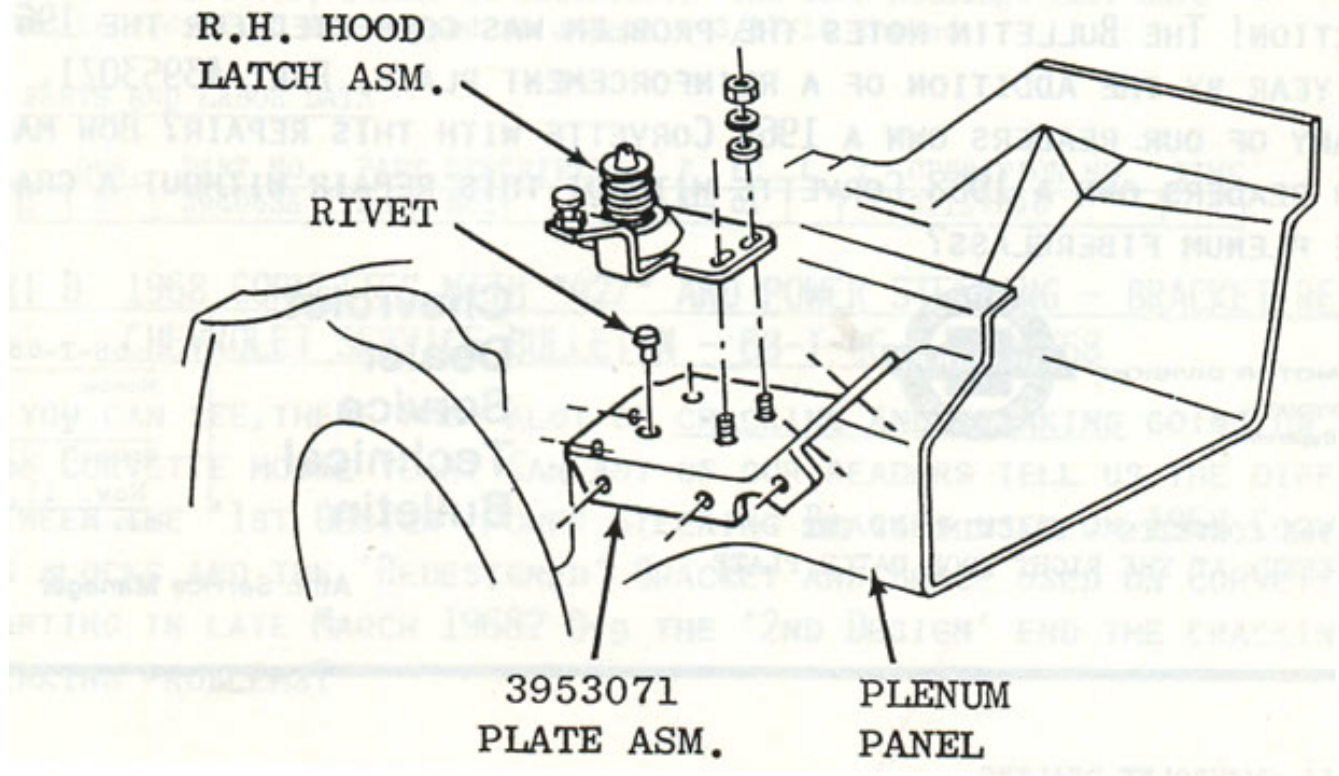
RIGHT HOOD LATCH REINFORCEMENT PLATE INSTALLATION 1968 CORVETTE

Cracking of the fiber glass plenum in the area of the right hood latch may be experienced on some 1968 Corvettes. This cracking is due to the manufacturing process of the plenum causing a glass rich condition in this area. This condition was corrected at the start of the 1969 production by the addition of a reinforcement plate to the area.

Whenever this cracking condition is encountered in the field, it may be corrected by riveting a reinforcement plate Part No. 3953071 to the outer surface of the plenum as outlined under Service Procedure.

1. Remove right hood latch assembly from the plenum panel and remove cowl vent grille.
2. Drill out two rivets retaining existing stud plate to plenum using a 7/32" dia. drill bit. Remove stud plate through cowl vent opening.
3. Position reinforcement plate on plenum as shown in sketch and drill seven (7) holes 7/32" dia. at hole locations in plate. The two (2) outboard holes are not accessible for drilling.
4. Attach the reinforcement plate to the plenum using 3/16" x 5/8" "Pop" Rivets.
5. Install and adjust right hood latch assembly as outlined in the August 1968 issue of "Chevrolet Service News." Install cowl vent grille.
