1968 Corvette: Service Bulletin: Cracking of the Plenum at the Right Hood Latch Plate

Bulletin No: 68-T-68

Date: Nov. 11, 1968

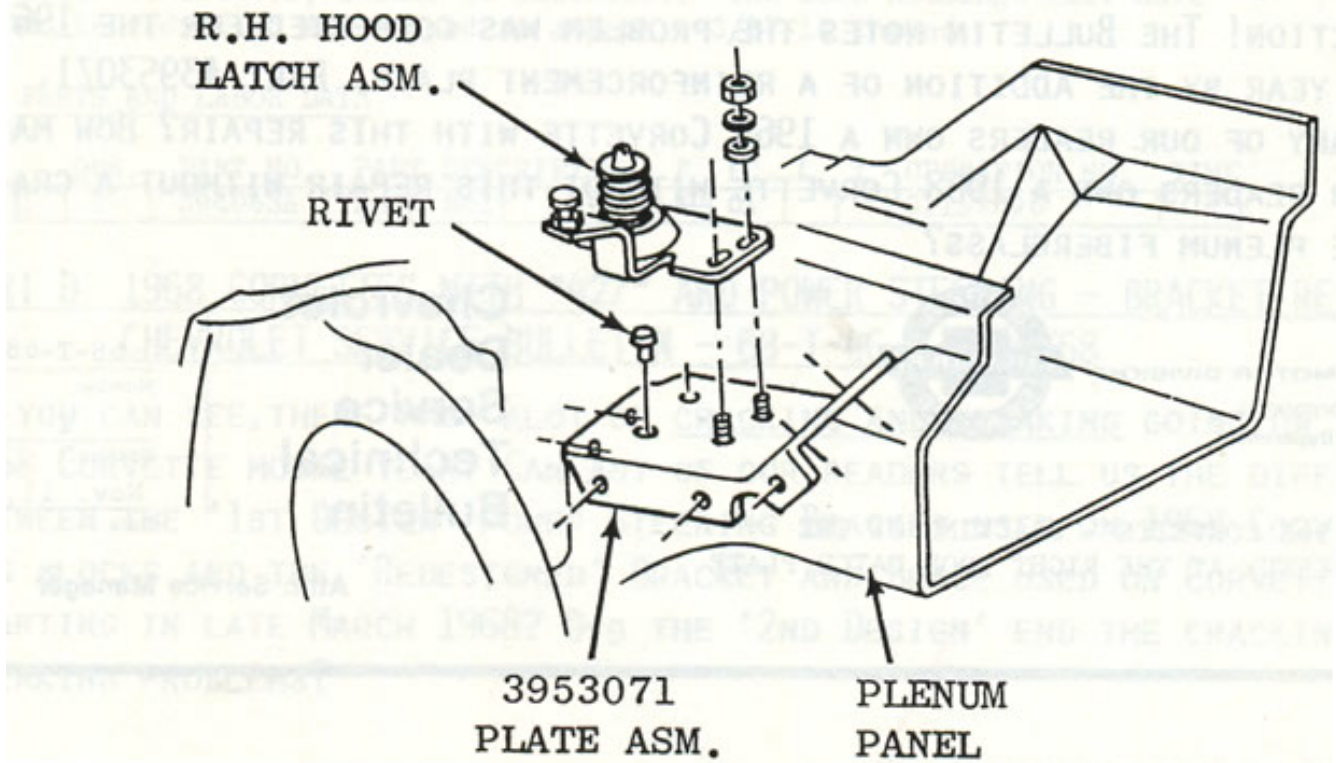
RIGHT HOOD LATCH REINFORCEMENT PLATE INSTALLATION
1968 CORVETTE

Cracking of the fiber glass plenum in the area of the right hood latch may be experienced on some 1968 Corvettes. This cracking is due to the manufacturing process of the plenum causing a glass rich condition in this area. This condition was corrected at the start of the 1969 production by the addition of a reinforcement plate to the area.

Whenever this cracking condition is encountered in the field, it may be corrected by riveting a reinforcement plate Part No. 3953071 to the outer surface of the plenum as outlined under Service Procedure.

1. Remove right hood latch assembly from the plenum panel and remove cowl vent grille.
2. Drill out two rivets retaining existing stud plate to plenum using a 7/32" dia. drill bit. Remove stud plate through cowl vent opening.
3. Position reinforcement plate on plenum as shown in sketch and drill seven (7) holes 7/32" dia. at hole locations in plate. The two (2) outboard holes are not accessible for drilling.
4. Attach the reinforcement plate to the plenum using 3/16" x 5/8" "Pop" Rivets.
5. Install and adjust right hood latch assembly as outlined in the August 1968 issue of "Chevrolet Service News." Install cowl vent grille.
