1968 Corvette: Service Bulletin: Cracking of the Plenum at the Right Hood Latch Plate

Subject: Cracking of the Plenum at the Right Hood Latch Plate

Model and Year: 1968 Corvette

Bulletin No: 68-T-68

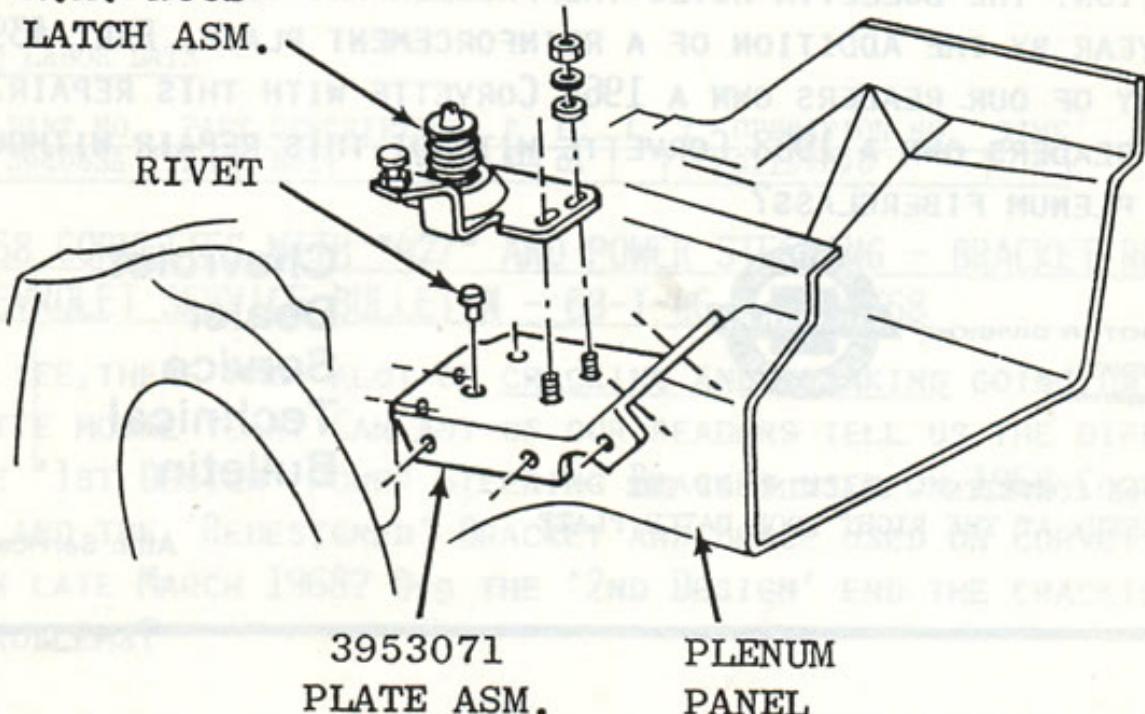
RIGHT HOOD LATCH REINFORCEMENT PLATE INSTALLATION 1968 CORVETTE

Cracking of the fiber glass plenum in the area of the right hood latch may be experienced on some 1968 Corvettes. This cracking is due to the manufacturing process of the plenum causing a glass rich condition in this area. This condition was corrected at the start of the 1969 production by the addition of a reinforcement plate to the area.

Whenever this cracking condition is encountered in the field, it may be corrected by riveting a reinforcement plate Part No. 3953071 to the outer surface of the plenum as outlined under Service Procedure.

1. Remove right hood latch assembly from the plenum panel and remove cowl vent grille.
2. Drill out two rivets retaining existing stud plate to plenum using a 7/32" dia. drill bit. Remove stud plate through cowl vent opening.
3. Position reinforcement plate on plenum as shown in sketch and drill seven (7) holes 7/32" dia. at hole locations in plate. The two (2) outboard holes are not accessible for drilling.
4. Attach the reinforcement plate to the plenum using 3/16" x 5/8" "Pop" Rivets.
5. Install and adjust right hood latch assembly as outlined in the August 1968 issue of "Chevrolet Service News." Install cowl vent grille.
