1968 Corvette: Service Bulletin: Cracking of the Plenum at the Right Hood Latch Plate

Source: Chevrolet Dealer Service Technical Bulletin

Bulletin No: 68-T-68

Date: Nov. 11, 1968

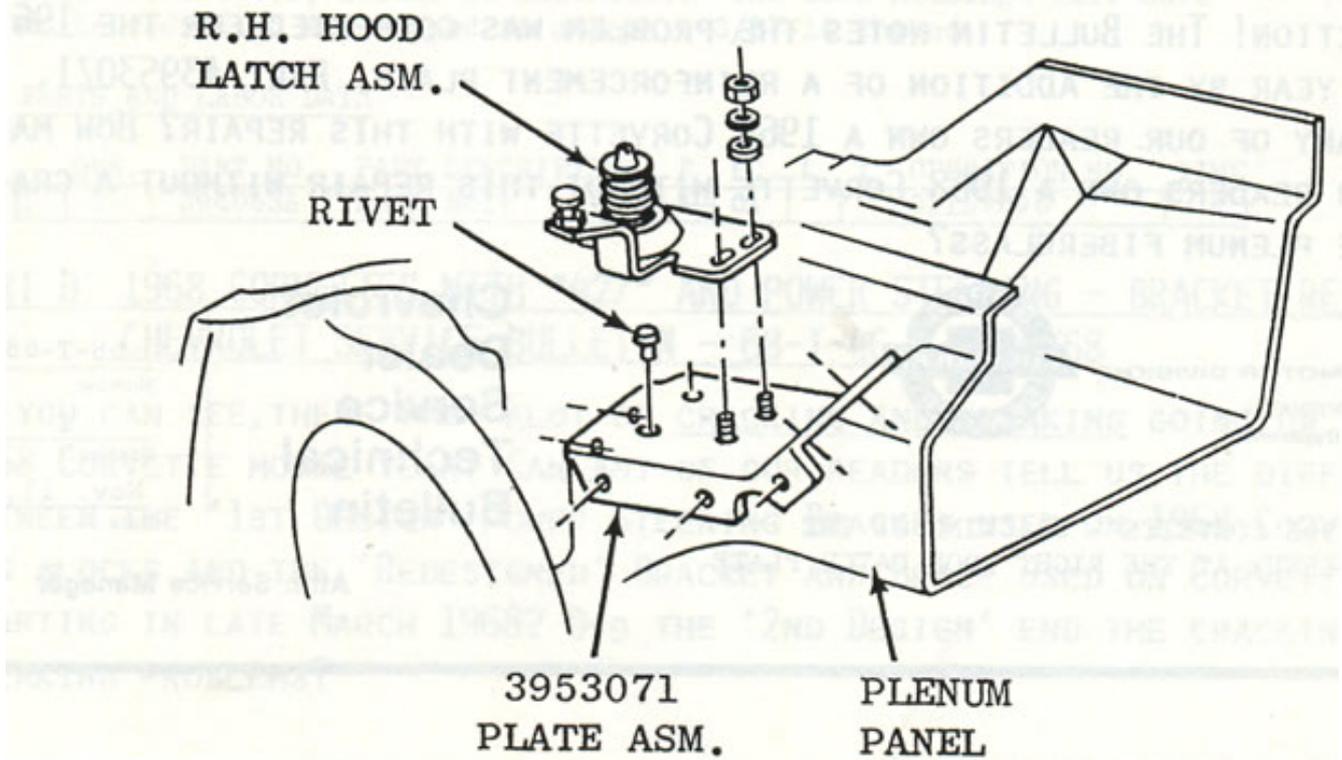
RIGHT HOOD LATCH REINFORCEMENT PLATE INSTALLATION
1968 CORVETTE

Cracking of the fiber glass plenum in the area of the right hood latch may be experienced on some 1968 Corvettes. This cracking is due to the manufacturing process of the plenum causing a glass rich condition in this area. This condition was corrected at the start of the 1969 production by the addition of a reinforcement plate to the area.

Whenever this cracking condition is encountered in the field, it may be corrected by riveting a reinforcement plate Part No. 3953071 to the outer surface of the plenum as outlined under Service Procedure.

1. Remove right hood latch assembly from the plenum panel and remove cowl vent grille.
2. Drill out two rivets retaining existing stud plate to plenum using a 7/32" dia. drill bit. Remove stud plate through cowl vent opening.
3. Position reinforcement plate on plenum as shown in sketch and drill seven (7) holes 7/32" dia. at hole locations in plate. The two (2) outboard holes are not accessible for drilling.
4. Attach the reinforcement plate to the plenum using 3/16" x 5/8" "Pop" Rivets.
5. Install and adjust right hood latch assembly as outlined in the August 1968 issue of "Chevrolet Service News." Install cowl vent grille.
