1966 - 1967 Corvette: Service Bulletin: Crankshaft to Water Pump Drive Belt Failure

Subject: Crankshaft to Water Pump Drive Belt Failure
Model and Year: 1966 - 1967 Corvettes with 427 CU. IN. Engine and Air Conditioning
Source: Chevrolet Service Technical Bulletin
Bulletin No: 67-T-26
Section: VI
Date: Sept. 26, 1967

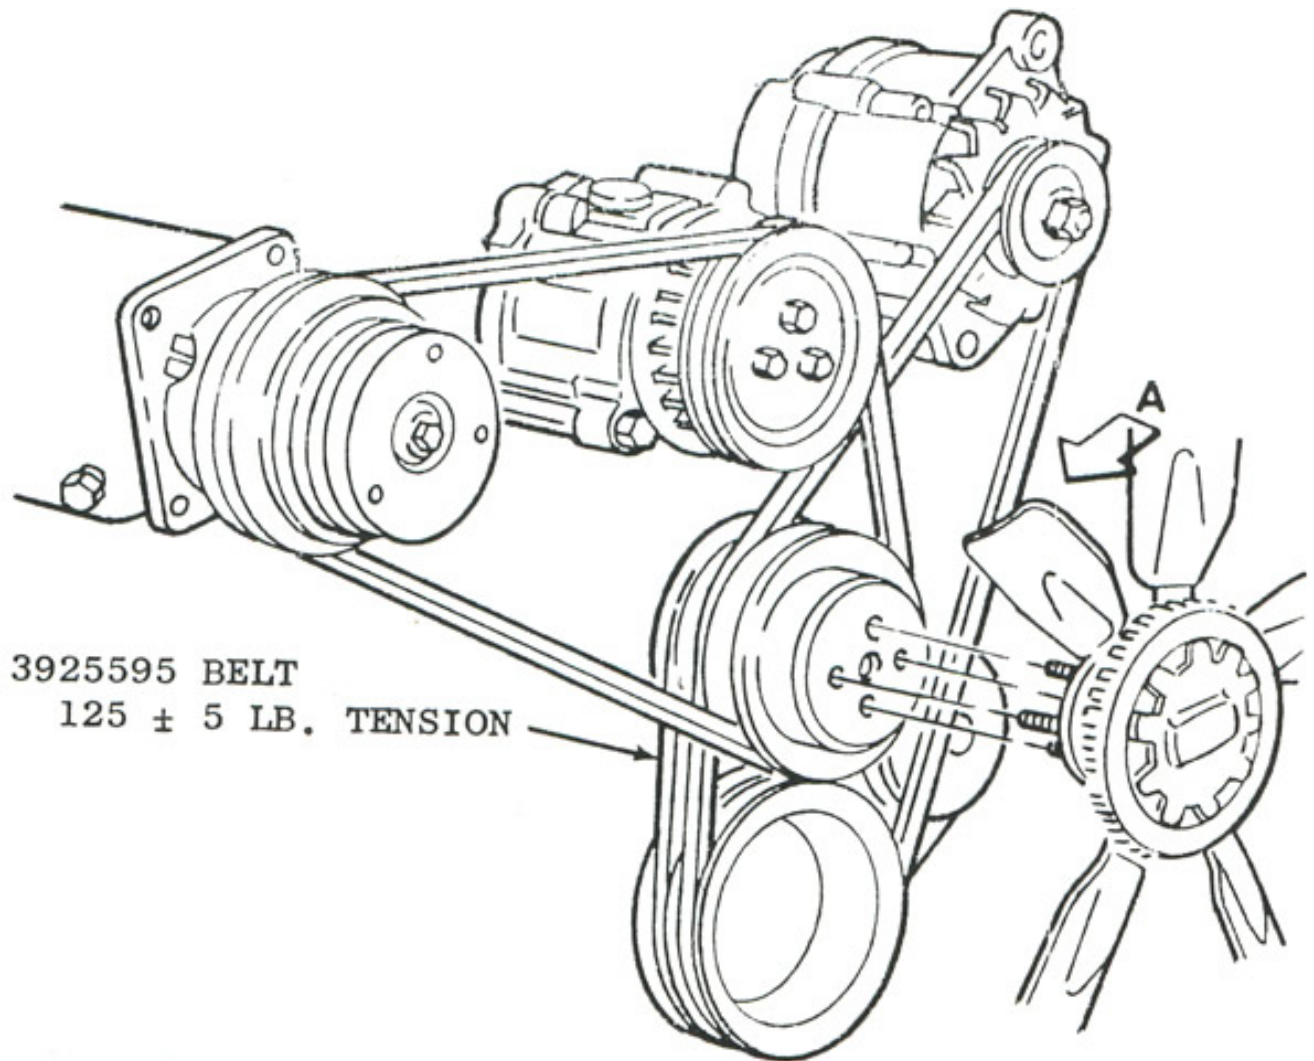
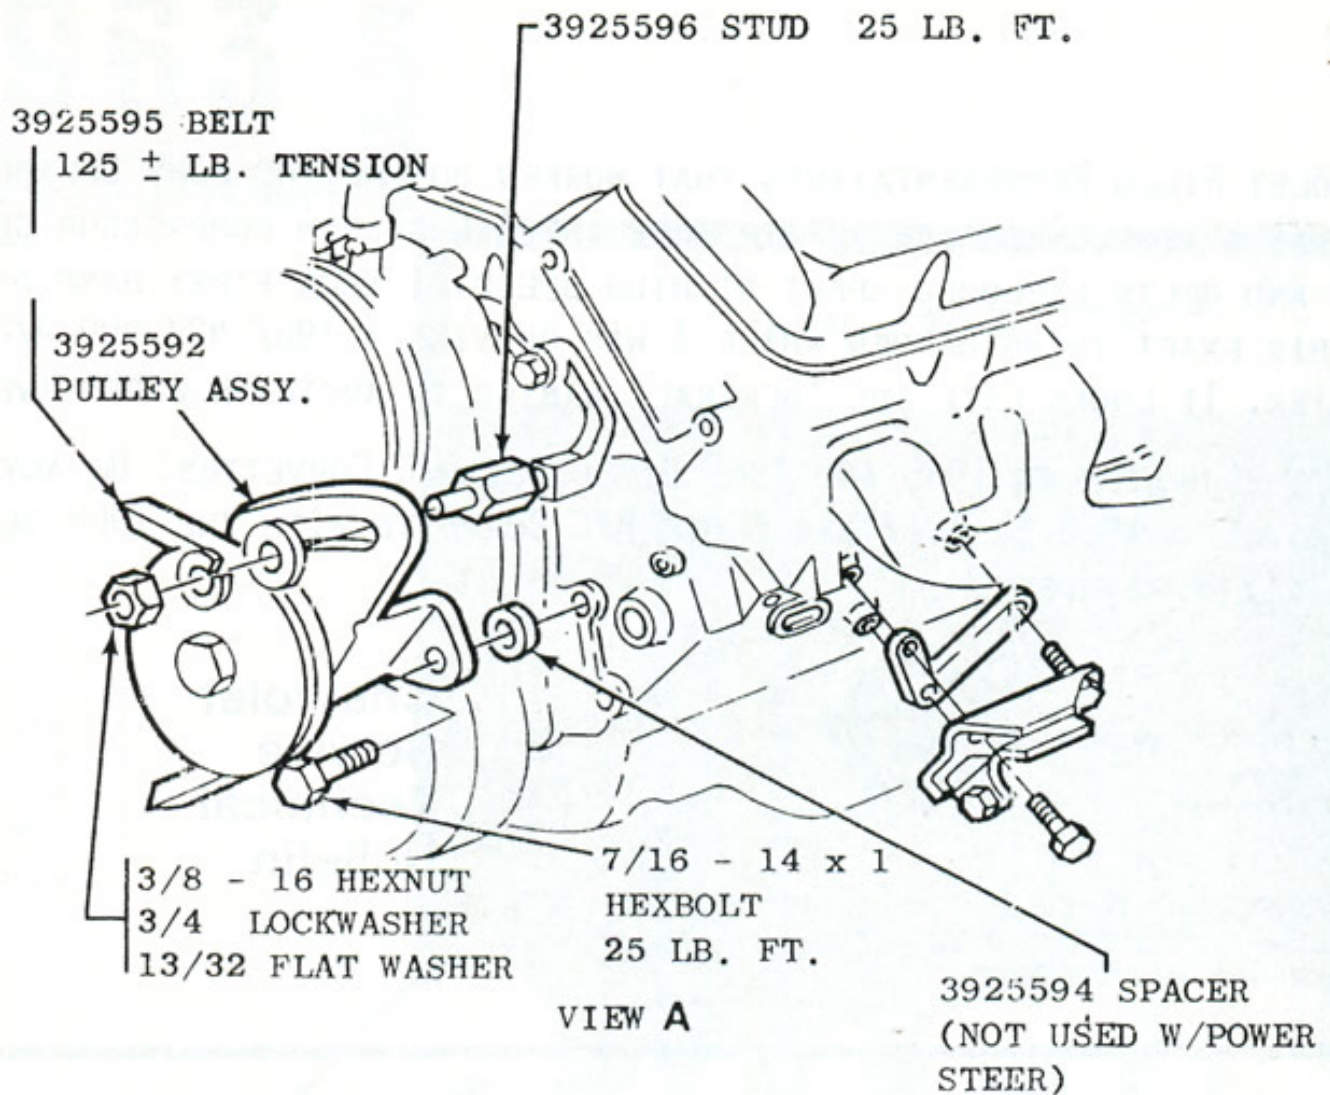
Reports have been received of crankshaft to water pump drive belt failures on 1966 and 1967 Corvettes equipped with 427 cubic inch engine and air conditioning. The belt failure occurs when the air conditioning compressor stalls under high head pressure after extreme hot soak conditions. With the compressor stalled, the water pump and the drive belt between the crankshaft and water pump also stall. As the crankshaft pulley continues to rotate, the crankshaft to water pump drive belt fails due to overheating and wear.

To permit belt tension adjustment between the crankshaft and water pump, 1968 Corvettes equipped with 427 cubic inch engine and air conditioning will incorporate an idler pulley shown in Figure 1.

In service, a similar idler pulley and longer drive belt can be installed to permit belt tension adjustment and correct the condition of belt slippage and wear. Parts information and installation instructions are illustrated in Figure 1
