1966 - 1967 Corvette: Service Bulletin: Crankshaft to Water Pump Drive Belt Failure

Subject: Crankshaft to Water Pump Drive Belt Failure
Model and Year: 1966 - 1967 Corvettes with 427 CU. IN. Engine and Air Conditioning
Source: Chevrolet Service Technical Bulletin
Bulletin No: 67-T-26
Section: VI
Date: Sept. 26, 1967

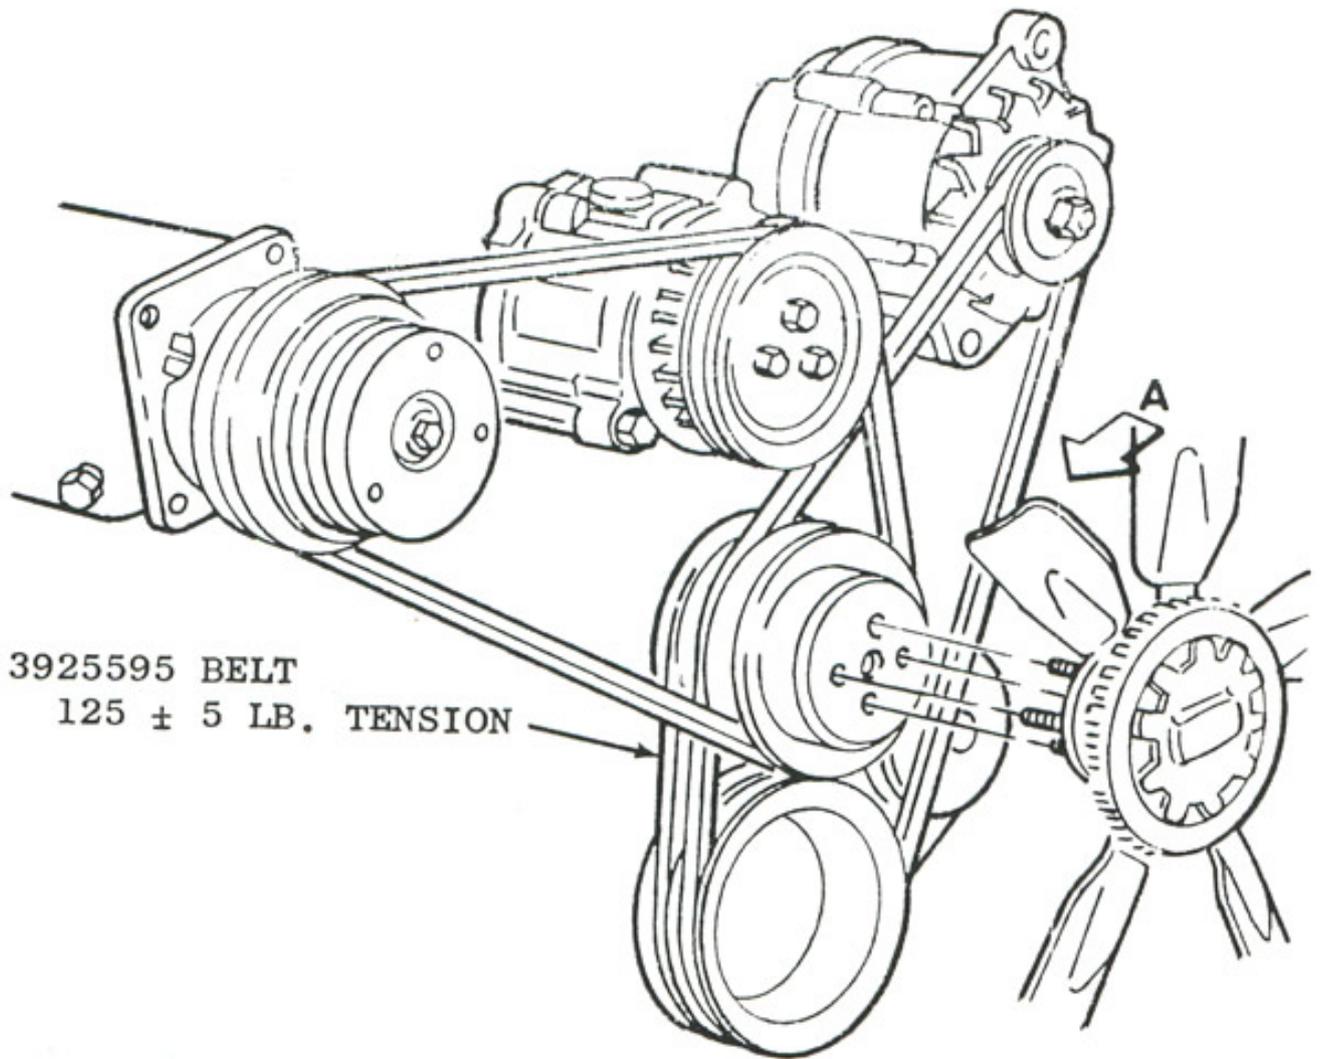
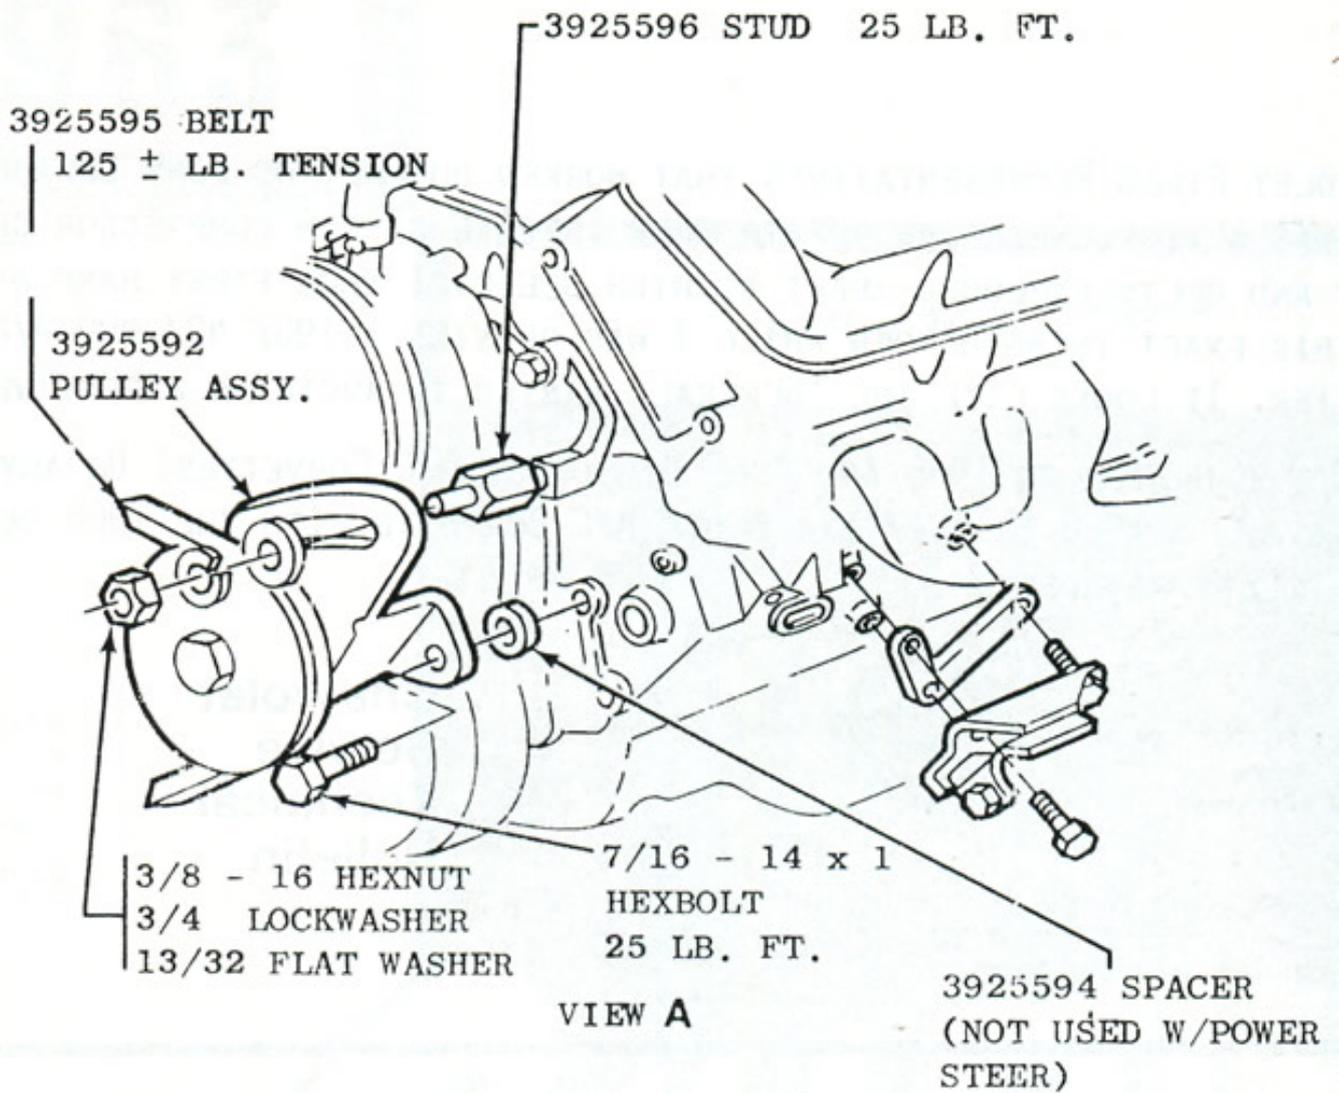
FIG. 1

Reports have been received of crankshaft to water pump drive belt failures on 1966 and 1967 Corvettes equipped with 427 cubic inch engine and air conditioning. The belt failure occurs when the air conditioning compressor stalls under high head pressure after extreme hot soak conditions. With the compressor stalled, the water pump and the drive belt between the crankshaft and water pump also stall. As the crankshaft pulley continues to rotate, the crankshaft to water pump drive belt fails due to overheating and wear.

To permit belt tension adjustment between the crankshaft and water pump, 1968 Corvettes equipped with 427 cubic inch engine and air conditioning will incorporate an idler pulley shown in Figure 1.

In service, a similar idler pulley and longer drive belt can be installed to permit belt tension adjustment and correct the condition of belt slippage and wear. Parts information and installation instructions are illustrated in Figure 1

3925595 BELT
125 ± 5 LB. TENSION
