# 1966 - 1967 Corvette: Service Bulletin: Crankshaft to Water Pump Drive Belt Failure

**Model and Year:** 1966 - 1967 Corvettes with 427 CU. IN. Engine and Air Conditioning

**Bulletin No:** 67-T-26

**Date:** Sept. 26, 1967

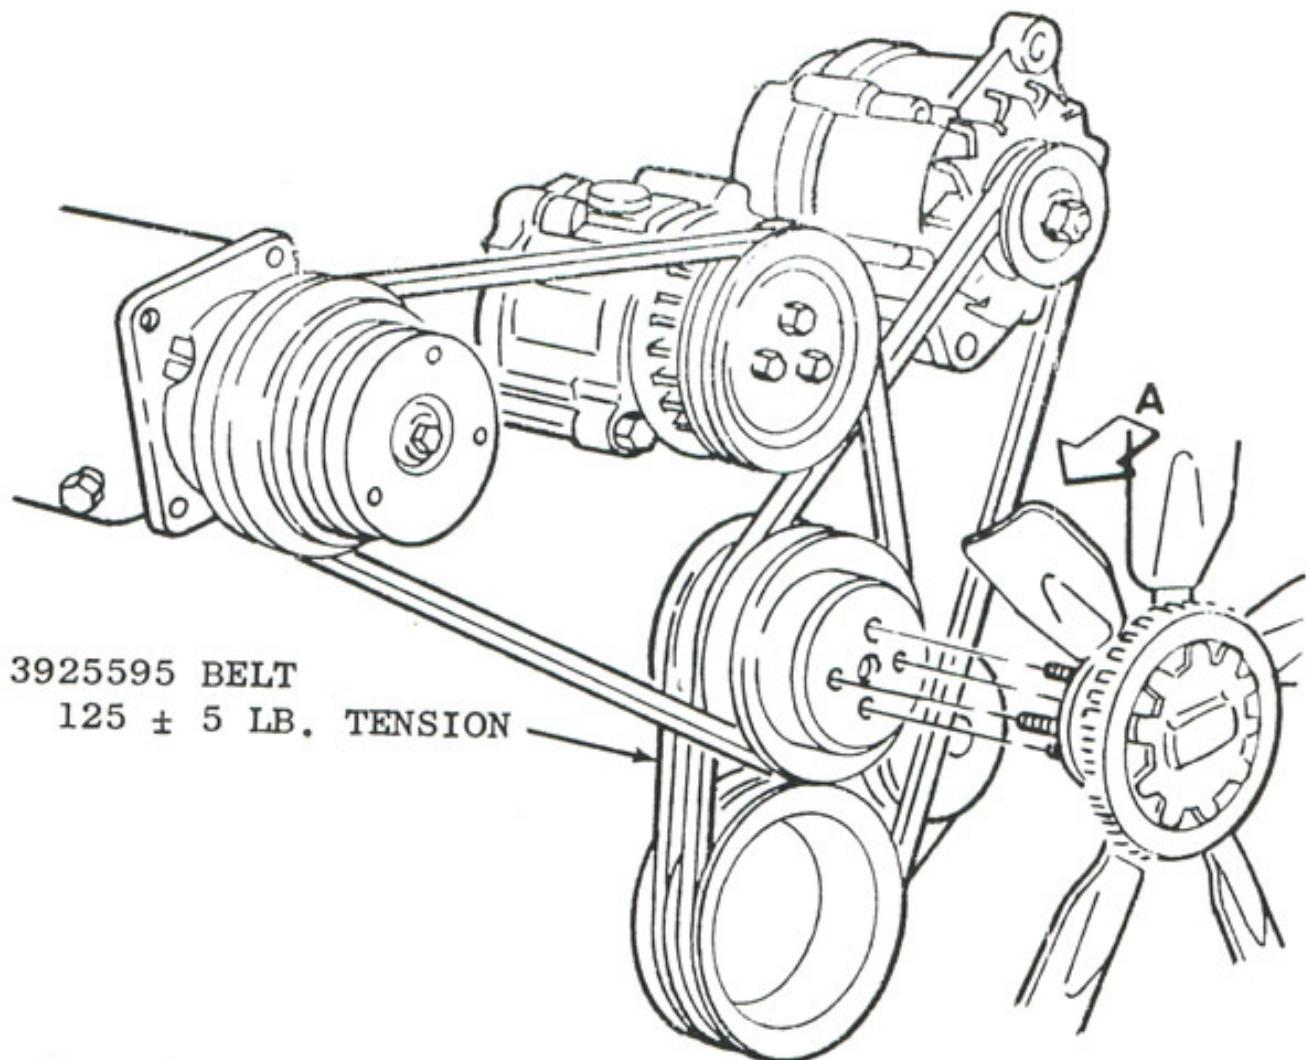
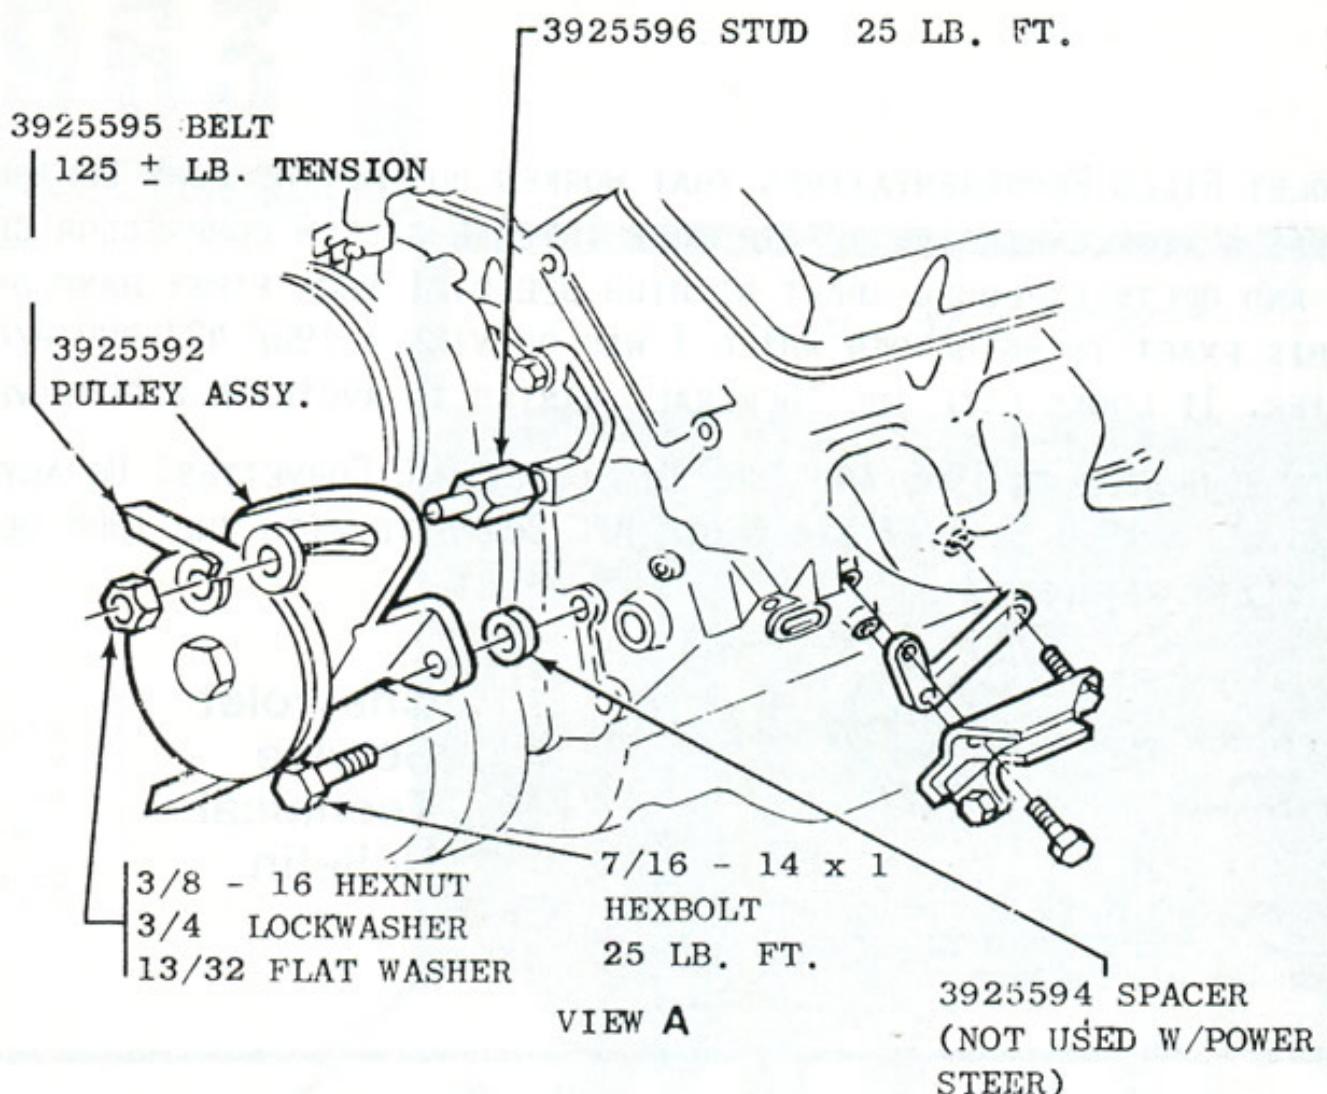
FIG. 1

Reports have been received of crankshaft to water pump drive belt failures on 1966 and 1967 Corvettes equipped with 427 cubic inch engine and air conditioning. The belt failure occurs when the air conditioning compressor stalls under high head pressure after extreme hot soak conditions. With the compressor stalled, the water pump and the drive belt between the crankshaft and water pump also stall. As the crankshaft pulley continues to rotate, the crankshaft to water pump drive belt fails due to overheating and wear.

To permit belt tension adjustment between the crankshaft and water pump, 1968 Corvettes equipped with 427 cubic inch engine and air conditioning will incorporate an idler pulley shown in Figure 1.

In service, a similar idler pulley and longer drive belt can be installed to permit belt tension adjustment and correct the condition of belt slippage and wear. Parts information and installation instructions are illustrated in Figure 1
