1978 Corvette: Service Bulletin: Air Conditioning Compressor Noise

Source: Chevrolet Dealer Service Technical Bulletin

Bulletin No: 78-T-76

Date: February 1979

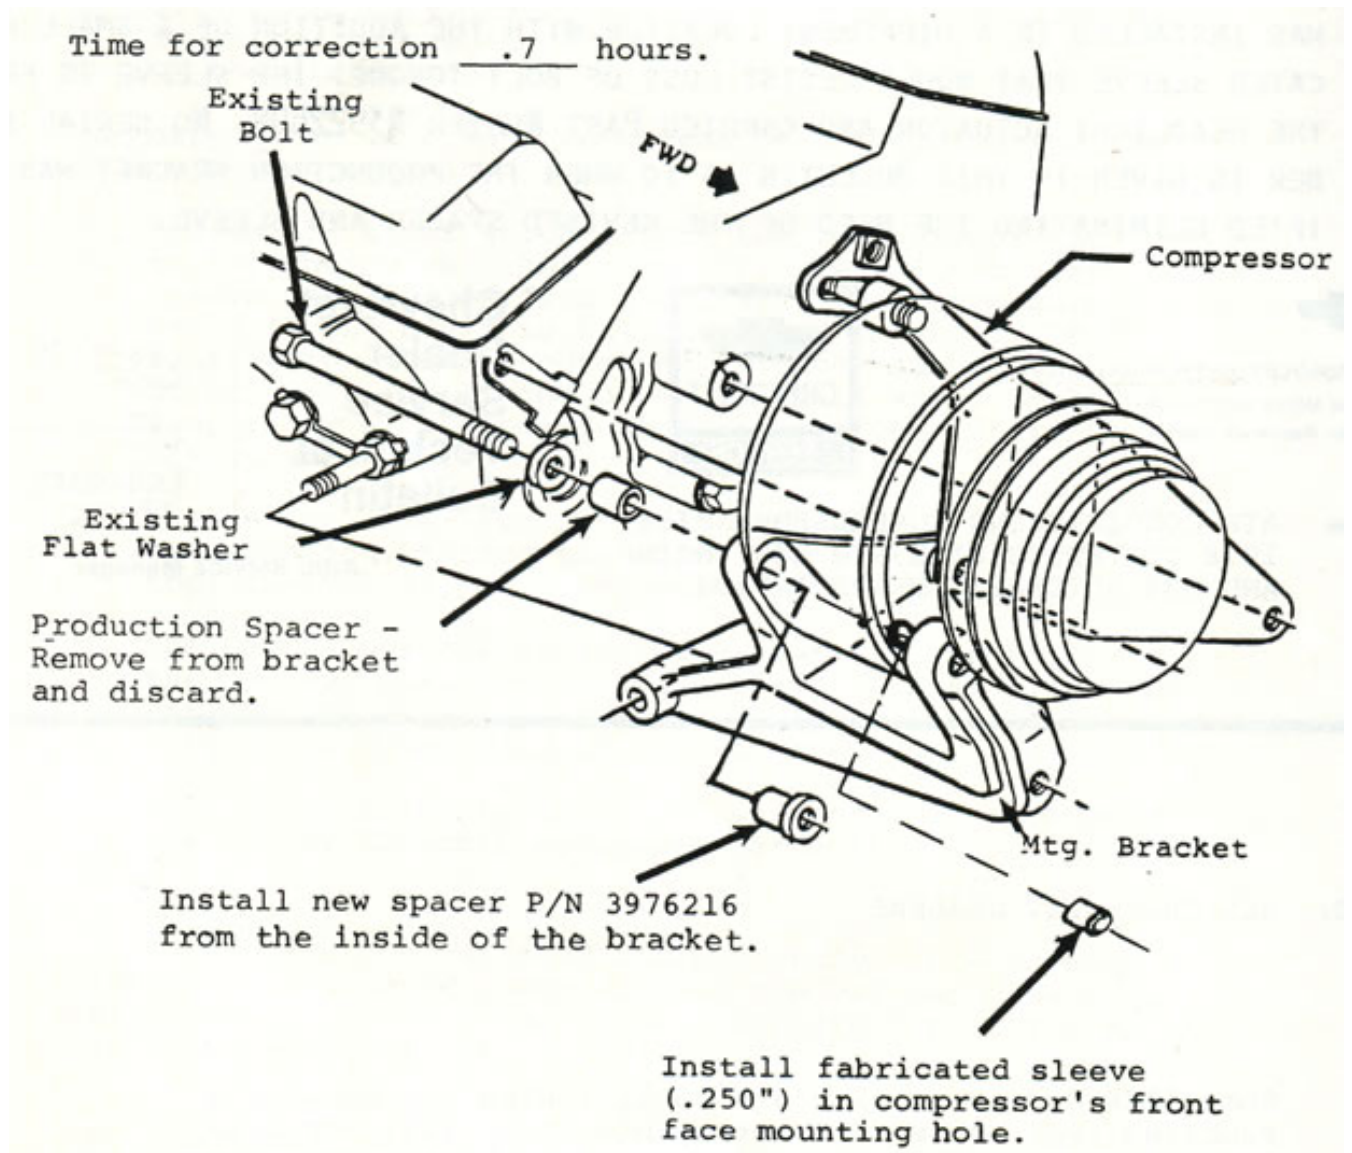
Some 1978 Corvettes with air conditioning may exhibit a rumbling type noise most noticeable at or just off idle RPM, with the air conditioning on, and the transmission in drive.

This condition usually occurs under high ambient temperatures and high head pressured and is caused by a reduction of compressor mounting bolt torque which results in compressor "wobble" and subsequent abnormal deflection of the compressor belt.

In production, the compressor mounting has been revised for 1979 Corvettes. Complaint vehicles can be corrected by using a new mounting bracket spacer, P/N 3976216, and the addition of a sleeve fabricated from a Corvette headlamp actuator sleeve, P/N 3922498, as outlined on page 2.

1. Obtain P/N 3976216 spacer and P/N 3922498 sleeve from stock.

2. Cut the P/N 3922498 plastic sleeve in half, resulting in two .250" long sleeves of which one will be used.
3. Remove the compressor belt and disassemble the compressor from the mounting brackets.
4. Lift compressor from bracket to allow access to both the original spacer in the mounting bracket hole and the mounting hole in the front face of the compressor where the feed-through bolt will exit.
5. Remove original spacer and install new spacer, P/N 3976216 in its place and the fabricated sleeve (.250") in the compressor face mounting hole as shown in Figure 1.
6. Reinstall compressor and belt.
7. Finalize the repair by tightening the compressor belt to 100 +/- 5 lbs. and torquing the compressor mounting bolts to 30 ft. lbs.
