1960 Corvette: Service Bulletin: Accelerator Pedal Falls Off Retaining Studs

Model and Year: 1960 Corvette Models

Source: General Motors of Canada - Service Bulletin

Date: June 15th, 1960

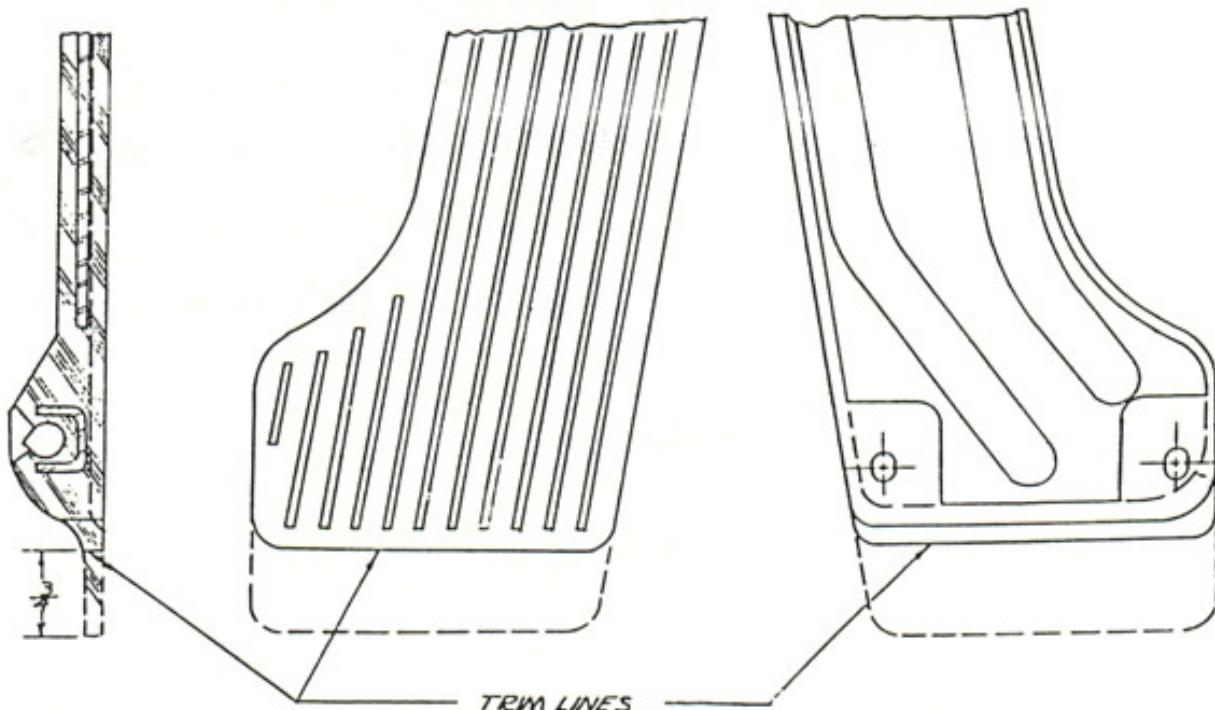
Fig. 31.

There has been a few complaints that the 1960 Corvette accelerator pedal snaps off of the two retaining studs at the heel end of the pedal, due to an interference condition between the floor mat material and the heel flap of the pedal.

REWORK INSTRUCTION DRAWING TO COVER THE MODIFICATION OF
THE 1960 CORVETTE ACCELERATOR PEDAL # 3771749

As a Production correction, the assembly plant will revert to the 1959 design pedal, part #3760271, which does not incorporate the heel flap.
