# 1963 Corvette: Service Bulletin: Transmission Shift Lever Vibration

**Model and Year:** 1963 1000 Series, Chevy II and Corvette with Floor Mounted Shift Lever

**Bulletin No:** DR #595

**Date:** June 24, 1963

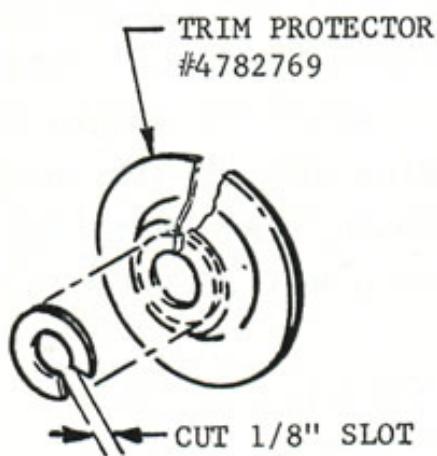
FIG. 1

Vehicles equipped with a Powerglide or 4-speed transmission which incorporates the floor mounted shift lever may be subject to a "buzzing" type noise as a result of shift lever-to-mounting bracket vibration and/or excessive shift lever-to-guide plate clearance.

A plastic insulating washer, approximately 1" O.D., fabricated from trim protector No. 4782769 (see fig. 1, below) will be required on all vehicles produced prior to November 15, 1962, when a complaint of shift lever "buzzing" is encountered.
