1963 Corvette: Service Bulletin: Transmission Shift Lever Vibration

Subject: Transmission Shift Lever Vibration
Model and Year: 1963 1000 Series, Chevy II and Corvette with Floor Mounted Shift Lever
Source: Chevrolet Technical Service Bulletin
Bulletin No: DR #595
Section: VII
Date: June 24, 1963

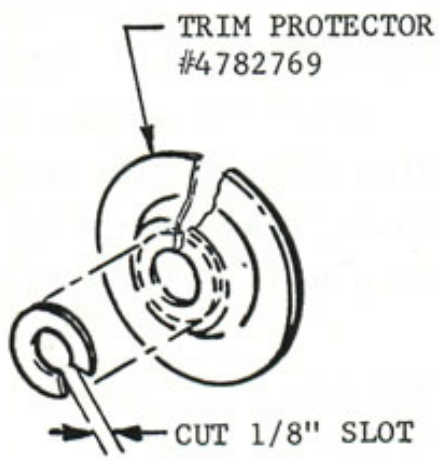
FIG. 1

A plastic insulating washer, approximately 1" O.D., fabricated from trim protector No. 4782769 (see fig. 1, below) will be required on all vehicles produced prior to November 15, 1962, when a complaint of shift lever "buzzing" is encountered.

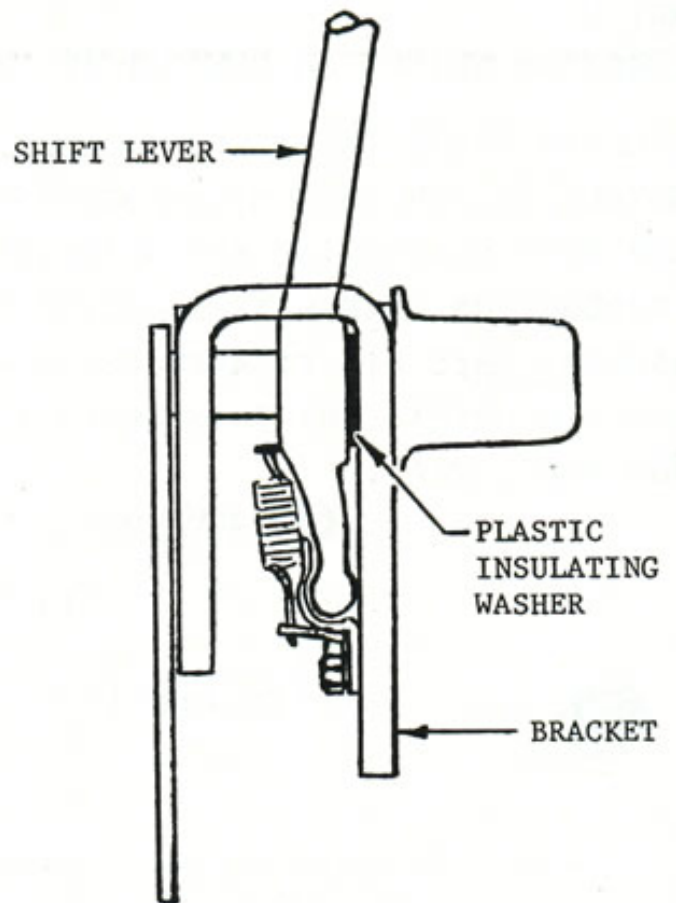
Vehicles equipped with a Powerglide or 4-speed transmission which incorporates the floor mounted shift lever may be subject to a "buzzing" type noise as a result of shift lever-to-mounting bracket vibration and/or excessive shift lever-to-guide plate clearance.

With the shift lever assembly removed from the vehicle, insert the above fabricated insulator washer on the shaft between the lever and bracket. (See Figure 2, below)
