1963 - 1965 Corvette: Service Bulletin: Rear Suspension Crossmember Isolation Mounts Pulling Loose

Source: Chevrolet Technical Service Bulletin

Bulletin No: TSB #1036

Date: September 15, 1964

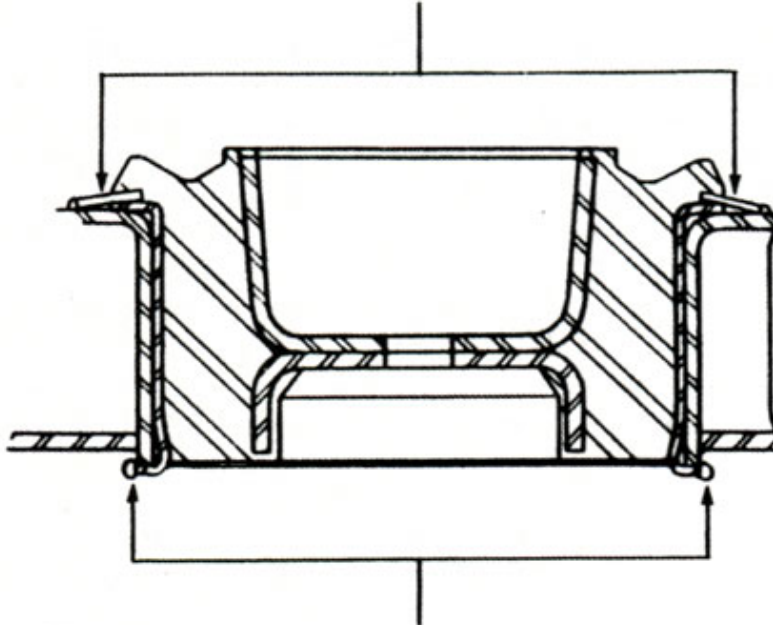
Under certain driving conditions on 1963, 1964 and 1965 Corvettes, the rear suspension isolation mount retaining tabs do not prevent the isolation mount from pulling out of the rear crossmember.

1. Cut rubber loose from outer shell and position two pieces of 1010 steel ($1/8" \times 1/2" \times 2"$) against shell.
