# 1963 - 1965 Corvette: Service Bulletin: Rear Suspension Crossmember Isolation Mounts Pulling Loose

**Source:** Chevrolet Technical Service Bulletin

**Bulletin No:** TSB #1036

**Date:** September 15, 1964

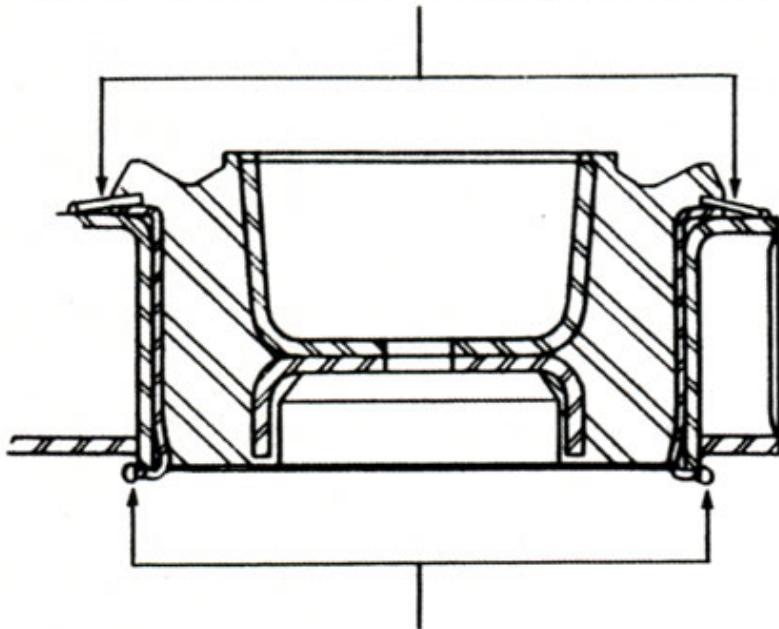
Under certain driving conditions on 1963, 1964 and 1965 Corvettes, the rear suspension isolation mount retaining tabs do not prevent the isolation mount from pulling out of the rear crossmember.

1. Cut rubber loose from outer shell and position two pieces of 1010 steel (1/8" x 1/2" x 2") against shell.
