# 1970 Corvette: Service Bulletin: 1970 Corvette Folding Top Material Interference with Lid Pin Support

**Source:** Chevrolet Dealer Service Technical Bulletin

**Bulletin No:** 70-T-46

**Date:** Oct. 27, 1970

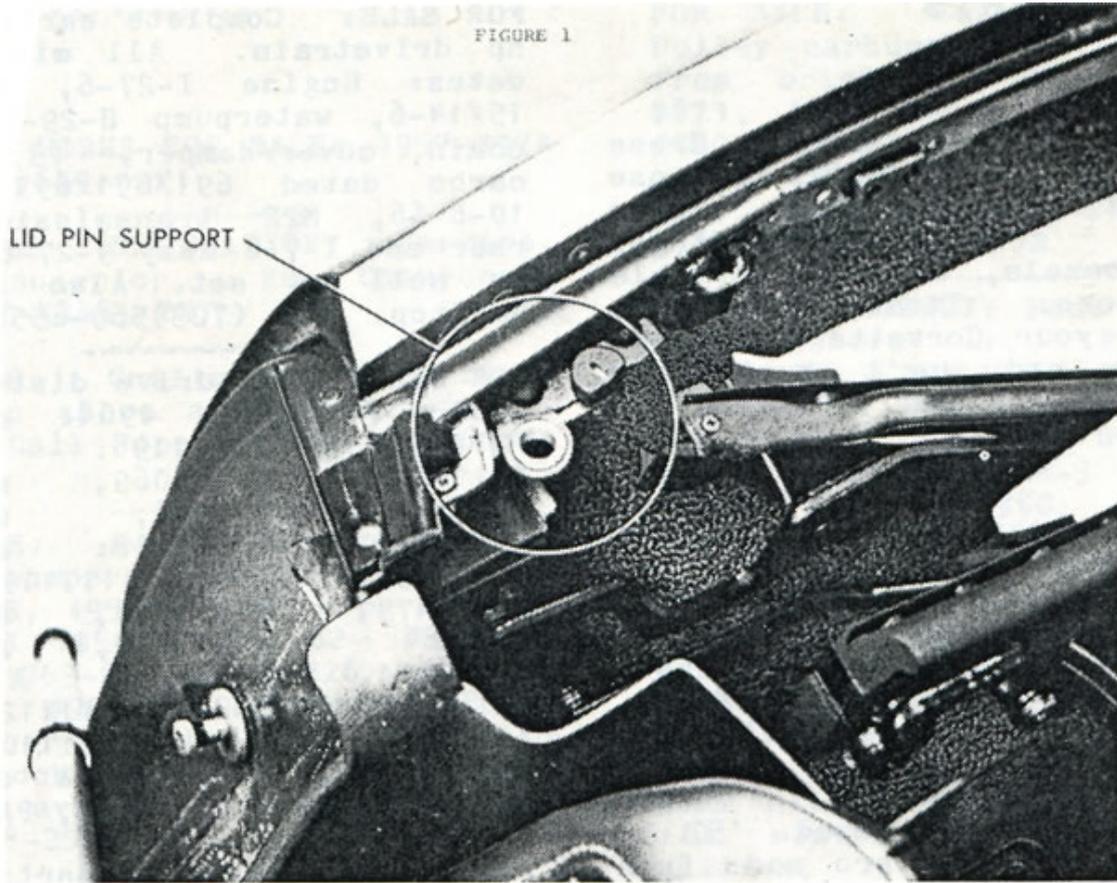
FIGURE 1

1970 Corvettes assembled prior to Serial Number S400748 may have interference between the folding top material and the top compartment lid pin support. This interference may result in damage to the folding top material.

1. Remove the lid pin support. (See Figure 1).
2. Grind 3/8" x 3/4" off the inboard edge of the support. (See Figure 2).
3. Reinstall the lid pin support and inspect to insure adequate clearance exists between the folding top material and the support.

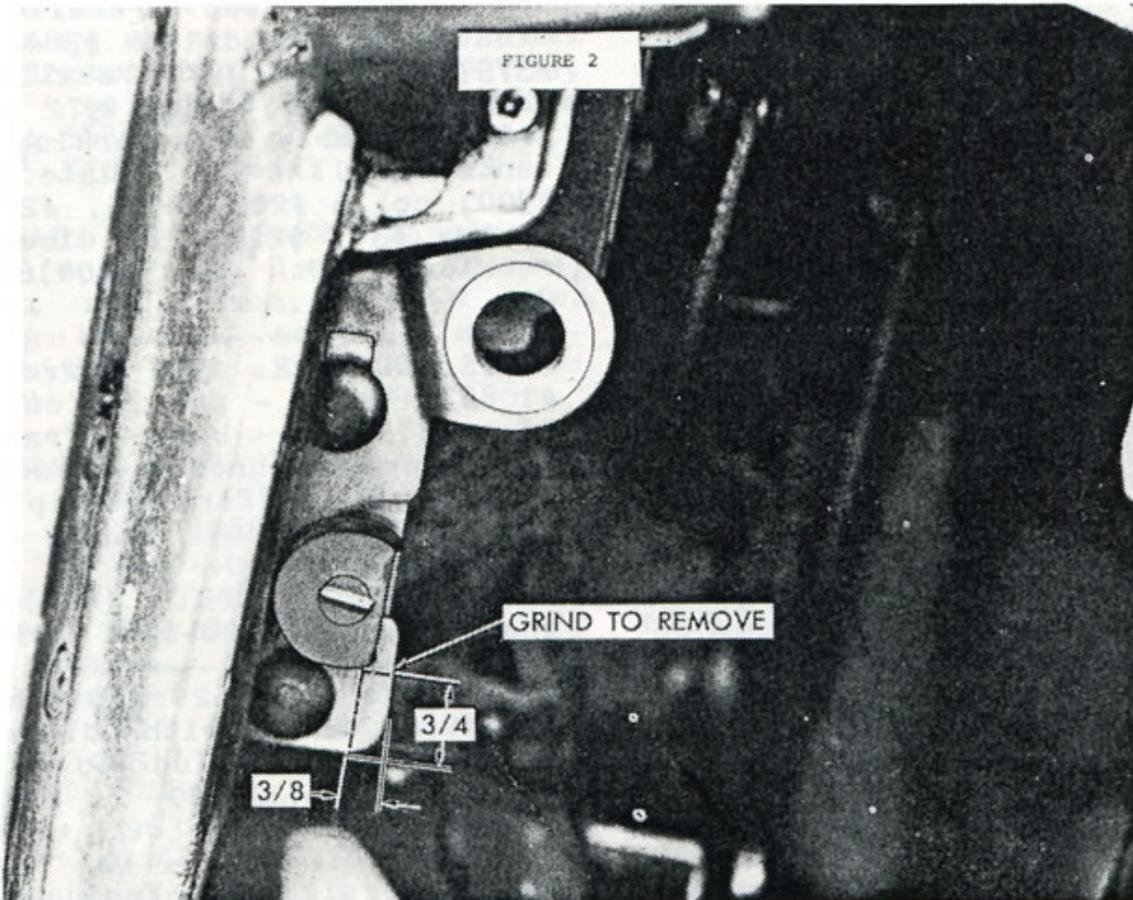
FIGURE 2

GRIND TO REMOVE
