1970 Corvette: Service Bulletin: 1970 Corvette Folding Top Material Interference with Lid Pin Support

Source: Chevrolet Dealer Service Technical Bulletin

Bulletin No: 70-T-46

Date: Oct. 27, 1970

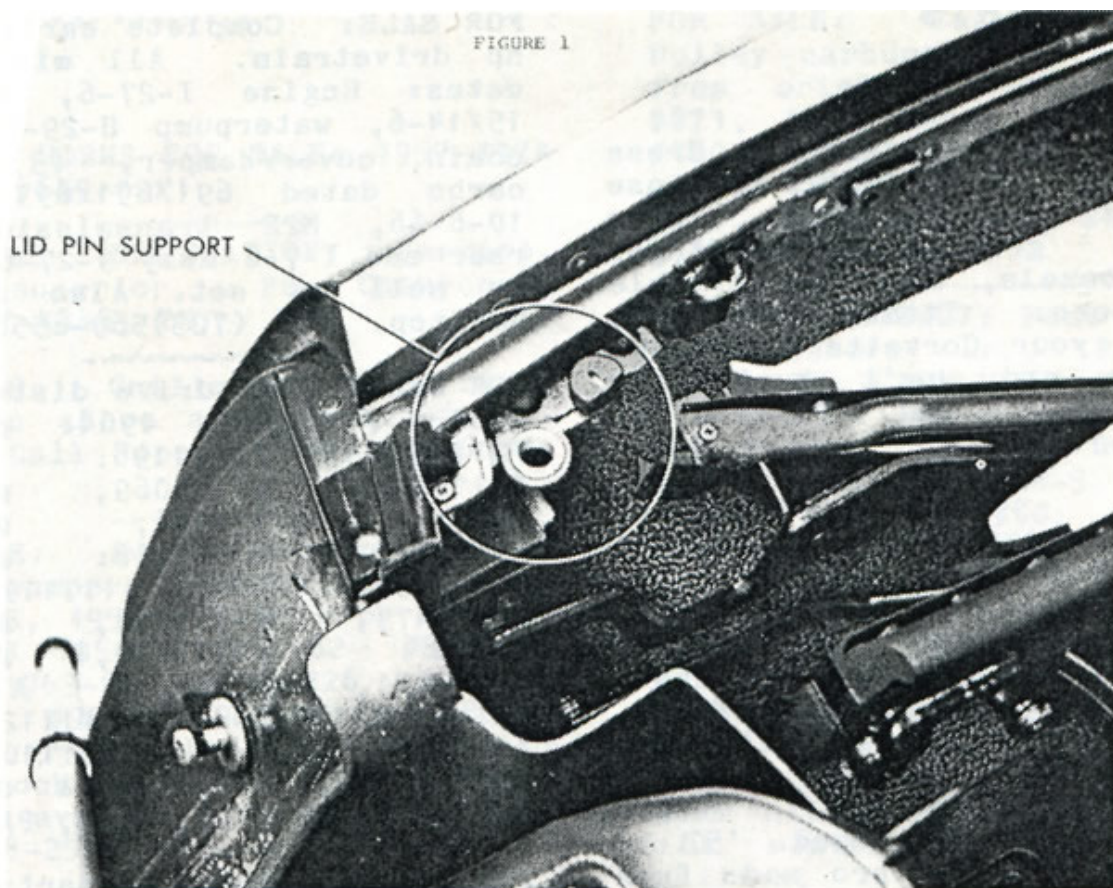
FIGURE 1

1970 Corvettes assembled prior to Serial Number S400748 may have interference between the folding top material and the top compartment lid pin support. This interference may result in damage to the folding top material.

1. Remove the lid pin support. (See Figure 1).
2. Grind 3/8" x 3/4" off the inboard edge of the support. (See Figure 2).
3. Reinstall the lid pin support and inspect to insure adequate clearance exists between the folding top material and the support.

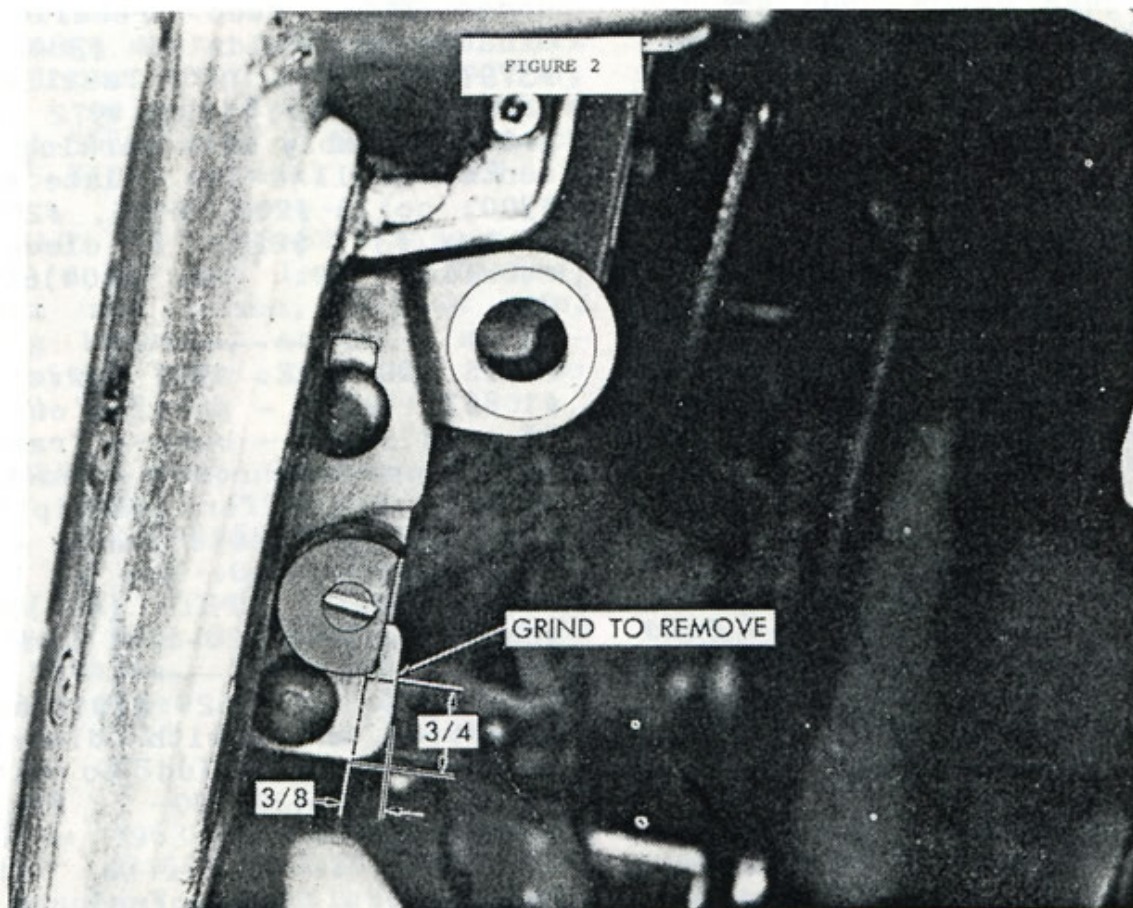
FIGURE 2

GRIND TO REMOVE
