1970 Corvette: Service Bulletin: 1970 Corvette Folding Top Material Interference with Lid Pin Support

Source: Chevrolet Dealer Service Technical Bulletin

Bulletin No: 70-T-46

Date: Oct. 27, 1970

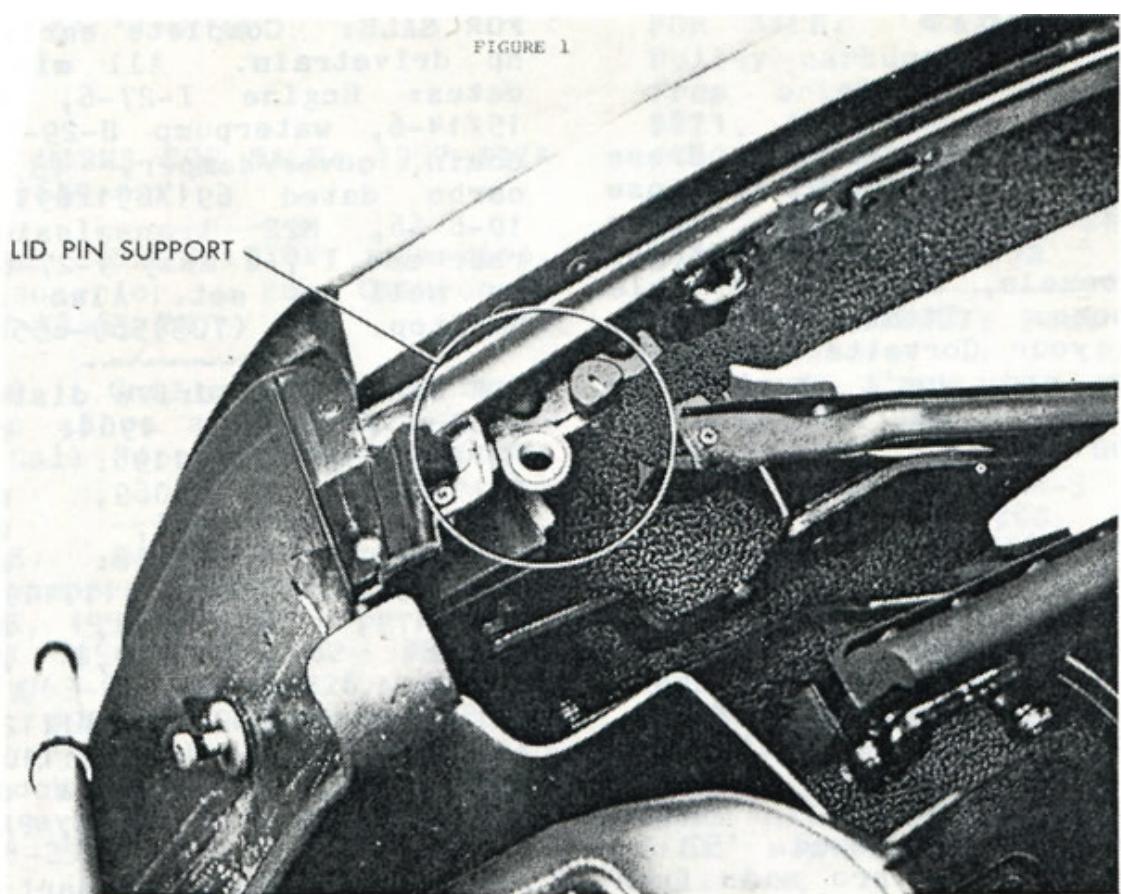
FIGURE 1

1970 Corvettes assembled prior to Serial Number S400748 may have interference between the folding top material and the top compartment lid pin support. This interference may result in damage to the folding top material.

1. Remove the lid pin support. (See Figure 1).
2. Grind 3/8" x 3/4" off the inboard edge of the support. (See Figure 2).
3. Reinstall the lid pin support and inspect to insure adequate clearance exists between the folding top material and the support.
