1984 Corvette: Service Bulletin: Broken Window Regulator Tapes

Source: Chevrolet Dealer Service Bulletin

Bulletin No: 84-3

Date: Oct., 1983

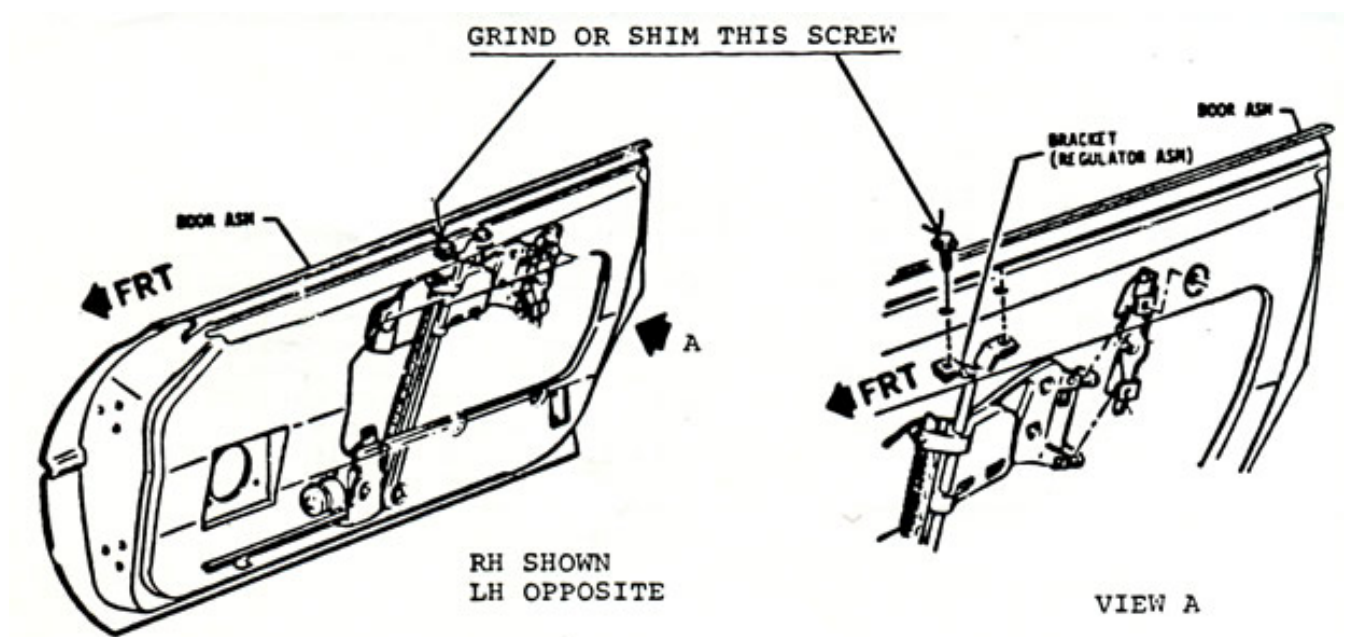
Whenever a vehicle requires service of door components, inspect for interference between the forward upper attaching screw and the upper end of the tape drive. if interference exists, one of the following options should be performed:

This is to prevent contact between the bottom of the screw and the upper end of the tape drive. if this contact exists, excessive stress is created in the tape and could cause a failure.

1. Add a washer (P/N 14038397), or equivalent, under the upper forward attaching screw (See Illustration).
2. Remove the forward attaching screw (P/N 11503800) and grind approximately 3mm from the threaded end.
