1980 Corvette: Service Bulletin: Rear Wheel Spindle Yoke Snapping Noise

Source: Chevrolet Dealer Service Technical Bulletin

Bulletin No: 80-T-44

Date: June, 1980

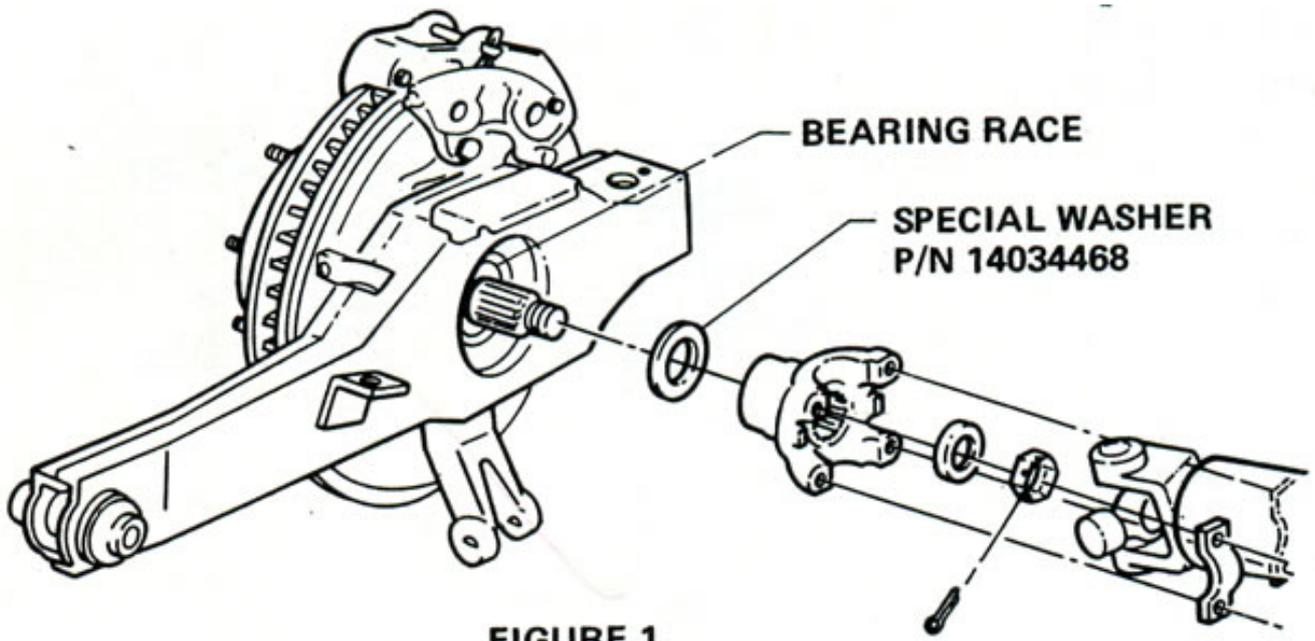
FIGURE 1

Owners of 1980 Corvettes, primarily those equipped with a manual transmission, may experience a snapping or crunching noise from either or both rear wheel locations during torque reversals and during acceleration or deceleration. This noise is the result of scuffing of the rear wheel spindle yoke against the inner wheel bearing inner race.

This condition can be corrected by installing a special Moly coated washer (P/N 14034468) between the spindle yoke and the inner wheel bearing (see Figure 1). Steps 2 through 8 of the following Service Procedure should be performed at each rear wheel.
