# 1980 Corvette: Service Bulletin: Rear Wheel Spindle Yoke Snapping Noise

**Model and Year:** 1980 Corvette

**Bulletin No:** 80-T-44

**Date:** June, 1980

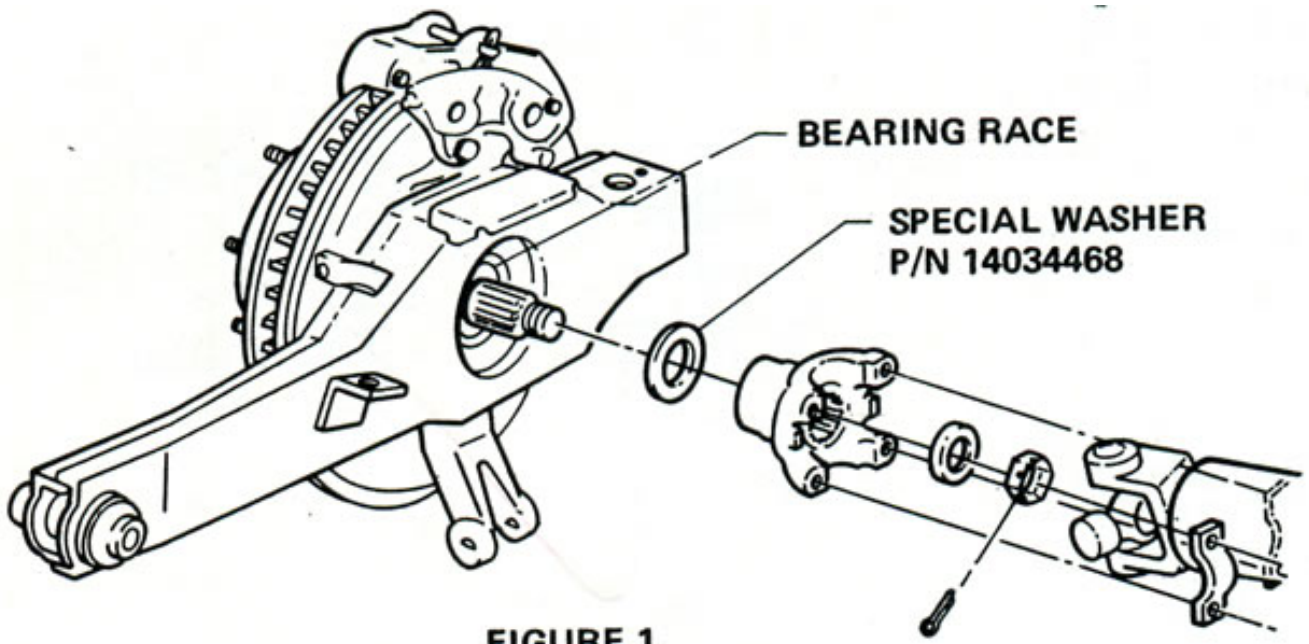
FIGURE 1

Owners of 1980 Corvettes, primarily those equipped with a manual transmission, may experience a snapping or crunching noise from either or both rear wheel locations during torque reversals and during acceleration or deceleration. This noise is the result of scuffing of the rear wheel spindle yoke against the inner wheel bearing inner race.

This condition can be corrected by installing a special Moly coated washer (P/N 14034468) between the spindle yoke and the inner wheel bearing (see Figure 1). Steps 2 through 8 of the following Service Procedure should be performed at each rear wheel.
