1980 Corvette: Service Bulletin: Rear Wheel Spindle Yoke Snapping Noise

Source: Chevrolet Dealer Service Technical Bulletin

Bulletin No: 80-T-44

Date: June, 1980

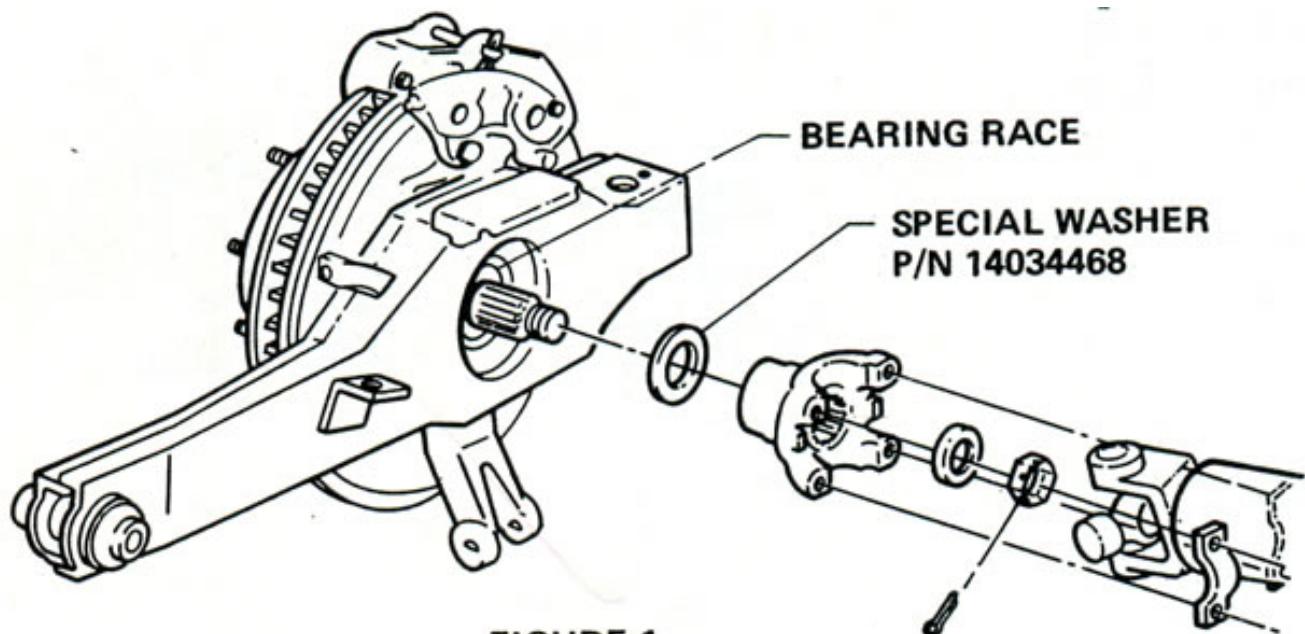
FIGURE 1

Owners of 1980 Corvettes, primarily those equipped with a manual transmission, may experience a snapping or crunching noise from either or both rear wheel locations during torque reversals and during acceleration or deceleration. This noise is the result of scuffing of the rear wheel spindle yoke against the inner wheel bearings inner race.

This condition can be corrected by installing a special Moly coated washer (P/N 14034468) between the spindle yoke and the inner wheel bearing (see Figure 1). Steps 2 through 8 of the following Service Procedure should be performed at each rear wheel.
