1980 Corvette: Service Bulletin: Rear Wheel Spindle Yoke Snapping Noise

Model and Year: 1980 Corvette

Source: Chevrolet Dealer Service Technical Bulletin

Bulletin No: 80-T-44

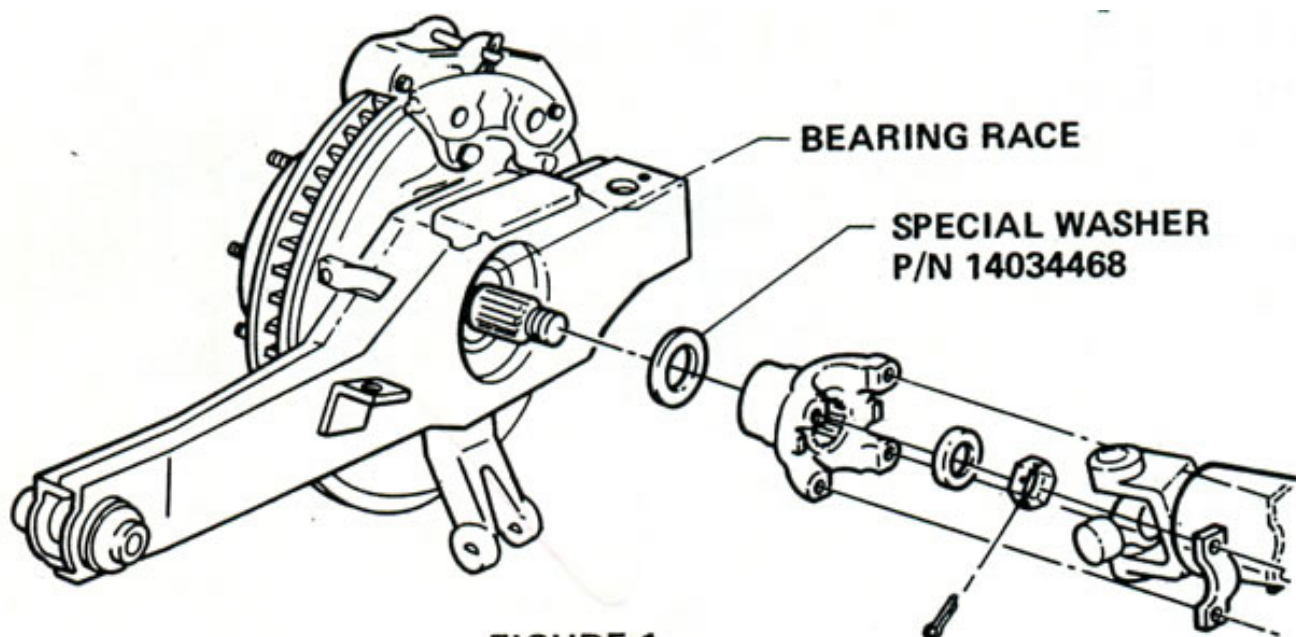
FIGURE 1

Owners of 1980 Corvettes, primarily those equipped with a manual transmission, may experience a snapping or crunching noise from either or both rear wheel locations during torque reversals and during acceleration or deceleration. This noise is the result of scuffing of the rear wheel spindle yoke against the inner wheel bearing inner race.

This condition can be corrected by installing a special Moly coated washer (P/N 14034468) between the spindle yoke and the inner wheel bearing (see Figure 1). Steps 2 through 8 of the following Service Procedure should be performed at each rear wheel.
